# MONTANA DEPARTMENT OF TRANSPORTATION STREAM MITIGATION MONITORING REPORT

*Ashley Creek  
Flathead County, Montana*

*Project Completed: 2010  
Monitoring Report #3: December, 2015*

MDT Project Number: NH-MT 5-3(59) FST  
Control Number: 2038

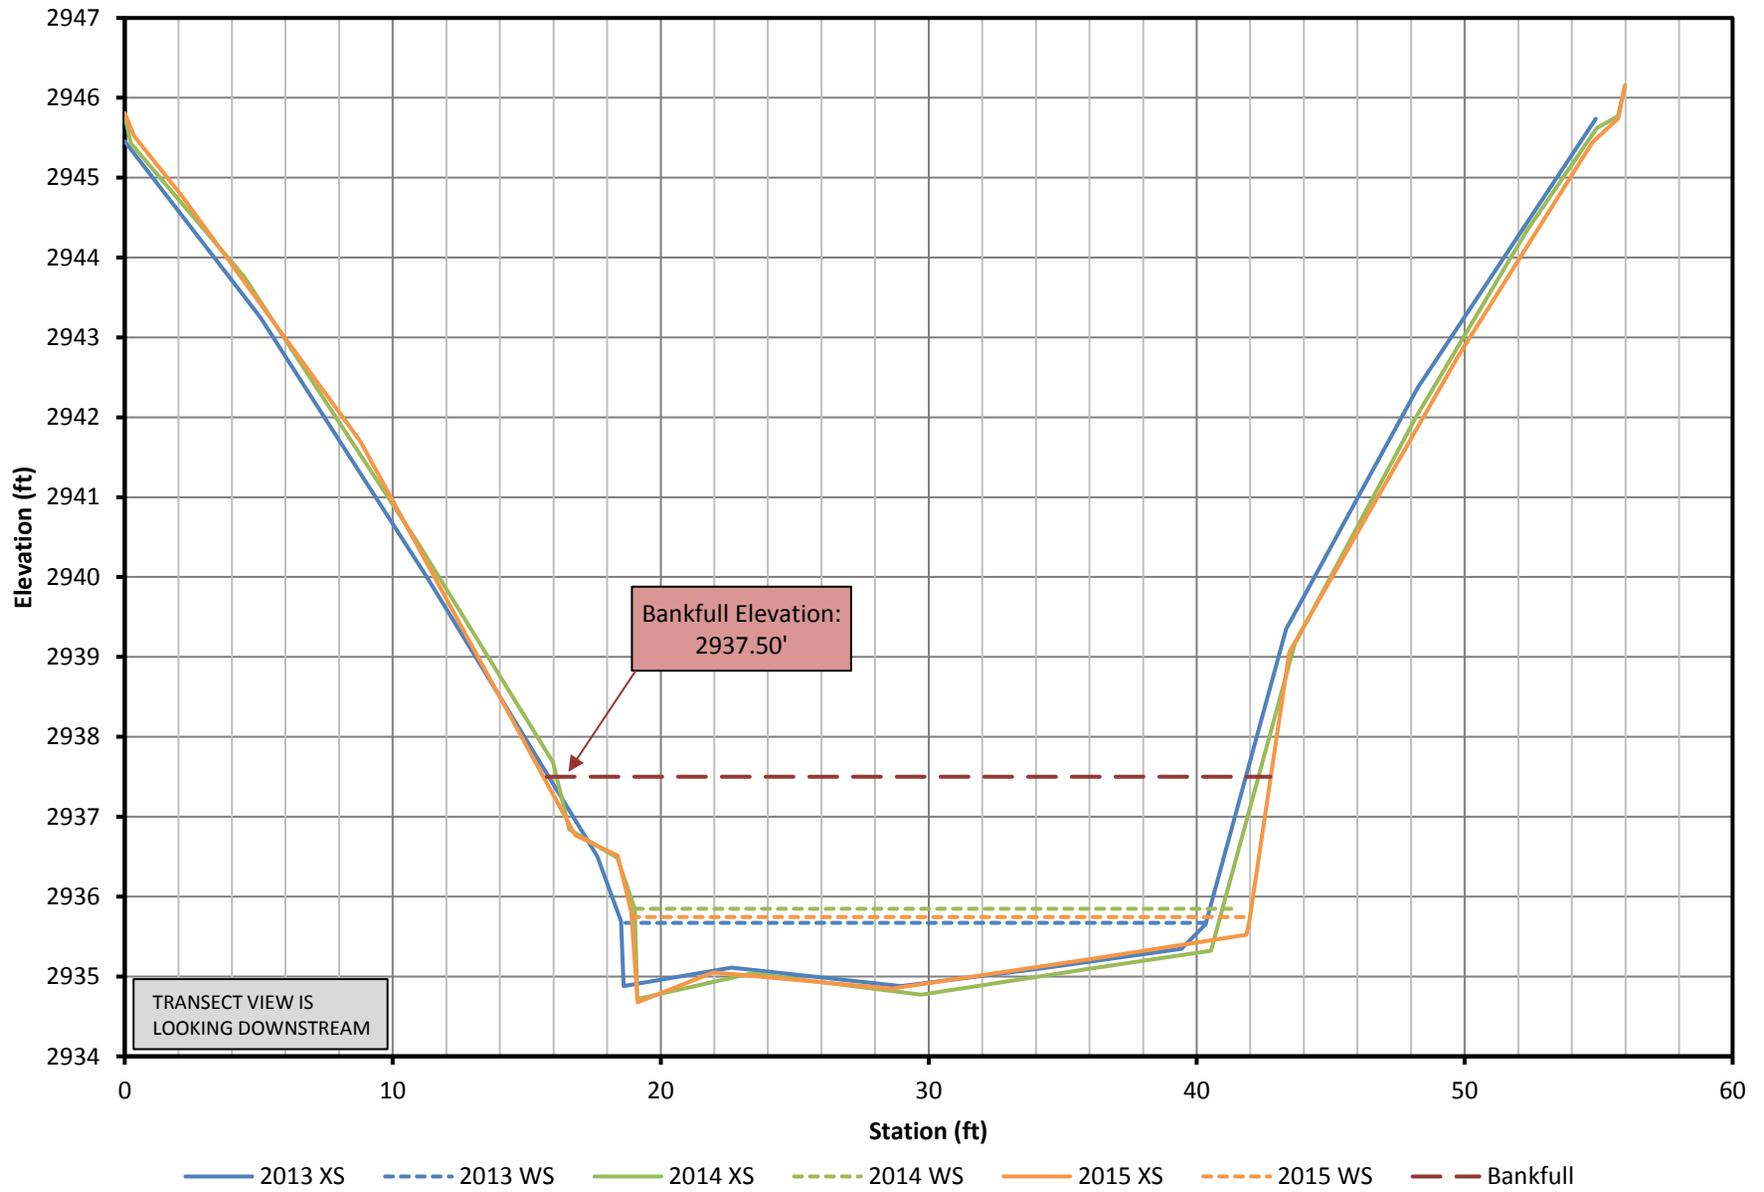
# Ashley Creek Transect #3 - Riffle

Transect #3 runs through a 50-foot riffle that extends from Station 2+30 to 2+80. Erosion has also been noted along the right bank of Transect #3, with lateral movement of approximately 1 foot over the past two years. Bankfull width at Transect #3 is 27 feet, while the maximum depth is 2.8 feet.

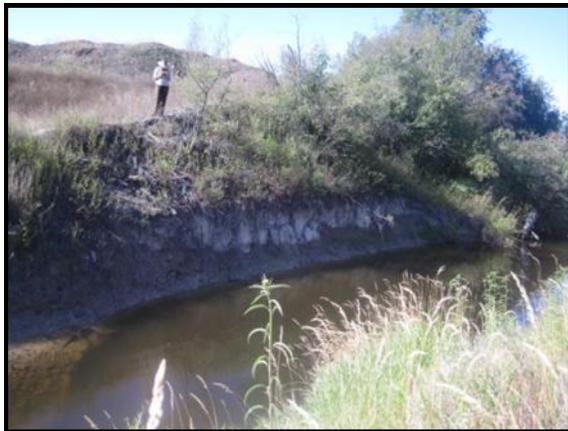
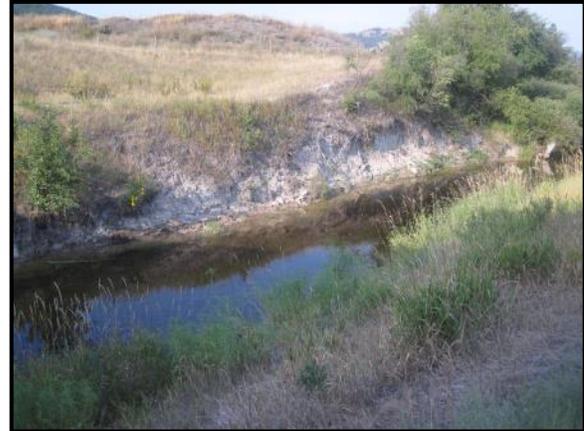
and stabilize as part of a bridge expansion project over Ashley Creek. Eroding bank EBR1 has lengthened to 97 feet from 53 feet in 2014. Based on Transects #2 and #3 (Section 4.6), this bank has retreated between 1 and 2 feet over the past year. Although this erosion rate is not particularly high, movement of the toe has resulted in a steep bank angle leading down to the channel that may not be able to establish vegetation. As a result, continued erosion along this bank is anticipated. Based on the percentage of eroding banks observed within the project reach, the success criteria for stream bank stability is not currently being met along Ashley Creek.

**Additional Photo 2 - 2013**  
**Description:** View of eroding bank EBR1  
**Compass:** 225 (South-Southwest)

**Additional Photo 2 - 2015**  
**Description:** View of eroding bank EBR1  
**Compass:** 225 (South-Southwest)

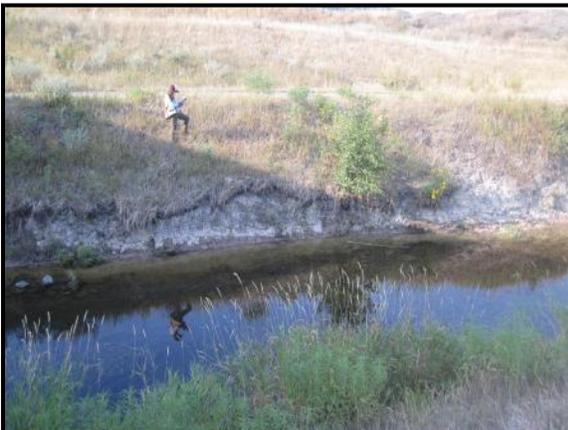
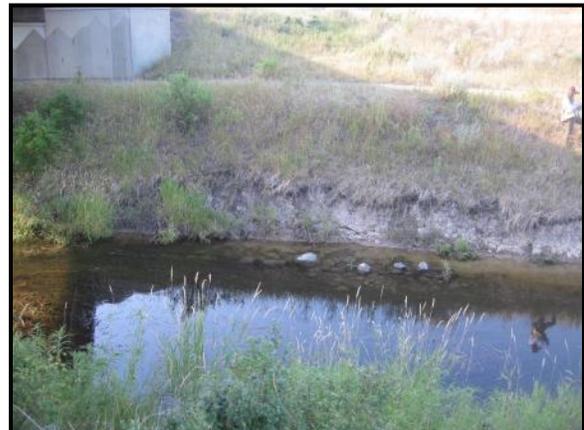
**Additional Photo 3 - 2015**  
**Description:** View of additional bank erosion along EBR1 noted in 2015. **Compass:** 315 (Northwest)

**Additional Photo 4 - 2015**  
**Description:** View of additional bank erosion along EBR1 noted in 2015. **Compass:** 0 (North)

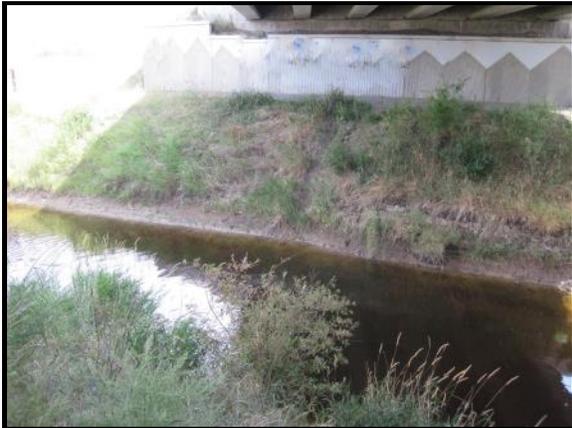
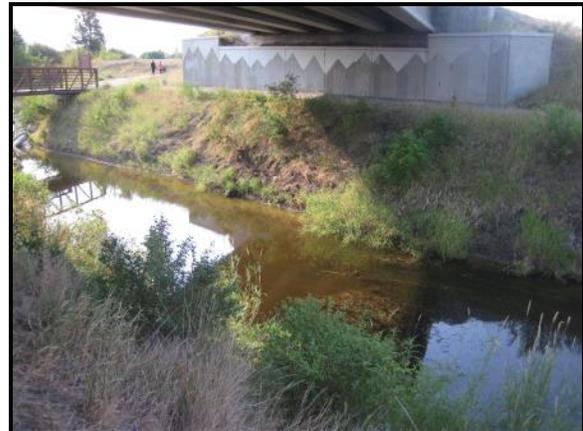
Eroding banks EBL2 and EBR2 also occur along the straight channel segment of Ashley Creek. These banks were documented as eroding during the 2014 monitoring event, but do not appear to have eroded further in 2015. The eroding bank length at EBL2 remains at 40 feet, while EBR2 remains at 56 feet. Bank conditions and causes of erosion are identical to EBR1, with fine grained soils, relatively steep bank slopes, and lack of functional floodplain adjacent to the channel. Erosion severity along these banks is considered moderate to high based on existing conditions and the likelihood that lateral erosion will continue. Due to these factors, stabilization efforts are warranted to meet mitigation performance criteria for stream bank stability.

**Additional Photo 5 - 2013**  
Description: EBR2  
Compass: 180 (South)

**Additional Photo 5 - 2015**  
Description: EBR2  
Compass: 180 (South)

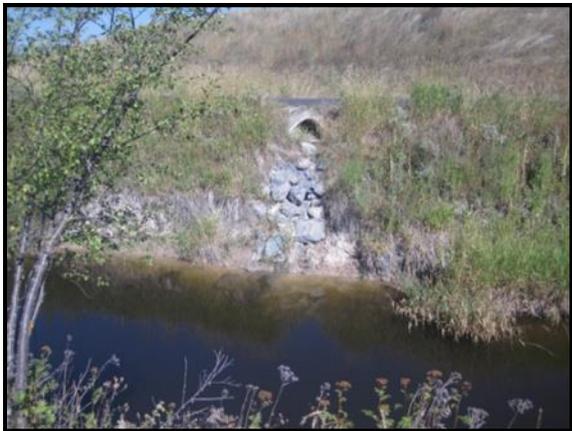
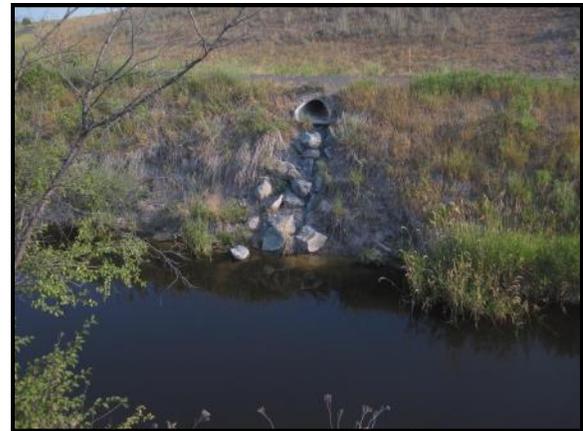
Portions of the riprap placed below the culvert have sloughed into the channel. A separate inspection (RESPEC, 2014) provided additional details, causes of erosion, and recommended actions to stabilize this bank. This report cited the lack of riprap placement in a key trench at the toe of the slope, poorly graded riprap, and disturbance of fine grained soils during construction as causes for riprap failure and bank instability at this location. Due to these factors, erosion severity is considered moderate at this location. The extent of erosion along EBL1 was 32 feet in 2013, 40 feet in 2014, and 45 feet in 2015. MDT intends to address this bank segment as part of a larger project to expand the U.S. 93 Alt roadway to 4 lanes in 2016/2017 (U.S. Army Corps Individual Permit NOW-2014-02184-MTB, #1).

The stream bank inventory identified four eroding stream banks, totaling 238 feet, or 28% of the total project bank length of 860 feet. Eroding bank EBL1, which has lengthened each of the past two years, is currently being evaluated by MDT to repair

**Additional Photo 6 - 2014**  
Description: EBL1  
Compass: 0 (North)

**Additional Photo 6 - 2015**  
Description: EBL1  
Compass: 0 (North)

Stone materials placed along the toe of the bank beneath a culvert upstream from the new bridge have continued to slough into the stream channel. These materials appear to be sloughing due to the steep bank angle (steeper than 1H:1V), saturation of the bank when the culvert discharges water on the bank, and improper placement of riprap beneath the culvert outlet. Stone toe protection beneath this culvert will need to be replaced to maintain bank and culvert protection if additional material continues to slough. MDT is currently evaluating stabilization alternatives at the outlet of this culvert as part of a bridge expansion project over Ashley Creek.

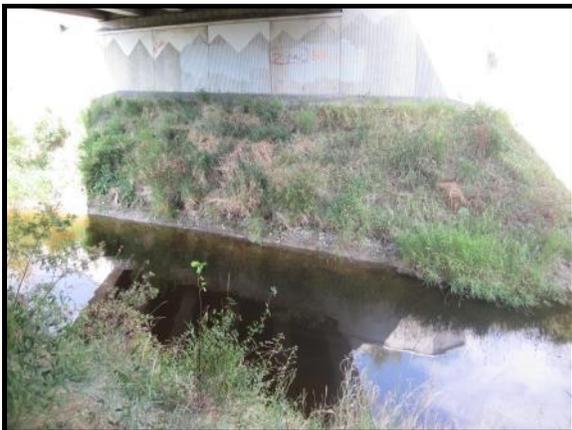
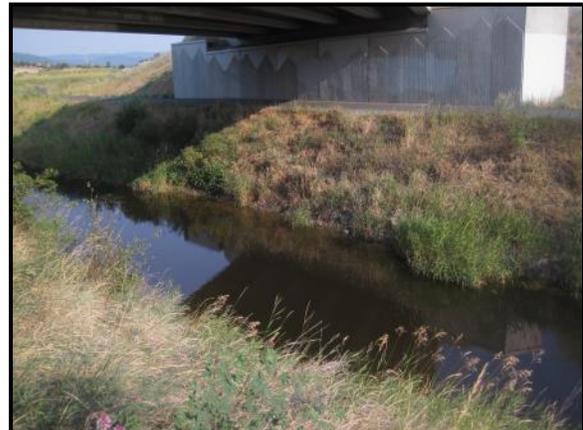
**Additional Photo 5 - 2014**  
Description: View of EBL2  
Compass: 315 (Northwest)

**Additional Photo 5 - 2015**  
Description: View of EBL2  
Compass: 315 (Northwest)
