MONTANA DEPARTMENT OF TRANSPORTATION STREAM MITIGATION MONITORING REPORT

*Bowser Creek
Flathead County, Montana*

*Project Completed: 2010
Monitoring Report #3: December, 2015*

MDT Project Number: NH 15(93)
Control Number: 2038-011

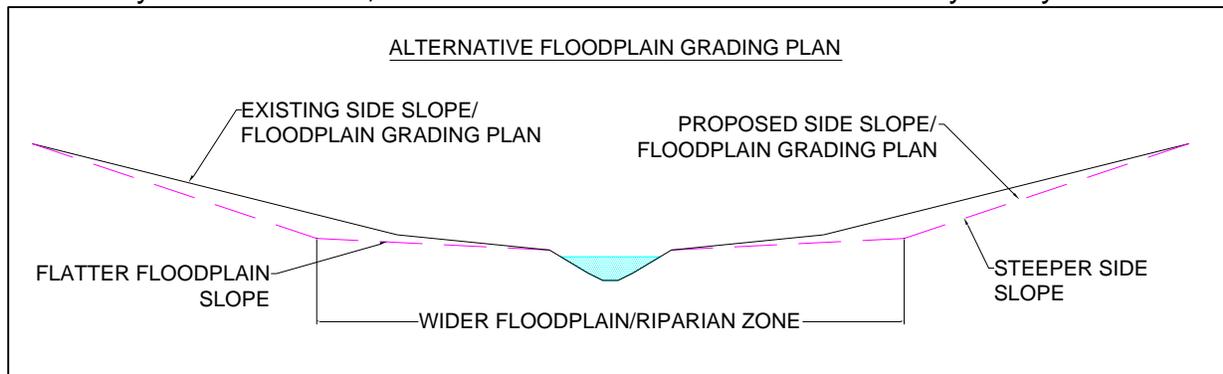
Figure 2. Alternative grading plan to increase floodplain and riparian areas.

Side slope designs along Bowser Creek provide room for a very narrow, 14-foot wide riparian and floodplain zone. Perpendicular transect survey results (Appendix B) illustrate a narrow bankfull bench adjacent to the creek has been constructed for flood inundation and wetland/riparian vegetation establishment. Integrating a slightly steeper upland side slope design would provide for a wider, more functional floodplain and riparian zone by allowing the stream to access a larger, flat zone adjacent to the active channel (Figure 2). Constructing steeper side slopes and a wider floodplain area requires additional excavation; therefore a cost/benefit analysis of creating additional

floodplain and wetland features, and the associated mitigation credits, is potentially worth consideration for future stream and riparian mitigation designs. Design of steeper side slopes along floodplains adjacent to highways also must take into account traffic and safety considerations, and allow for vehicles to exit the roadway safely.

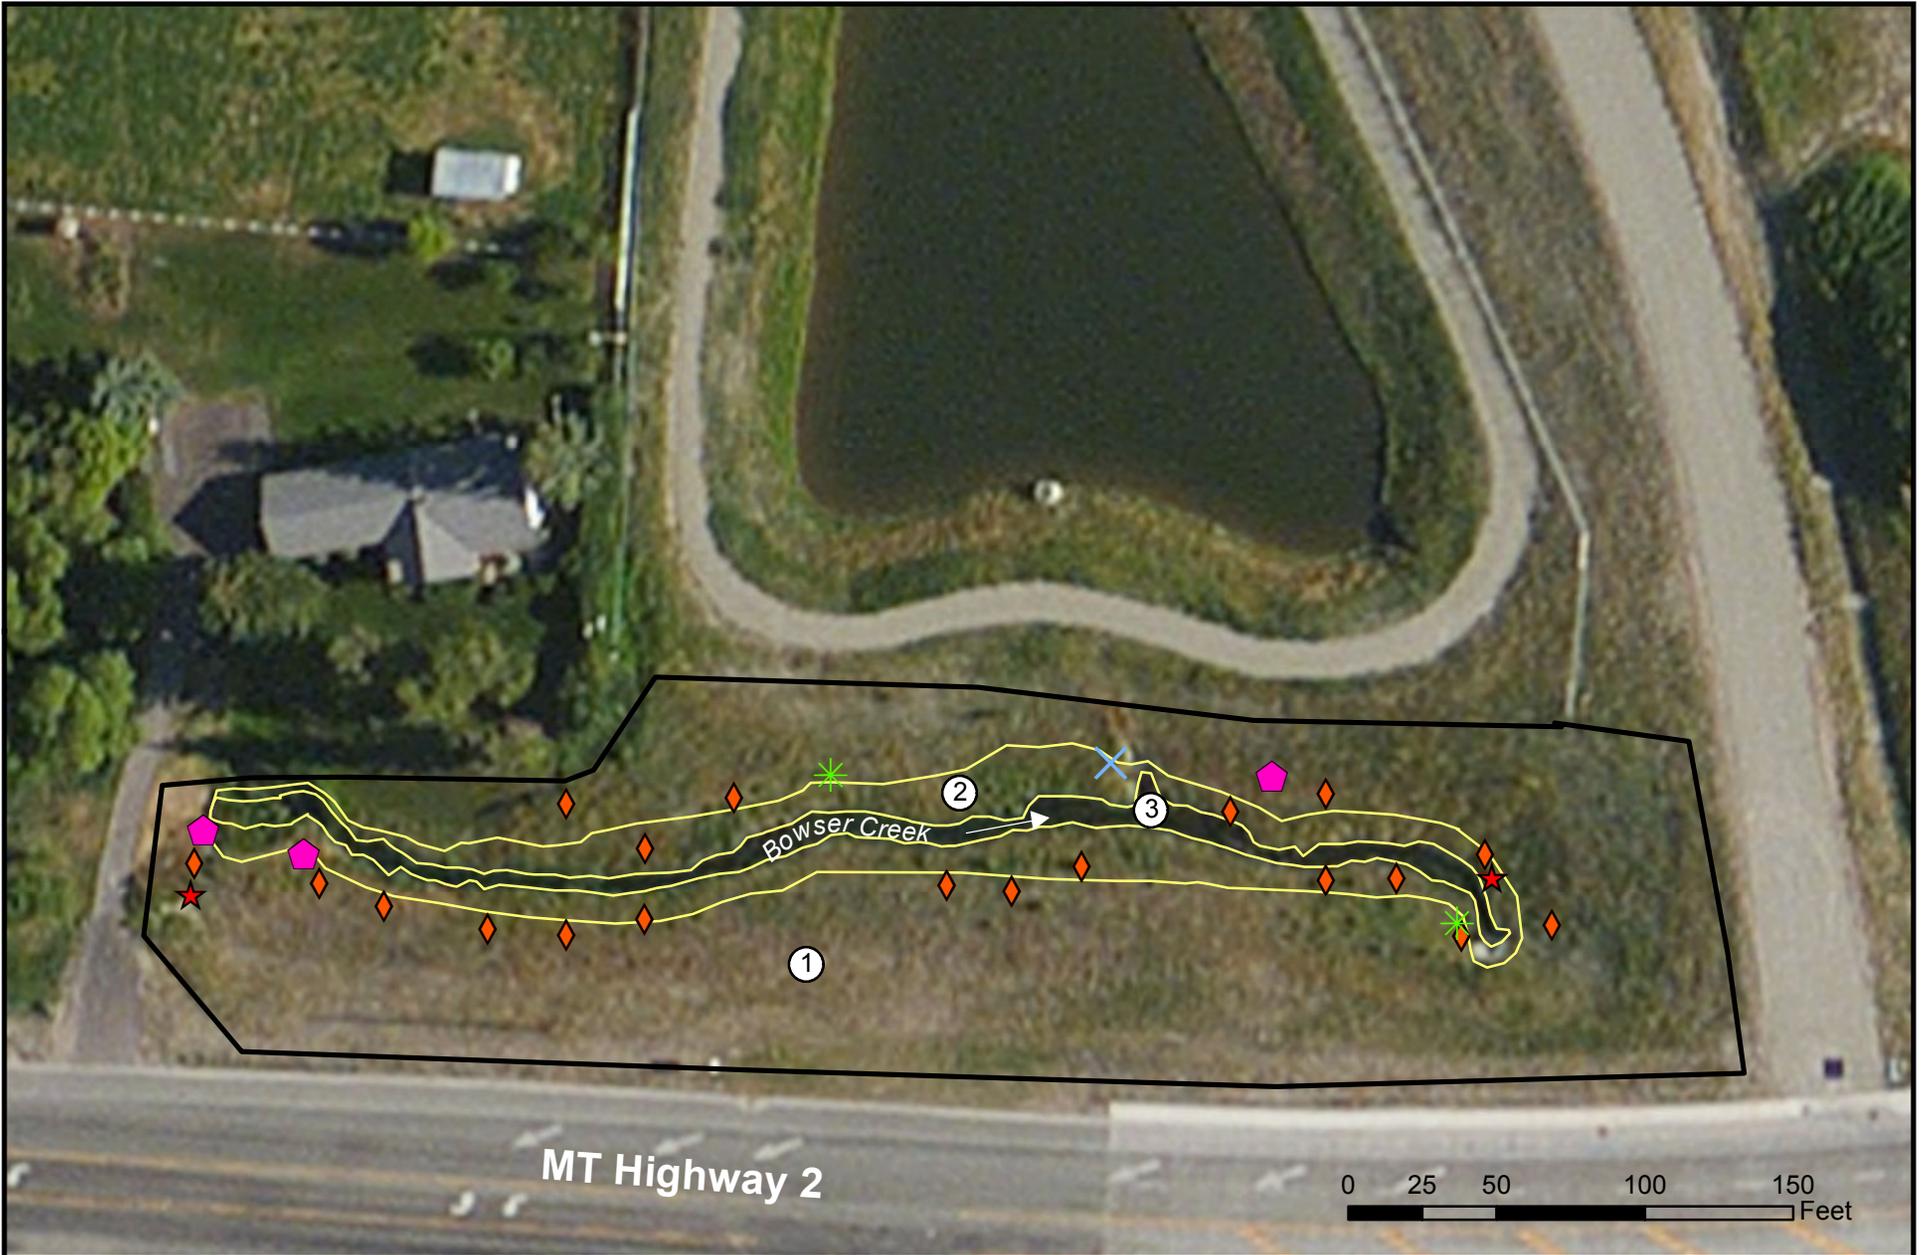
Noxious weeds were observed on approximately 10% of the Bowser Creek project area, with occurrences in riparian and stream bank areas (Figure 4, Appendix A). Recent weed control efforts appear to have been effective at controlled infestations of St. John's wort and Oxeye daisy, as these species were noted during previous monitoring surveys but were not observed in 2015. Although these results are promising, the percent noxious weed cover is currently at the maximum allowable limit to meet the performance standards; therefore continued weed control is recommended to maintain success in this category. The documentation of noxious weed occurrences provided in this monitoring report allow for MDT to develop management plans for controlling noxious weeds along the reconstructed segment of Bowser Creek. Weed control conducted by MDT in the future should concentrate efforts in areas that are most heavily infested by noxious weeds.

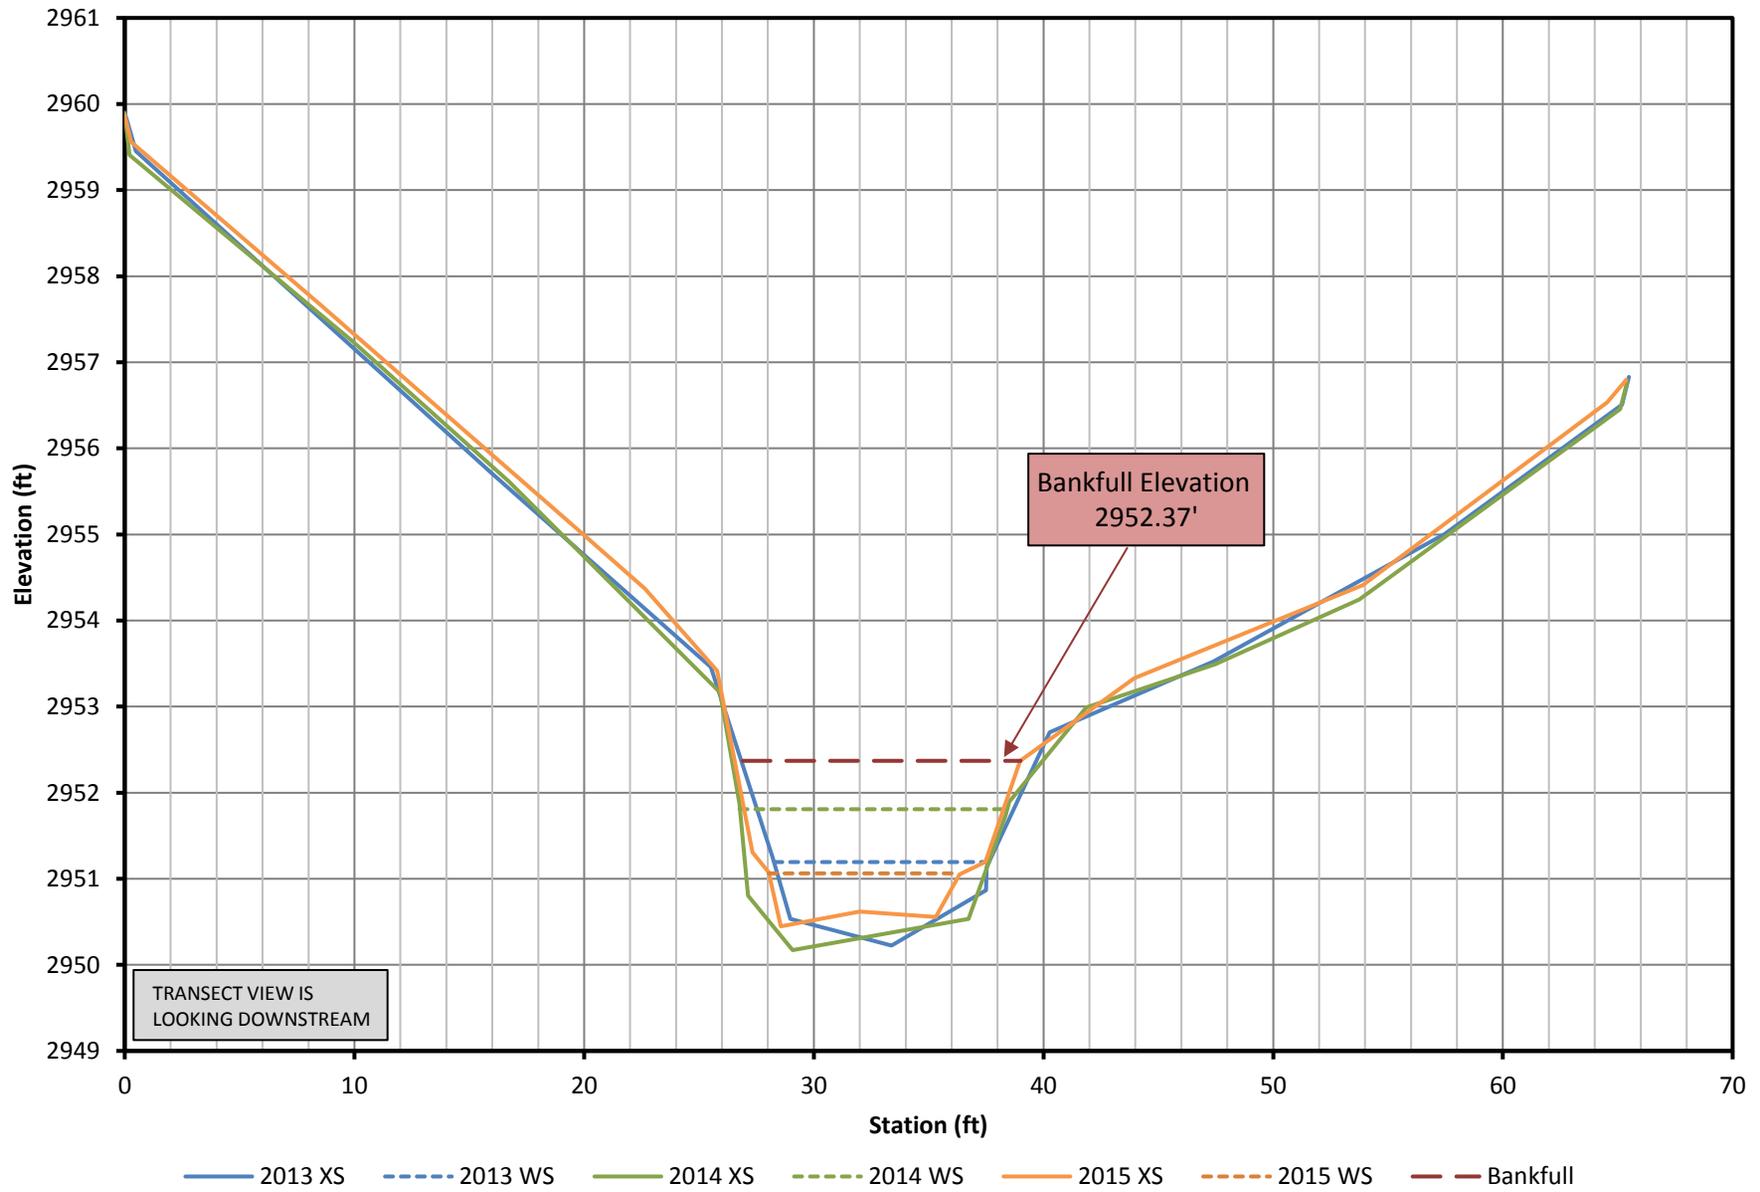
Bowser Transect #2 - Riffle

Bankfull widths at transects #2 (12.5 feet) and #3 (13.6 feet) indicate the channel has become wider through some segments than the design width of 5.5-6.5 feet. Evidence of this was also observed where the banks have retreated from the wooden stakes that were used to pin a stack of coir logs along the edge of the channel. These coir logs do not appear to have resulted in a stable bank configuration following their

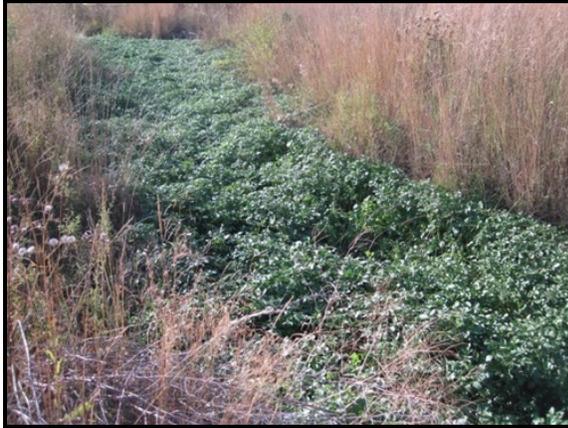
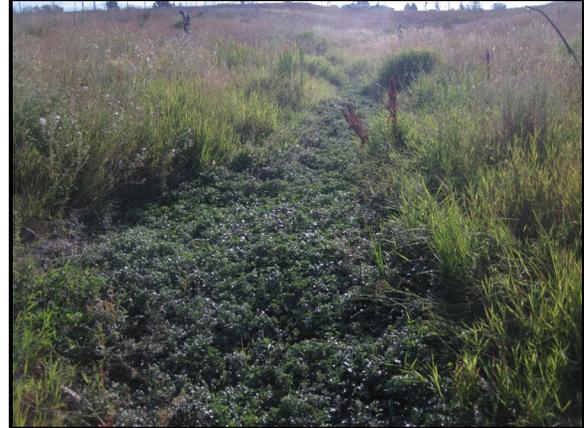
Additional Photo 1—2013
Description: Nasturtium growth in Bowser Creek.
Compass: 90 (East)

Additional Photo 1—2015
Description: Nasturtium growth in Bowser Creek.
Compass: 90 (East)

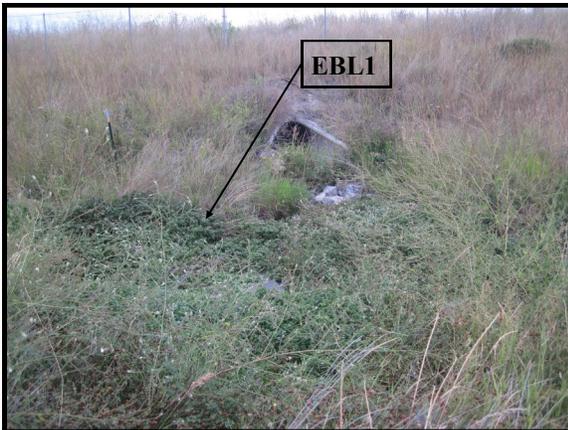
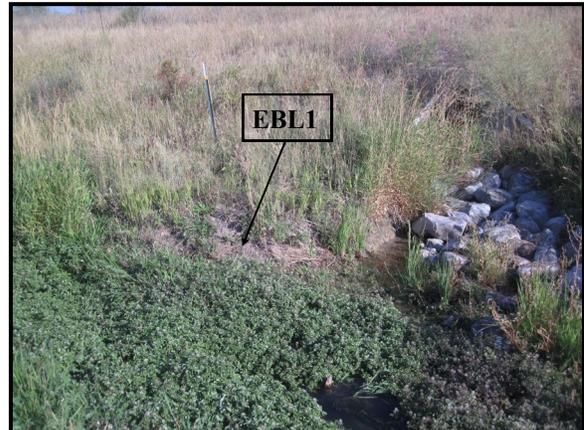
Eroding stream bank EBL1 and EBL2 are located upstream and downstream, respectively, of a culvert entering Bowser Creek from the north. Stone placed underneath the culvert to the toe of the stream bank was installed to prevent localized bank erosion from flows through the culvert; however, this material was not placed far enough up or downstream and erosion is occurring as a result. Fine grained soils are becoming saturated and sloughing during high flow events from the culvert and the stream. No additional erosion was noted during the 2015 monitoring event, and transect surveys at this location do not reveal evidence of additional erosion during the past two years. Erosion severity is considered low at both EBR1 and EBR2.

Additional Photo 2—2013
Description: Eroding Bank L1
Compass: 0 (North)

Additional Photo 2—2015
Description: Eroding Bank L1
Compass: 0 (North)

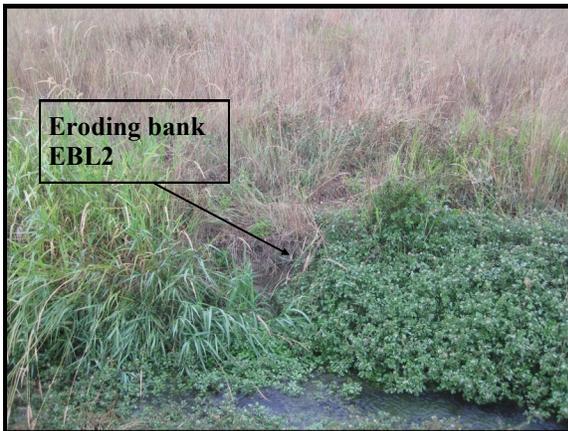
Additional Photo 3—2013
Description: Eroding bank L2 downstream of culvert. **Compass:** 0 (North)

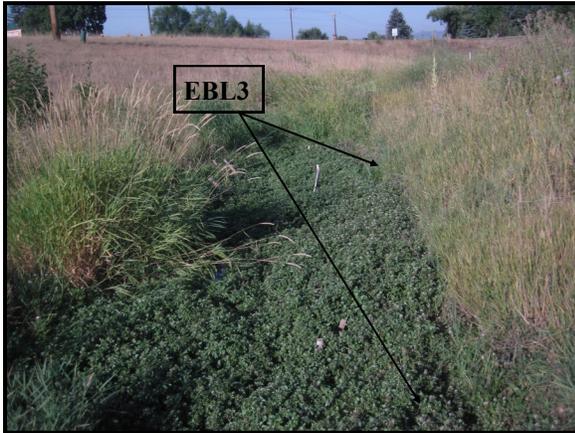
Additional Photo 4 - 2015
Description: Eroding Bank EBL3. Note wood stakes previously at edge of bank are now 2-3 feet from bank. Compass 270 (West)

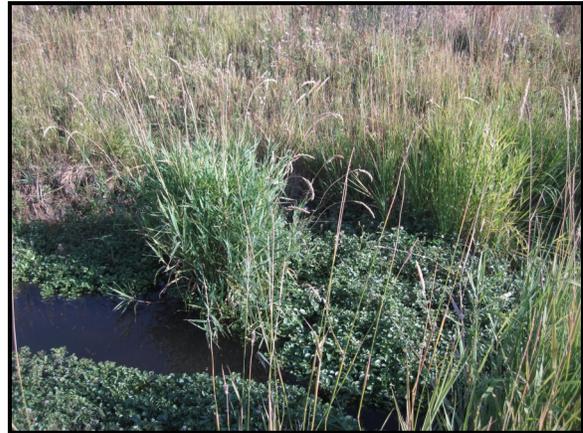
The stream bank inventory identified two new eroding banks in 2015, bringing the total length of erosion to 209 feet, or 24% of the total project bank length of 878 feet. Although a total of six eroding banks have been identified within the project reach, the performance criteria of less than 25% of the project reach exhibiting signs of instability is currently being met at this site. It should be noted that any additional erosion within the project reach will result in failure of this performance criteria. Corrective actions are warranted in channel segments that have become over-wide following construction and along areas near the confluence with the retention pond outlet.

Additional Photo 5 - 2015
Description: Lower end of new eroding bank L4. Compass 0 (North)

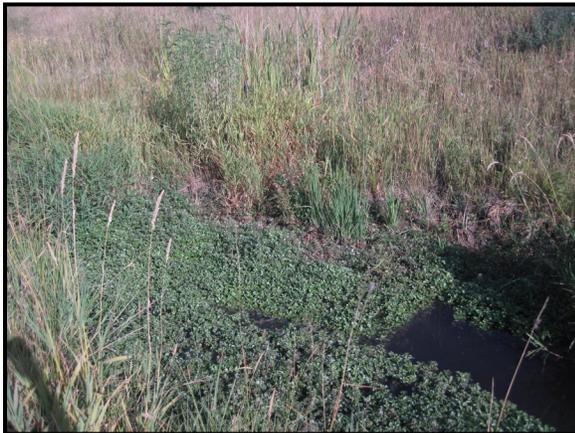
Additional Photo 6 - 2015
Description: Upper end of new eroding bank L4. Compass: 0 (North)

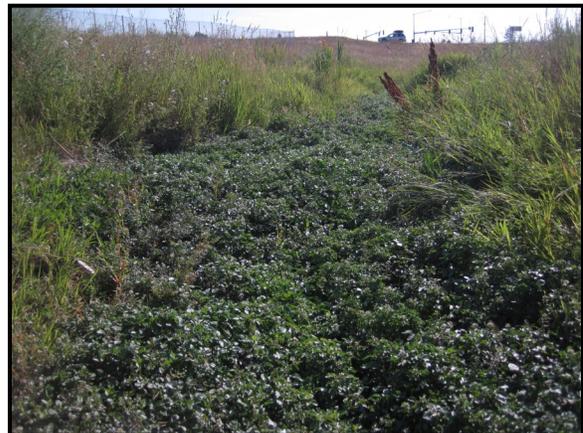
Fine sediments accumulating in the channel may be due to a combination of factors, including 1) increased roughness of the channel bed and water column caused by proliferation of watercress during the growing season, 2) the reduced ability of the channel to transport fine sediments through segments that have become over-wide, and 3) upstream development along Bowser Creek that may be contributing fine sediment. While upstream sediment sourcing was not a component of the monitoring plan, residential development and extension of the Highway 93 North bypass project are occurring immediately west and north of the project site. Each of these types of development may be contributing sediment loads to Bowser Creek and may be contributing to the sediment observed in the channel. The dense watercress observed in the channel will trap some of the sediment moving downstream during the growing season, and may help to narrow some of the over-wide areas along the channel if the depositional areas are able to vegetate with annual or perennial species. Continued monitoring will reveal whether the channel flushes fine sediment deposits during future high flow events, or if continued sedimentation within the channel continues to occur.

habitat features. Although the channel dimensions offer aquatic habitat complexity, the abundance of watercress observed throughout the water column limits the potential use of this habitat by fish and other aquatic life during the growing season.

Additional Photo 7 - 2015
Description: Dense infestation of watercress found throughout Bowser Creek mitigation site. Compass 90 (East)

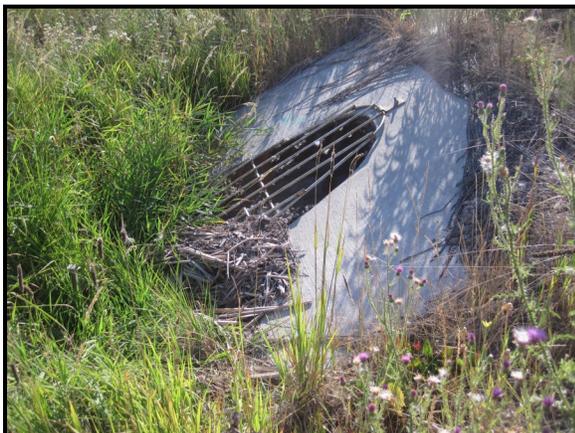
Additional Photo 8- 2015
Description: Culvert partially blocked by cattail debris at downstream end of project reach.
