# MONTANA DEPARTMENT OF TRANSPORTATION STREAM MITIGATION MONITORING REPORT

*Mill Creek  
Ravalli County, Montana*

*Project Constructed: 2011  
Monitoring Report #3: December, 2015*

## **STREAM MITIGATION MONITORING REPORT #3**

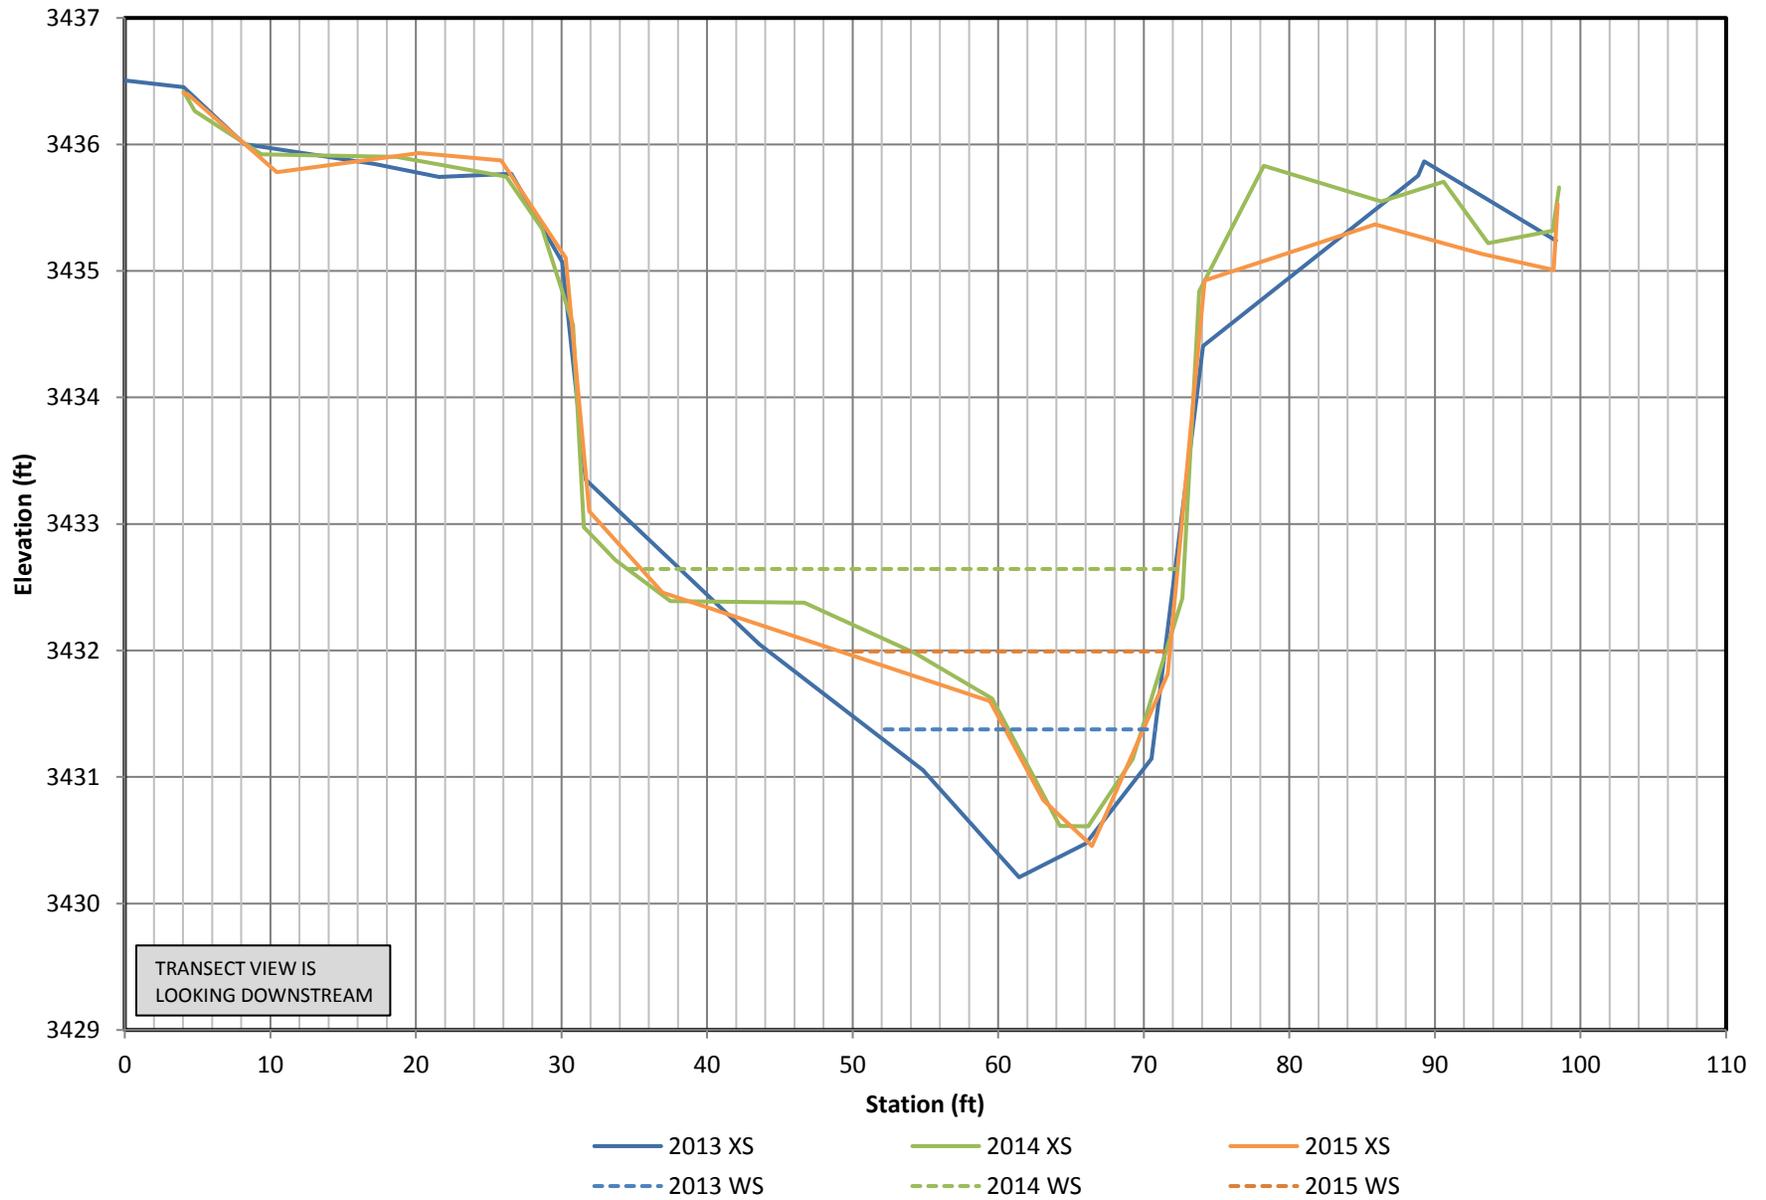
# Mill Creek Transect #1 - Riffle

The channel at riffle transect #1 was intended to be positioned at a riffle; however, monitoring indicates this feature is more indicative of a pool. A shallow bar has formed on the left side of the channel and thalweg near the right bank. Minor erosion was noted along the right bank during the 2014 monitoring event, although the re-surveys do not indicate significant lateral migration further southward. Upstream of this transect, the channel has migrated northward (Eroding Bank EBL1-2), and the channel has now established a shallow pool along the right bank through transect #1. Inspection of the longitudinal profile also indicates the bed at this transect occurs at a shallow pool (STA 140+00).

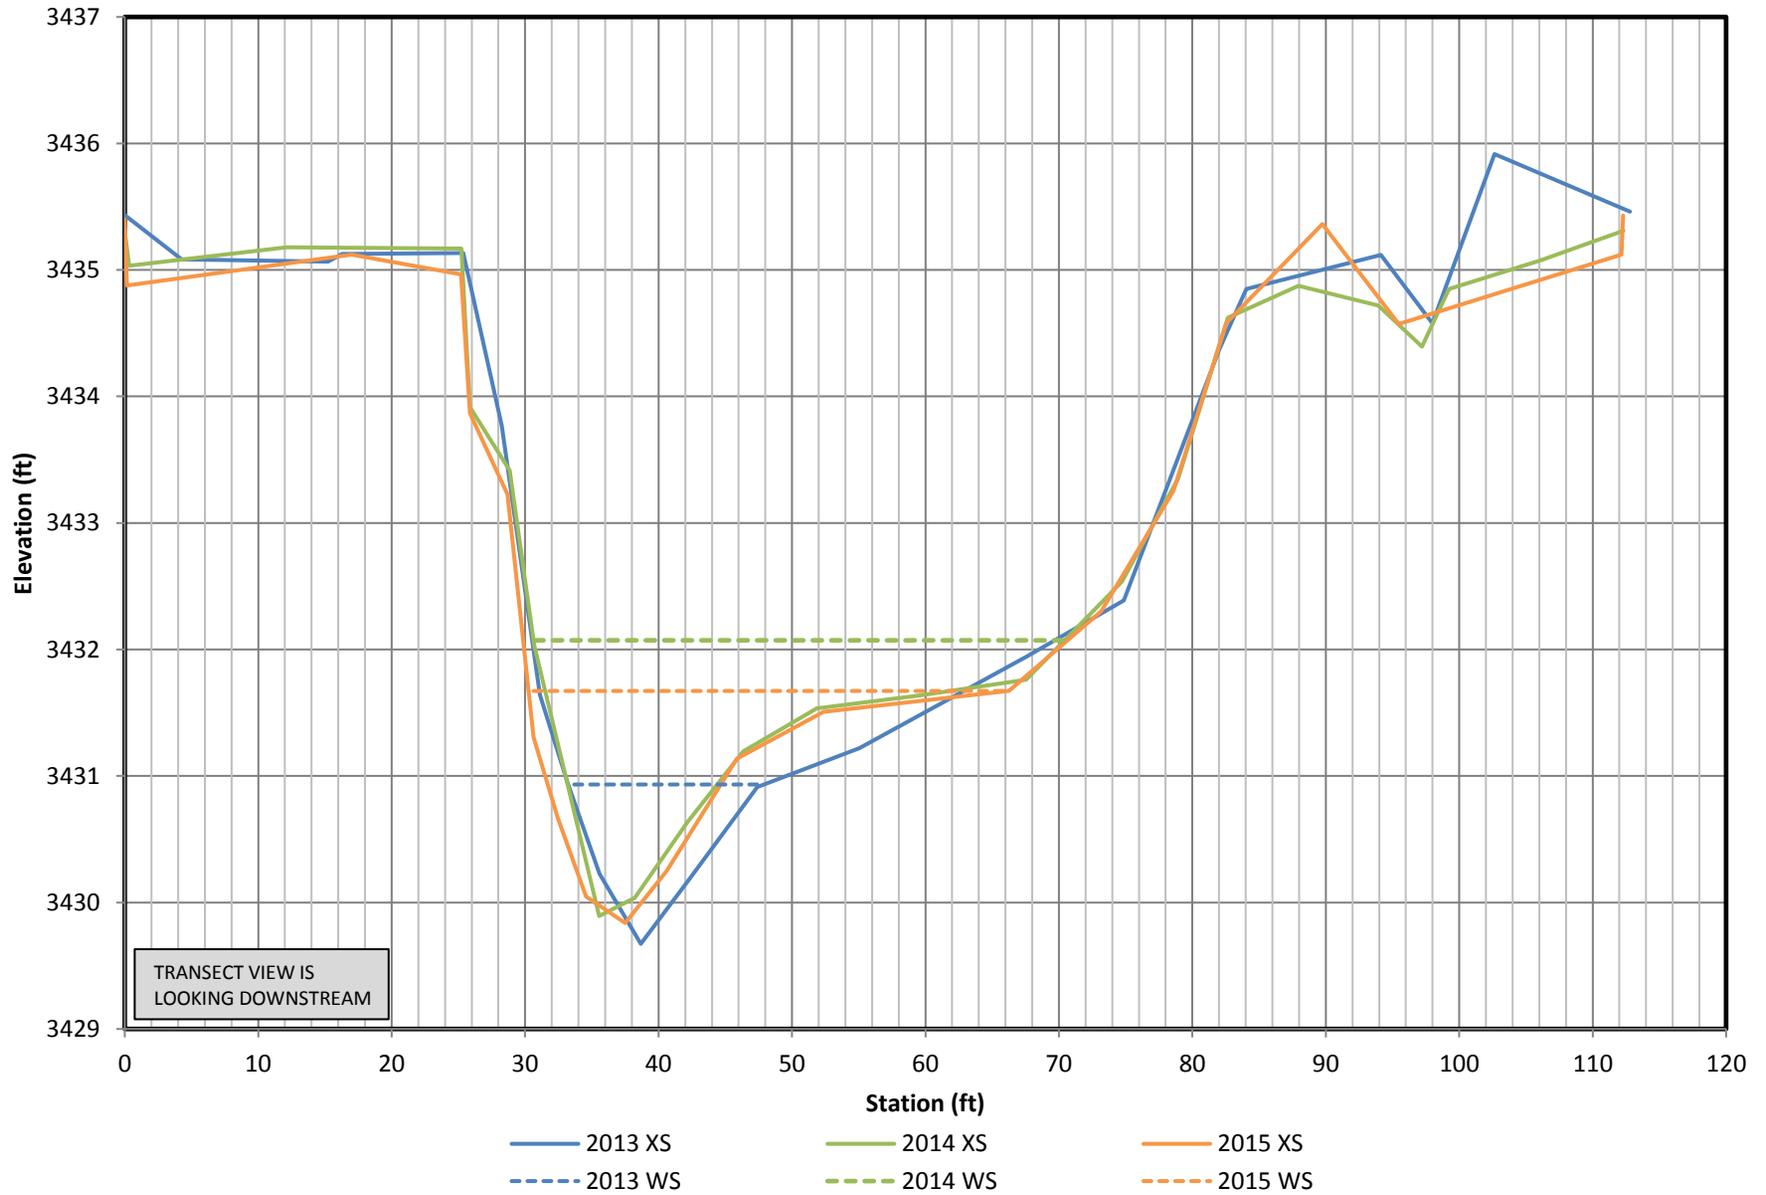
# Mill Creek Transect #2 - Pool

Pool transect #2 occurs at a woody debris jam, and has maintained its width and depth over the past two monitoring events. Only slight elevation changes are noted in the repeat surveys. Inspection of the longitudinal profile indicates this transect occurs within a shallow pool at Station 235+00.

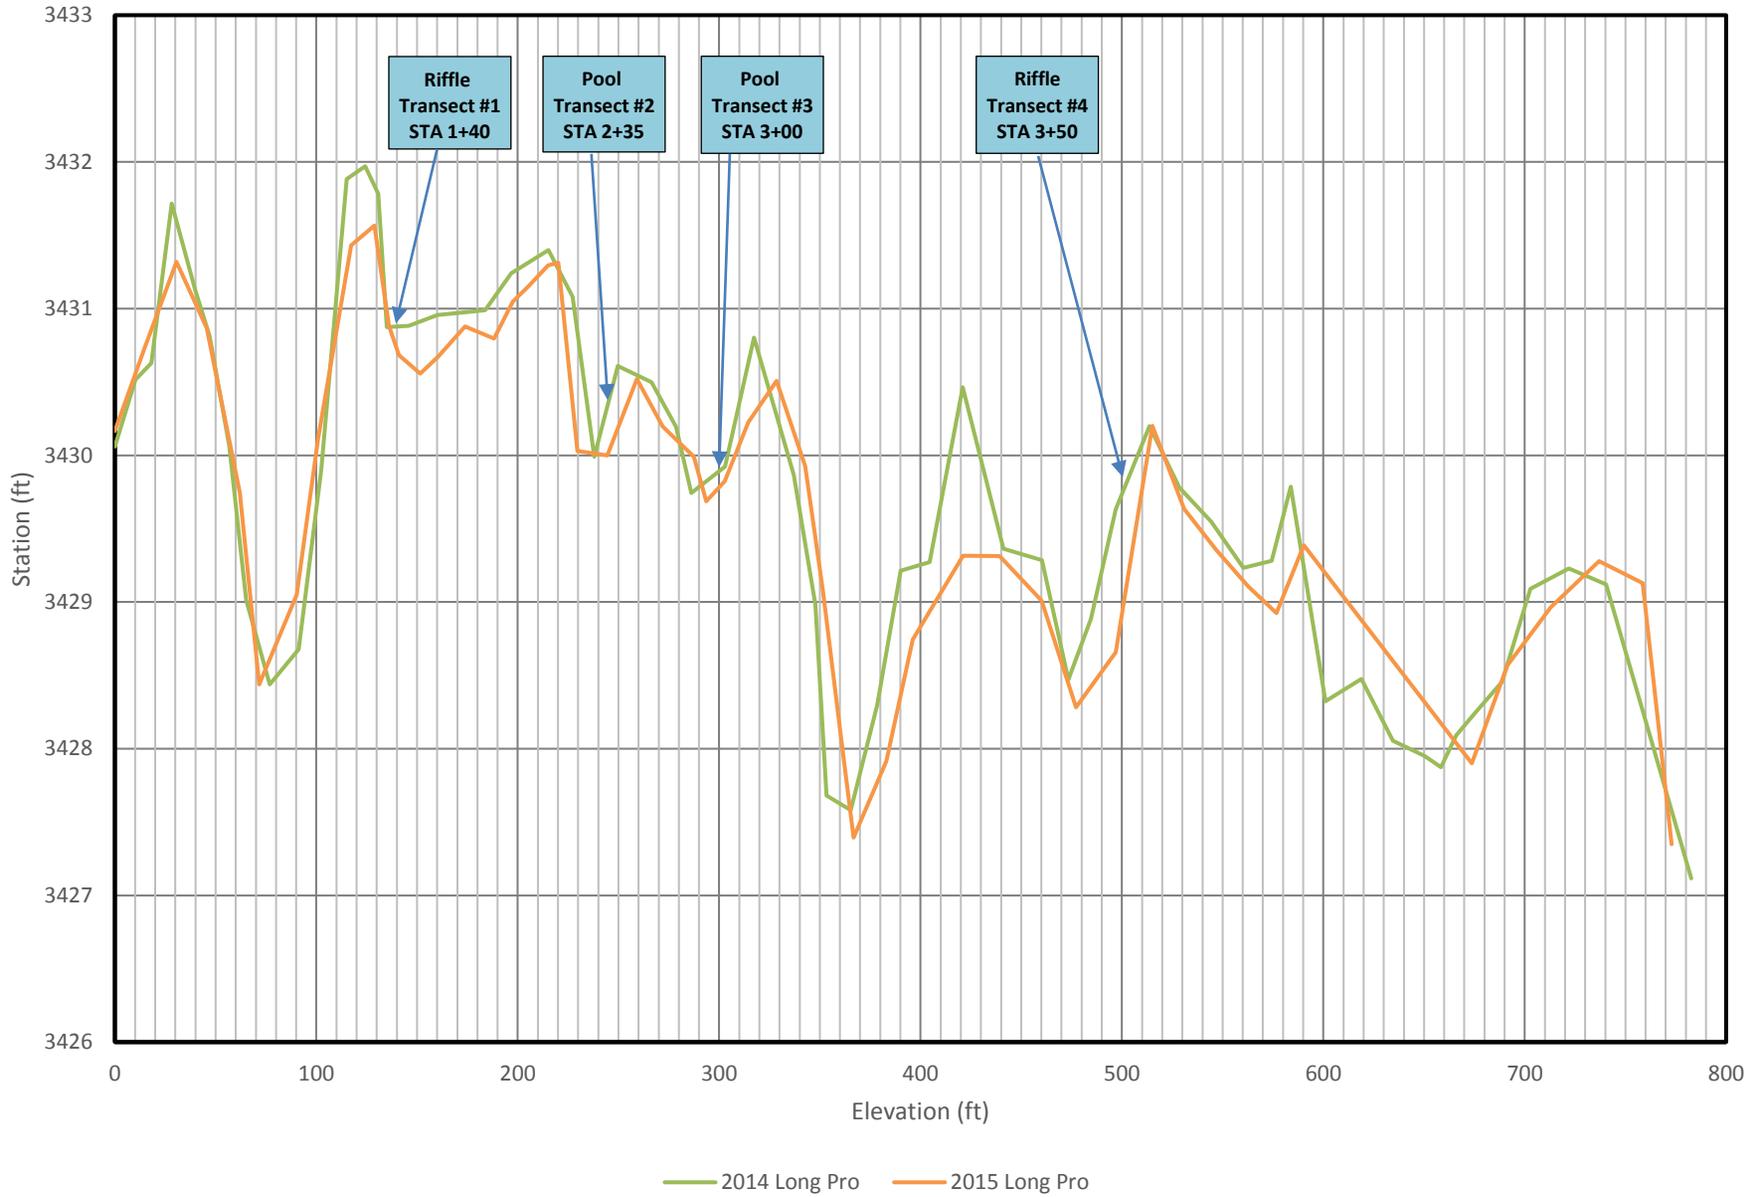
# Mill Creek Longitudinal Profiles: 2014 and 2015

A longitudinal profile of the stream bed along the thalweg was surveyed in 2014 and again in 2015 to document bedform complexity and aquatic habitat conditions (Appendix B). The bed profile indicates continued presence of several shallow as well

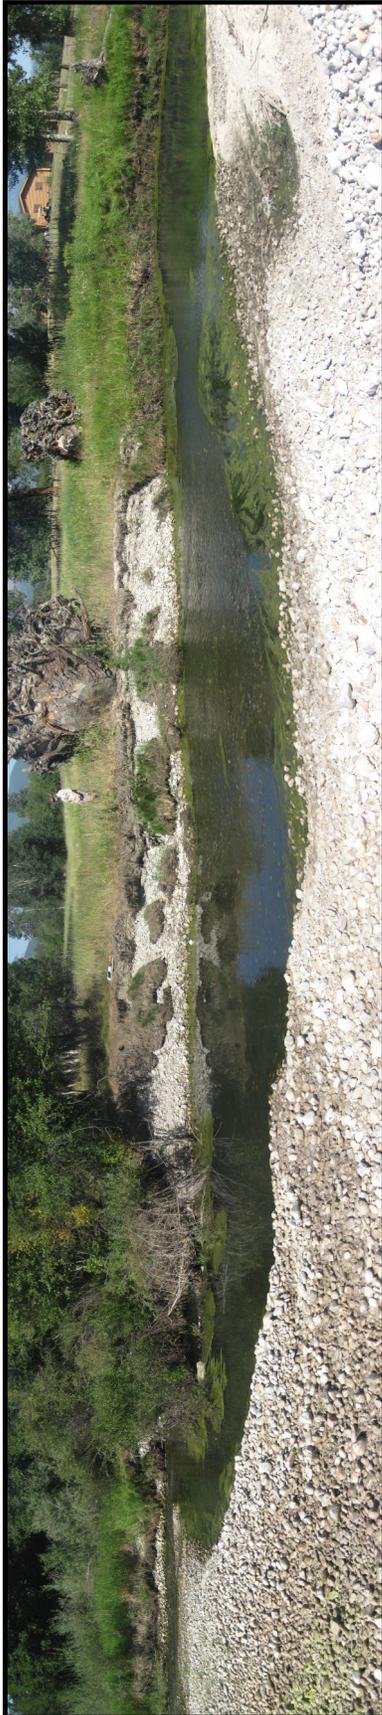
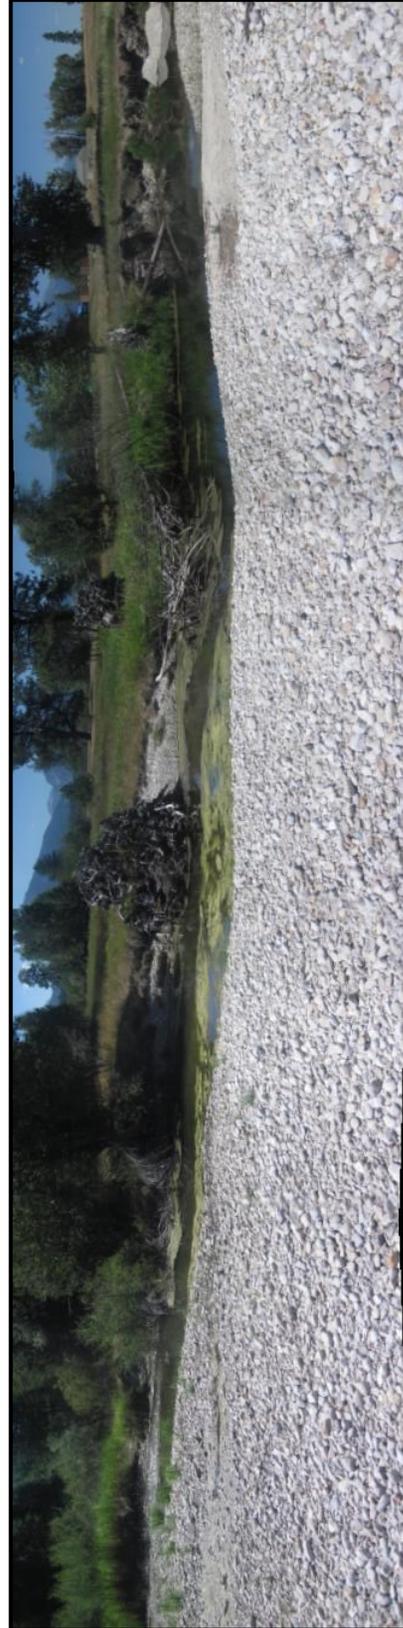
Bank erosion at EBL1-2 is due to adjacent point bar formation forcing the channel against a relatively high, herbaceous vegetated stream bank along a relatively sharp meander. Root wads and large rocks placed, but not keyed into the toe of the banks are causing increased scour and block failure. The vegetation community along these banks include speckled alder, Kentucky bluegrass, smooth brome, sedges, common yarrow, western-wheat grass, Canadian goldenrod, and ox-eye daisy. The bank retreated between 3 and 7 feet from 2013 to 2014 and an additional 2-5 feet from 2014

**Additional Photo 1**  
**Description: Eroding Bank EBL1 - 2013 (panoramic)**

**Additional Photo 1**  
**Description: Eroding Bank EBL1 - 2015 (panoramic)**

Two eroding banks identified during the 2013 monitoring event have combined into one long, eroding bank immediately upstream of the project reach (EBL1-2). Although these banks lie on private land upstream of the project reach, they have been noted and mapped due to their potential to affect the reconstructed channel segment. This bank lies along a very sharp bend of Mill Creek, where the channel turns approximately 135 degrees over a length of about 200 feet. This sharp turn in the channel will likely continue to result in lateral movement of the channel to the north until a stable meander radius is established. Continued northward movement of the meander may result in flows directed toward the south bank of Mill Creek, where erosion along bank EBR2 has been noted. The landowner has attempted to slow the erosion along EBR1-2 by cabling a tree and placing large boulders along the bank; however, these efforts are unlikely to successfully reduce the rate of lateral bank movement at this location. Erosion along this bank could be reduced with bioengineering techniques including installing a stone toe, resloping the vertical bank, and installing dense woody riparian vegetation.

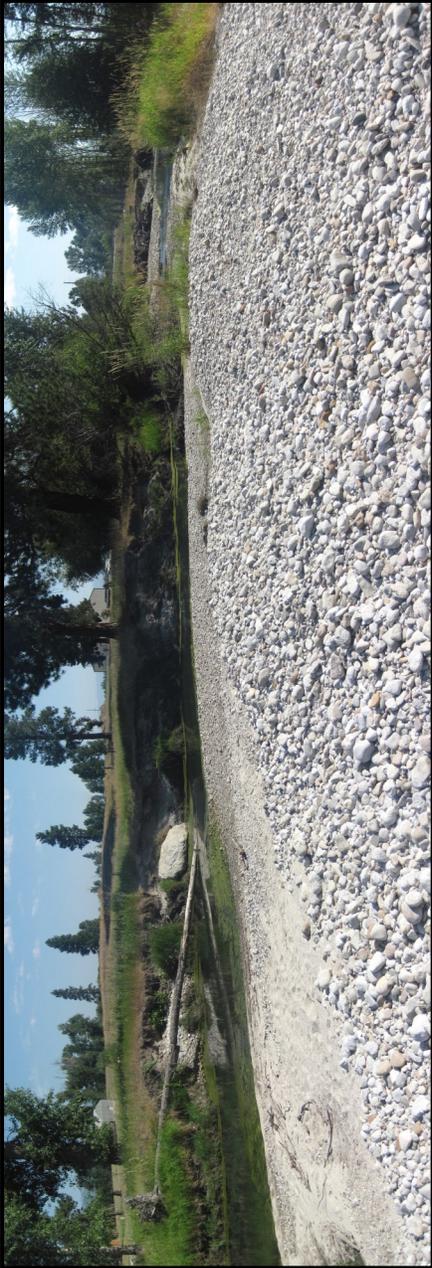
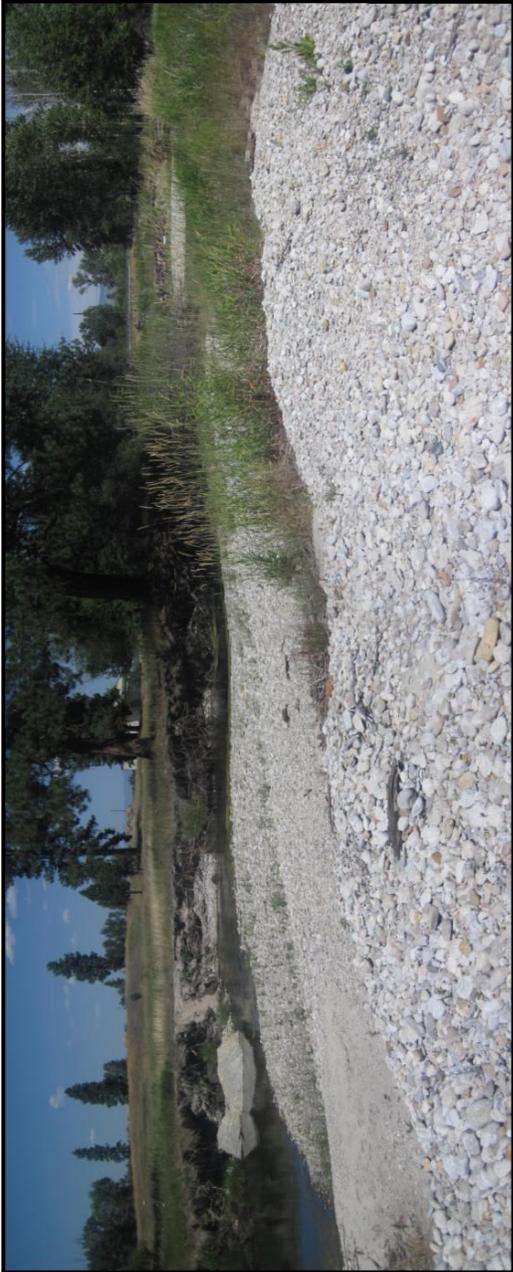
**Additional Photo 2**  
**Description: Eroding Bank EBL2- 2013 (panoramic)**

**Additional Photo 2**  
**Description: Eroding Bank EBL2 - 2015 (panoramic)**

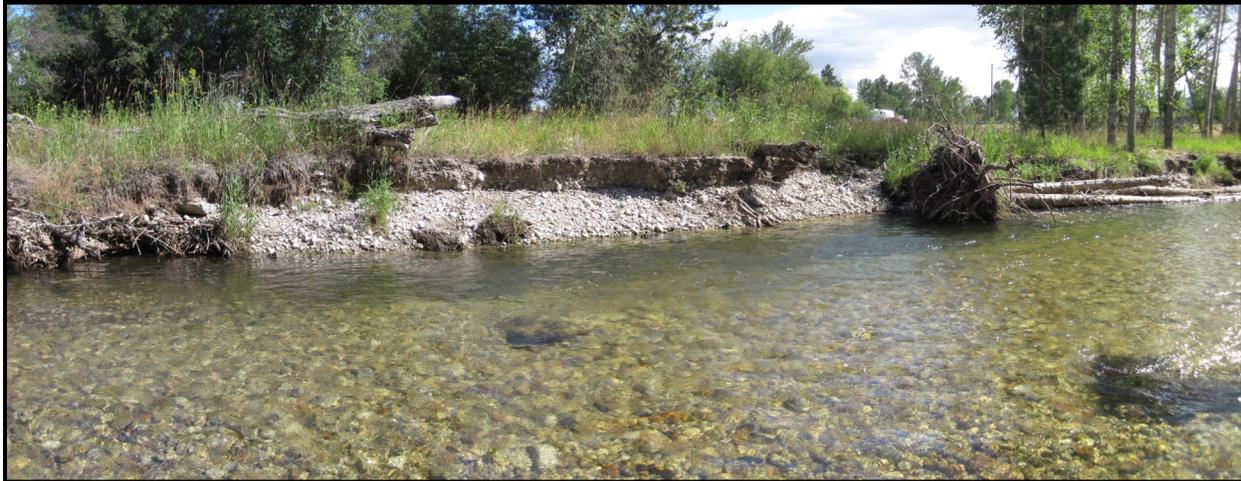
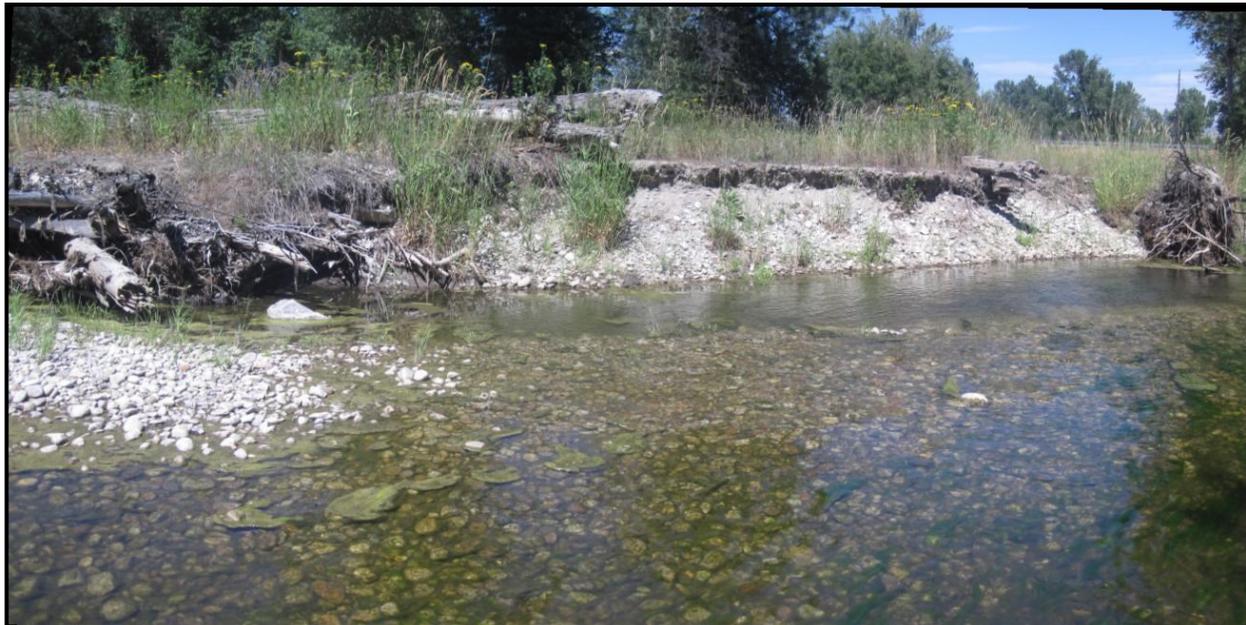
Erosion at EBL3 is occurring at the head of the former channel alignment (now backfilled with gravel, cobble, and soil), and extends downstream approximately 90 feet beyond the root ball of a fallen tree. In 2014, erosion was noted along the toe of the bank, causing it to retreat. The vegetation community consists of short-awn meadow foxtail, white and red clover, Kentucky bluegrass, common tansy, and ox-eye daisy. Erosion along this bank did not appear to advance in length or retreat further in 2015. The bank has retreated approximately 1 to 2 feet since 2013. Based on the combination of erosion factors, severity of erosion along EBL3 is considered low.

**Additional Photo 3**  
**Description:** Upper section of Eroding Streambank EBL3 in 2014

**Additional Photo 3**  
**Description:** Upper section of Eroding Streambank EBL3 in 2015

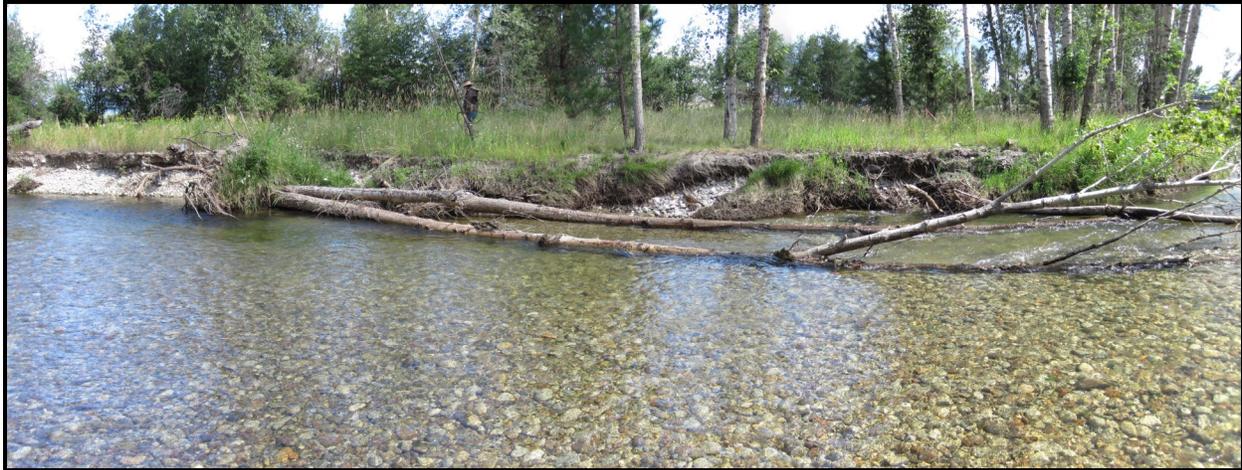
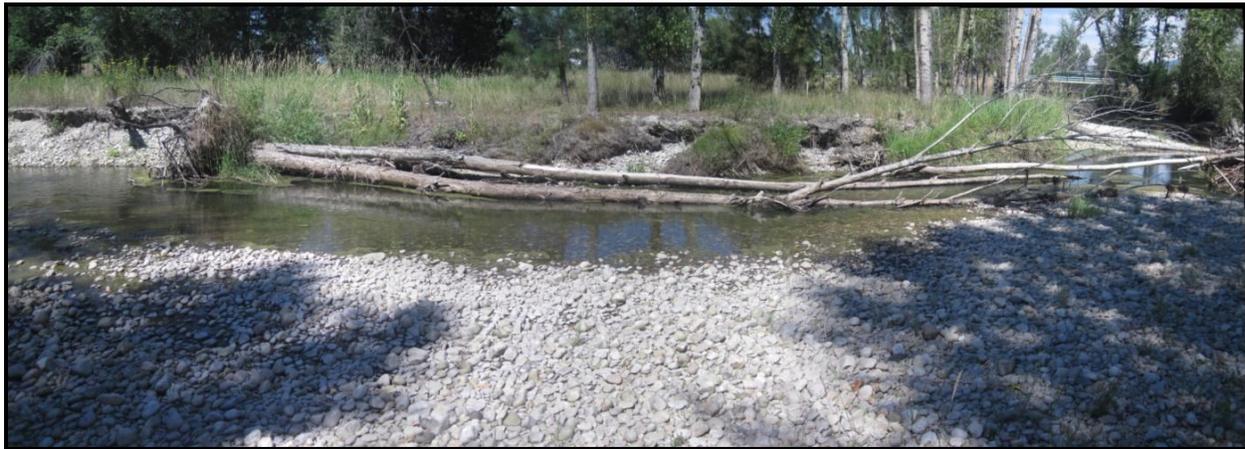
**Additional Photo 4**  
**Description:** Lower section of Eroding Streambank L3 in 2014 (panoramic)

**Additional Photo 4**  
**Description:** Lower section of Eroding Streambank L3 in 2015 (panoramic)

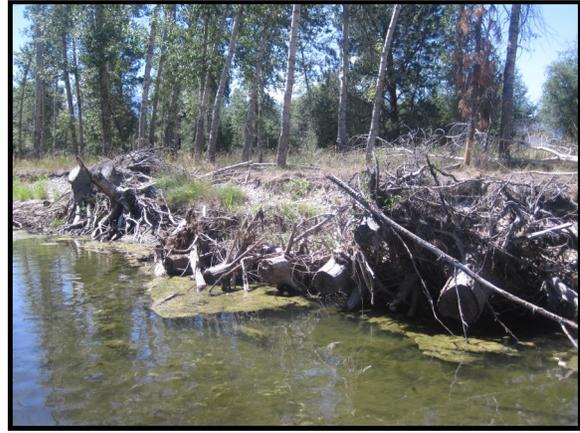
At eroding bank EBL4, bank sloughing has continued to occur upstream and downstream of several root balls that fell into the channel. The 64-foot long eroding bank has several root balls from cut trees along the toe, which may have been used to construct the log and root wad revetment just downstream. Bank instability at this location was potentially caused by removal of the trees for use in log revetment construction, or from natural channel adjustments following construction. The dominant vegetation along the bank includes reed canary grass and smooth brome. The bank retreated approximately 1 to 2 feet between 2013 and 2014, but does not appear to have retreated further in the past year. Erosion severity along this bank is considered low to moderate.

**Additional Photo 5**  
**Description:** Eroding streambank EBL4 in 2013.

**Additional Photo 5**  
**Description:** Eroding streambank EBL4 in 2015.

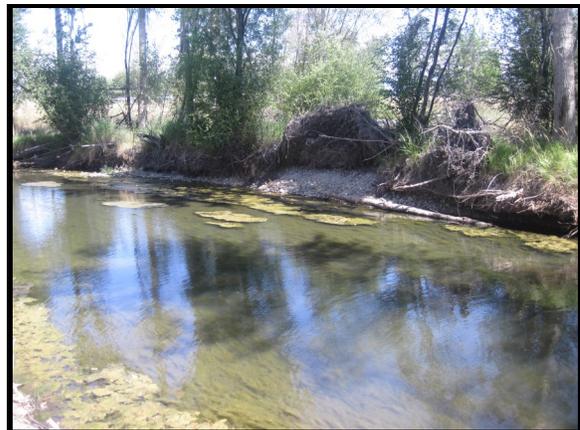
At eroding bank EBR1, several trees have fallen into the channel due to undercutting directly across the channel from EBL4. Trees have also fallen away from the channel, providing evidence of undercutting and block failure, or blow down. Photo evidence does not indicate further erosion beneath the fallen trees, and it does not appear this bank has laterally migrated in the past year. The vegetation community along this bank consists of cottonwood, speckled alder, smooth brome, and bog birch. Bank erosion severity along this 58-foot segment is considered low.

**Additional Photo 6**  
**Description:** Eroding streambank EBR1 in 2013.

**Additional Photo 6**  
**Description:** Eroding streambank EBR1 in 2015.

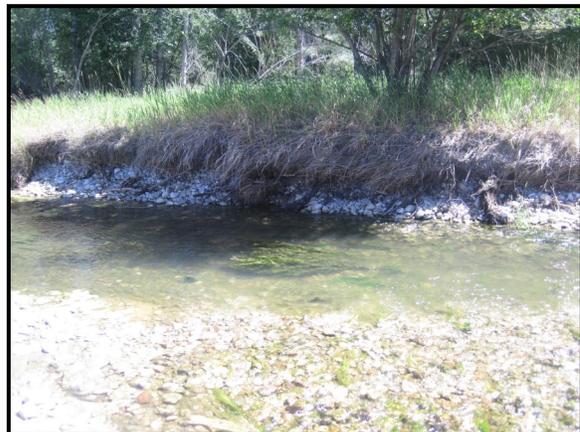
Erosion at EBR2 was noted along 65 feet of the channel across from the head of the deactivated stream channel. Erosion at this location is due to channel adjustments and scour along the outside of a meander. No additional erosion was noted over the past year at this bank. The vegetation community is dominated by reed canary grass with a speckled alder and bog birch overstory. These factors contribute to an overall low erosion severity rating. Of note, the adjustment in channel alignment due to erosion at EBL1-2 may eventually result in additional erosion at eroding bank EBR2 due to high flows directed toward eroding bank EBR2.

**Additional Photo 7**  
**Description:** Eroding streambank EBR2 in 2014.

**Additional Photo 7**  
**Description:** Eroding streambank EBR2 in 2015.
