## **EXPERIMENTAL PROJECTS CONSTRUCTION AND SITE INSPECTIONS REPORT**

### **GEOSYNTHETIC REINFORCED SOIL - INTEGRATED BRIDGE SYSTEM (GRS-IBS)**

**Location:** Highway 89 (P-3/C000003), Pondera County-South Fork/Dry Fork Marias River Crossing

**Project Name:** S.E. of Dupuyer – S.E.

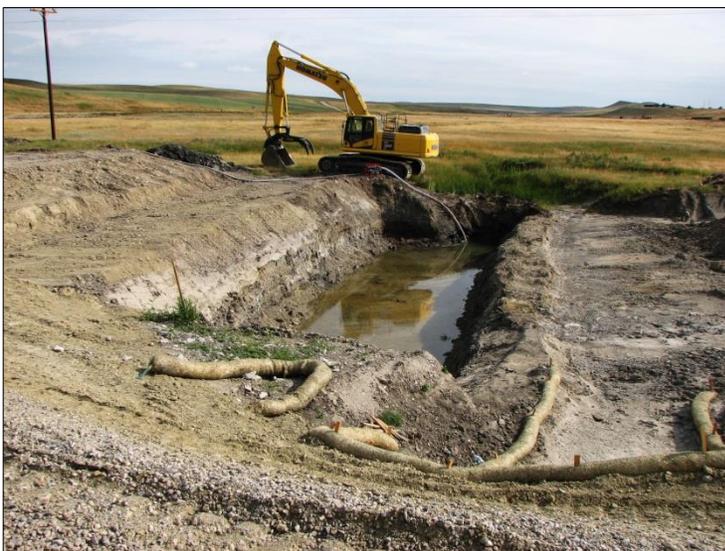
← Excessive soil saturation within the GRS abutment sites required the contractor to install a trench in order to drain or wick the water to the base of the channel, where a sump pump removed the standing water.

Once the area was determined adequately drained and stable the trench was filled.

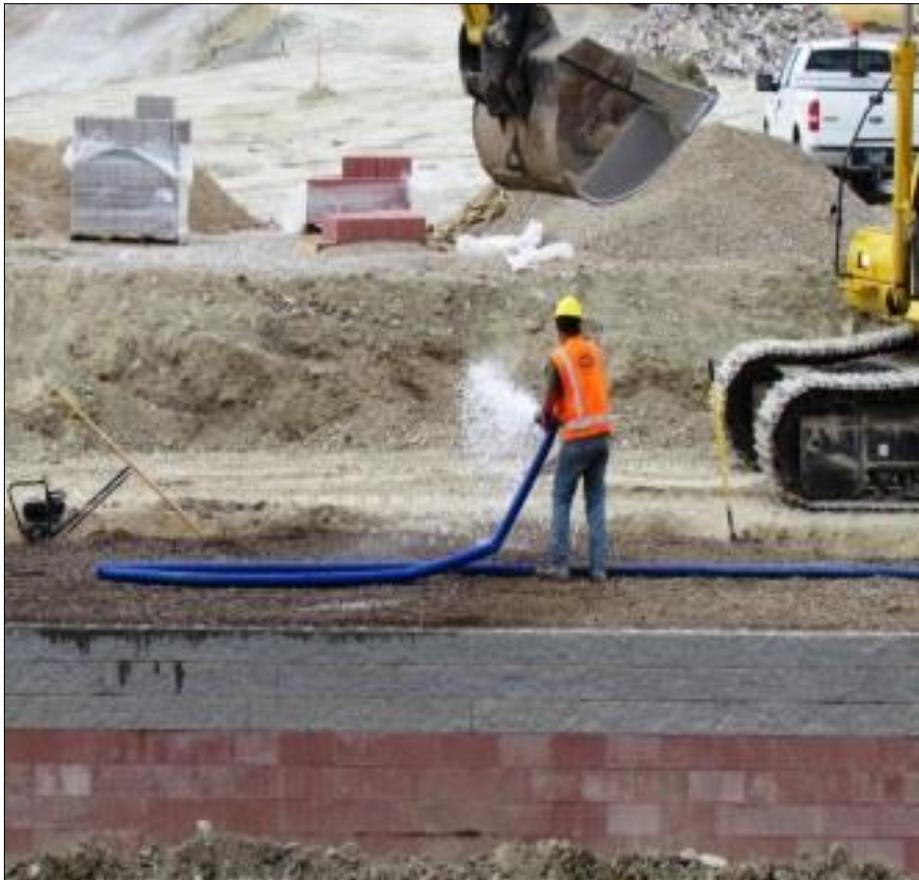
← Water was added to aid in required compaction.

Soil moisture averaged around 4%; the moisture specification was 7.4%.

It was reported that one fill layer was overly saturated and had to be removed and replaced with new backfill.

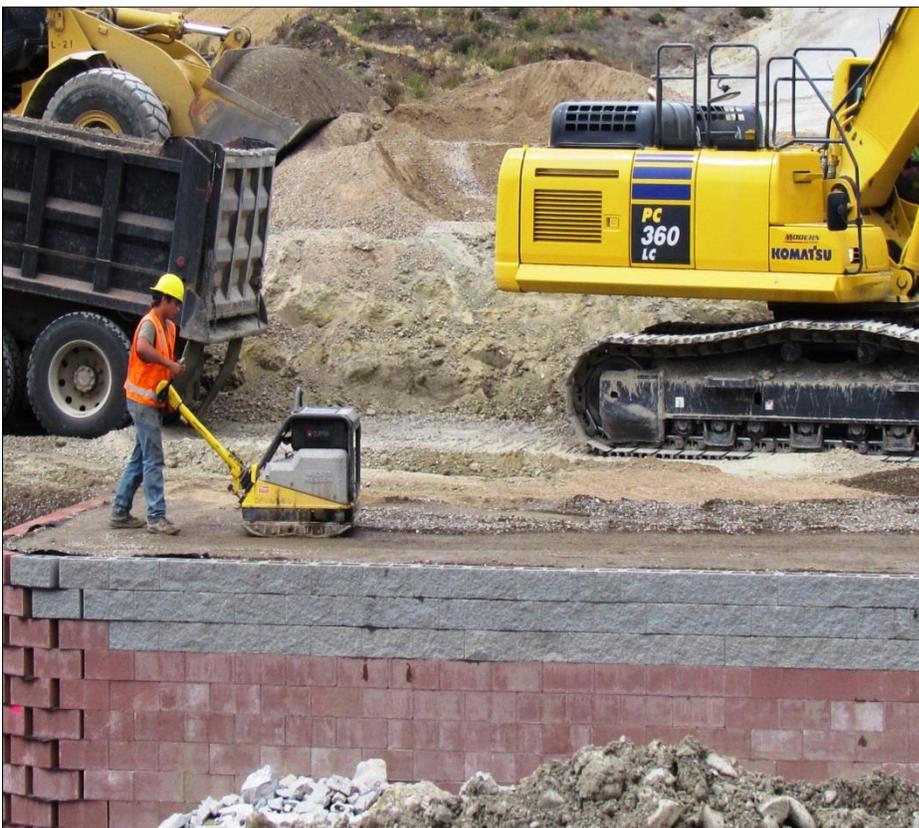
← Sample image of plate compactor used to consolidate the GRS mass layers.

Due to compaction some of the hollow core facing blocks were pushed outward and needed to be pounded back flush with the facing wall. These occurrences were minor.

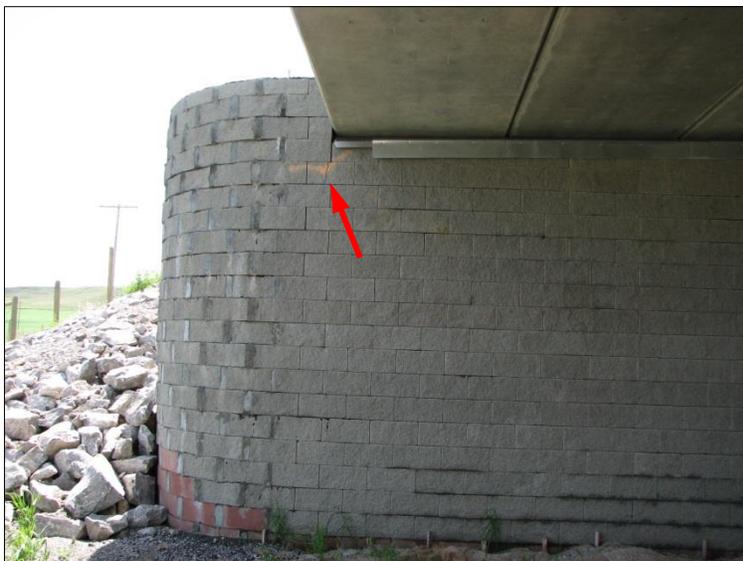
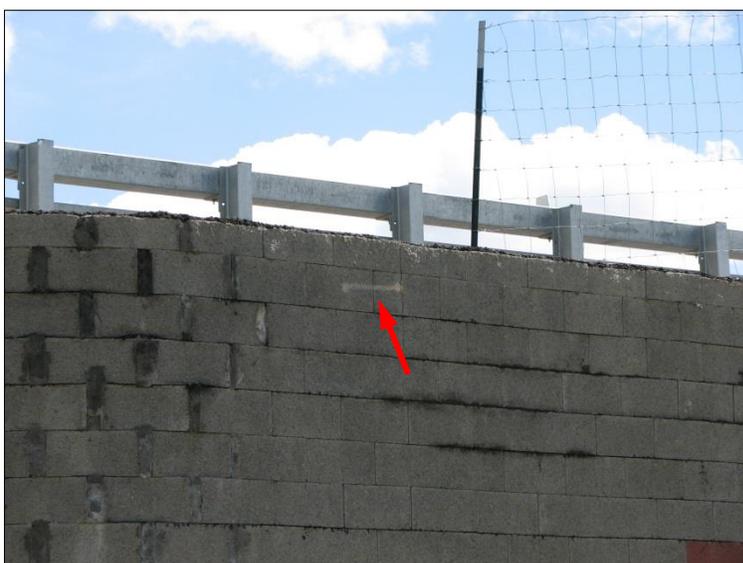
Pavement approaches to slab transition are smooth. As noted in the 2014 inspection several of the fascia CMU blocks were cracked. Several more have cracked; MDT staff has sprayed paint as a locator on the current visible cracks. To date this block cracking is not seen as an indicator of performance.

← ↓ As documented in the 2014 inspection, several fascia blocks developed cracks (red arrows).

All cracks are located near the top layer of block, or at the edge of the abutment placement.

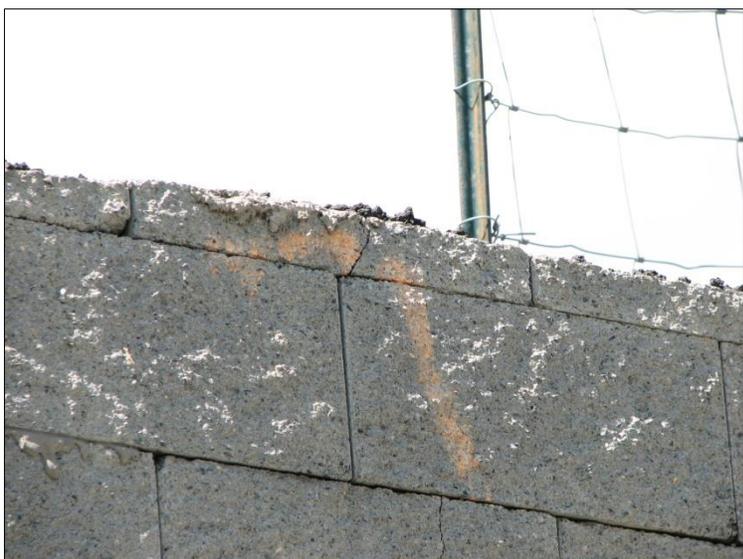
← MDT District staff has applied paint to visible cracked blocks for reference.

To date about seven (7) blocks have developed cracks since installation.

At this time it is not considered a performance issue.

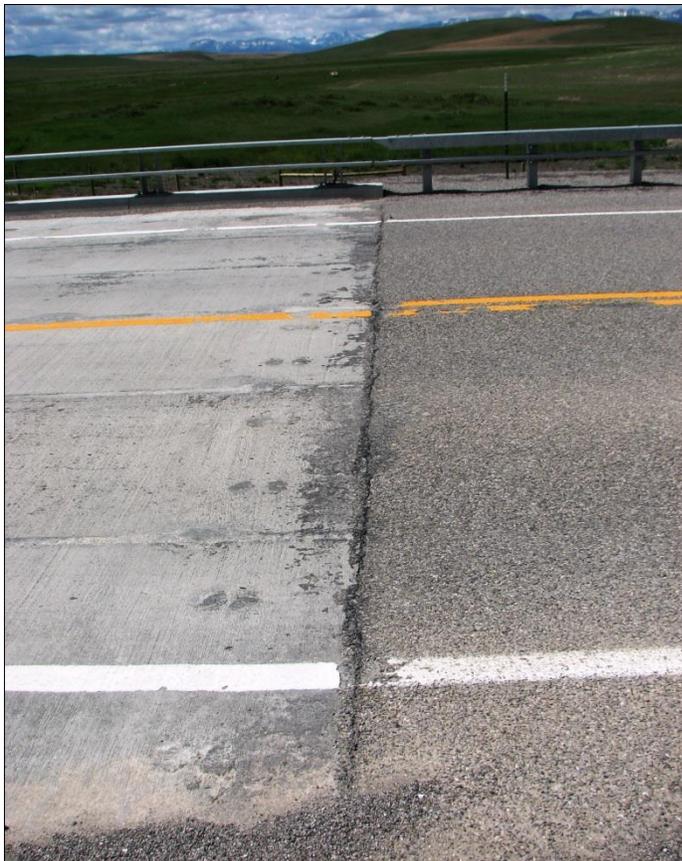
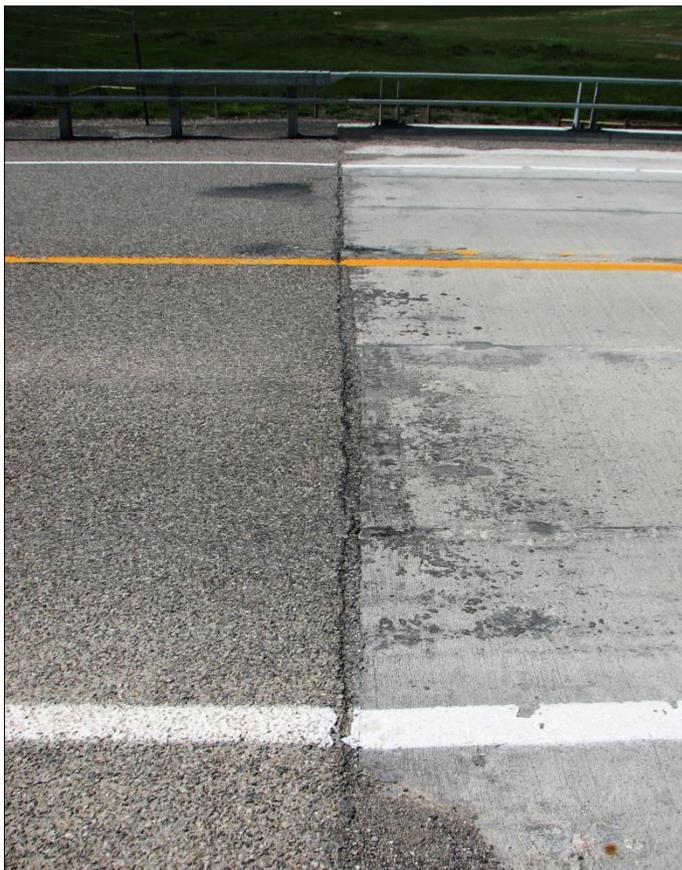
← Pavement approach to slab is a smooth transition.

Top photo is the north end, bottom photo; south end of deck
