**EXPERIMENTAL PROJECTS CONSTRUCTION REPORT AND ANNUAL
EVALUATION**

SMART CUSHION INNOVATIONS (SCI) 100GM CRASH ATTENUATOR

Project Name: Taft-West

Project Number: IM-90-1(84)0

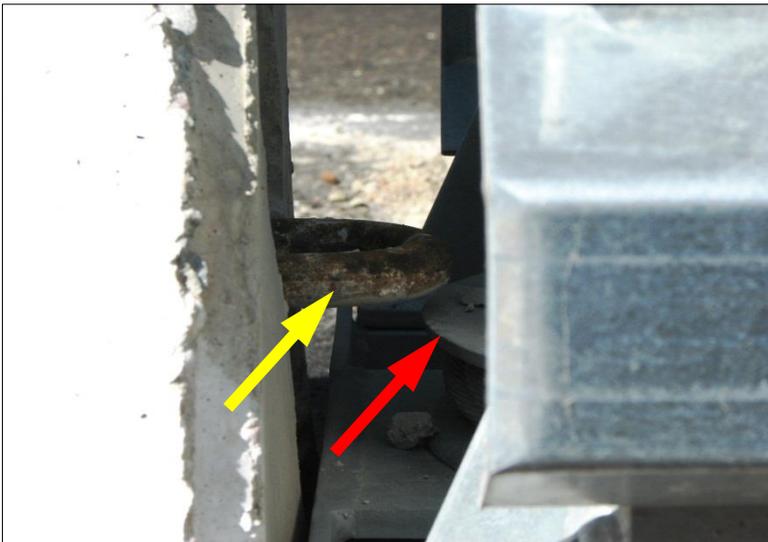
← Although difficult to see in this image, the lower loop of the concrete jersey barrier (yellow arrow) must not interfere with the attenuator's cable sheave cover (red arrow).

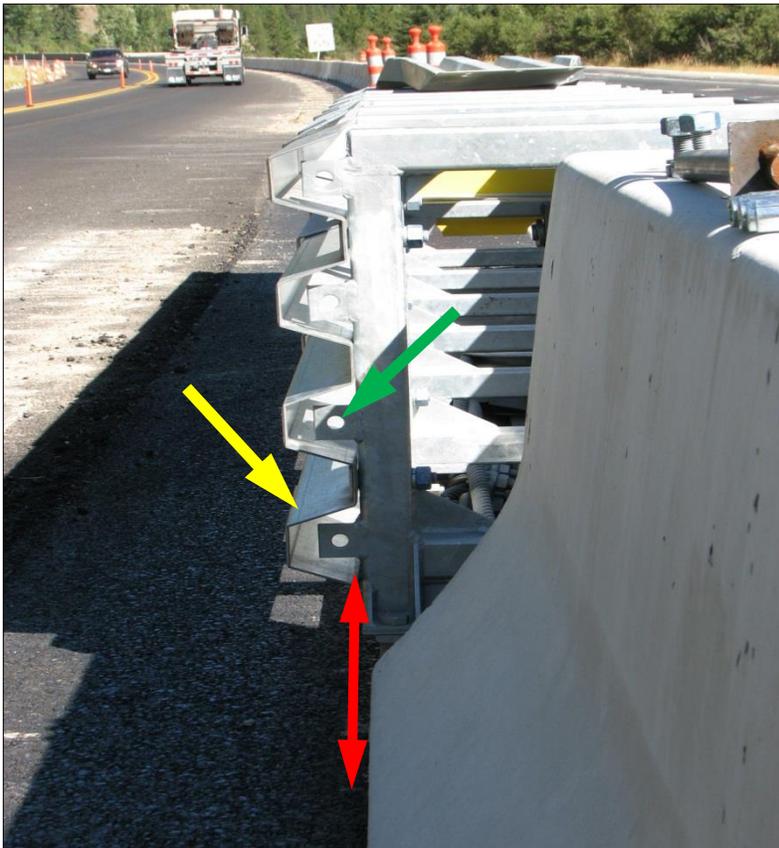
← This image details how the rear panel of the attenuator (yellow arrow) must not be obstructed by the (F shape) jersey barrier (red arrow).

The green arrow points to the bolt holes which the transition panel will attach to.

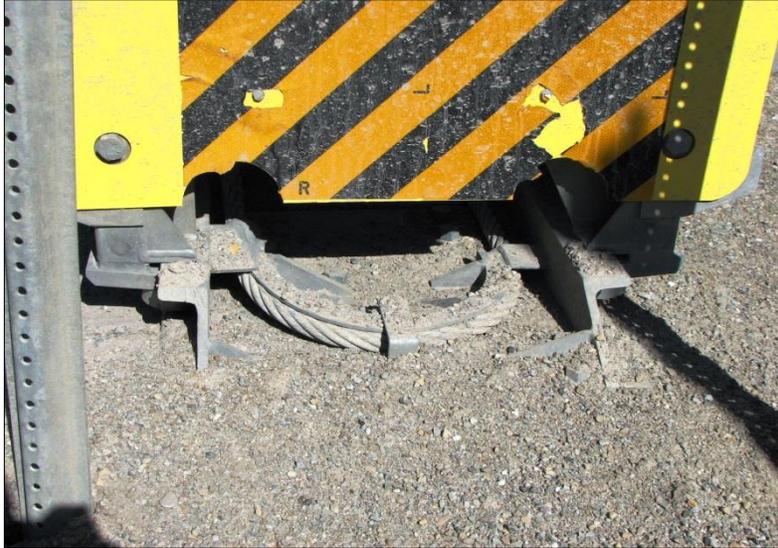
All five SCI installations appear in good shape. No impacts to the units have occurred. Some road sanding material has accumulated in and around the SCI components. The manufacturer's representative has previously stated that this will not reduce the effectiveness of the ride down function of the SCI; however to note that excessive material build-up around the sheave and hydraulic components may reduce the effectiveness of the unit and regular maintenance is suggested.

← Representative view of SCI front sled cable assembly.

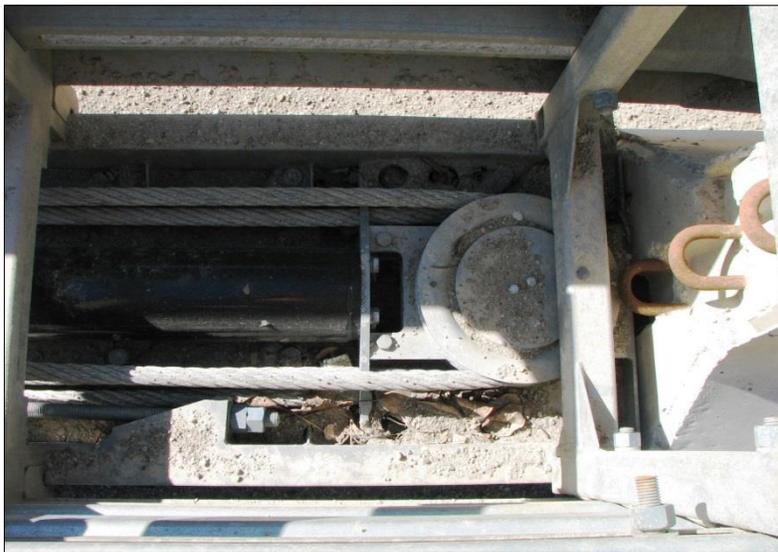
← Representative view of SCI rear mobile sheave assembly and hydraulic cylinder.

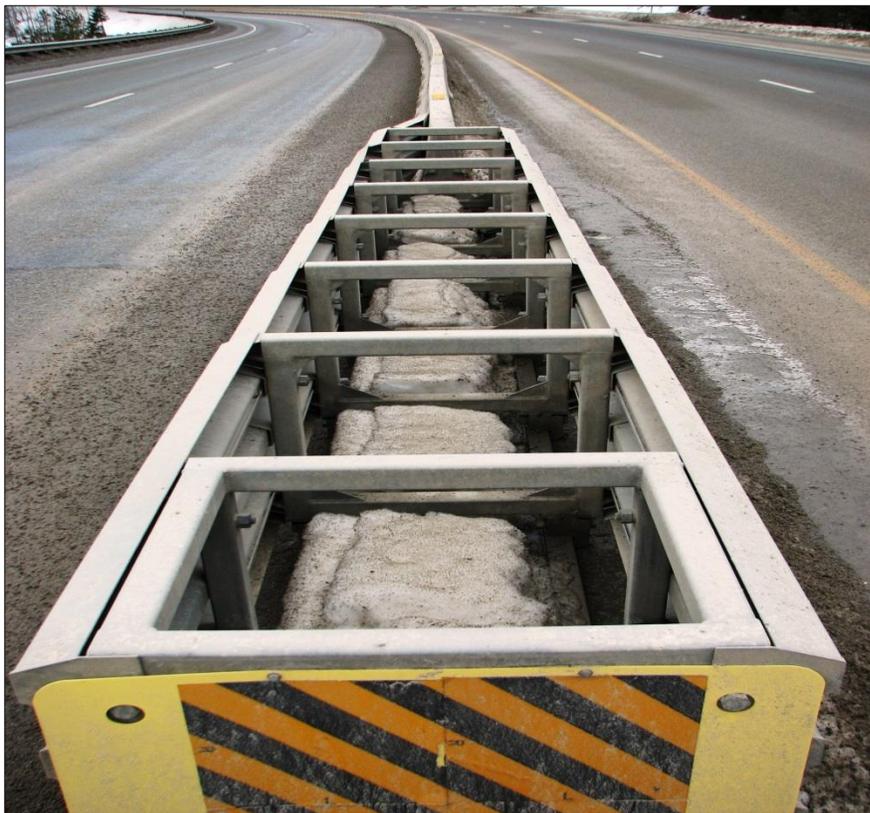
← SCI crossover installation at approximately mile point eight (8), view west.

Image shows minor accumulation of snow and ice in the interior of the SCI unit.

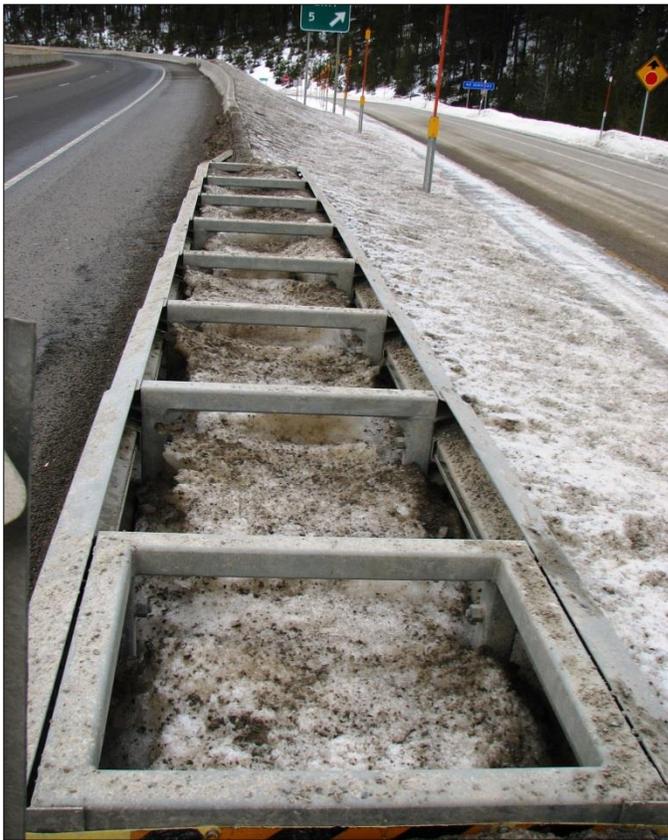
This inspection was scheduled to document the SCI units under winter conditions. No impacts to the units have occurred. Road sanding material has accumulated in and around the SCI components as documented in the 2013 site visit. Hard-pack snow and ice has collected to a depth of 3-4" over the cylinder and cable/sheave assembly on the four SCI units located at the crossover sites. Most noticeable is the northbound SCI unit at exit 5 (Reference point 6). The accumulation of snow and ice has almost completely filled the body of the attenuator to a density that you are able to walk on top without depressing the mass.

Per the manufacturer, attenuators of the type used on this project was developed and tested under the guidelines of NCHRP 350. The condition the crash cushion is in during the timeframe of this report is not applicable to NCHRP 350 performance criteria therefore it would be difficult to ascertain if this condition will affect optimum performance to any lesser degree.

↙ Northbound I-90 at reference point 6. Exit 5 location of SCI unit.

Note the level of snow and ice inside and in front of the attenuator.

As stated earlier it is uncertain how this condition would affect the performance of the cushion if struck by a vehicle.

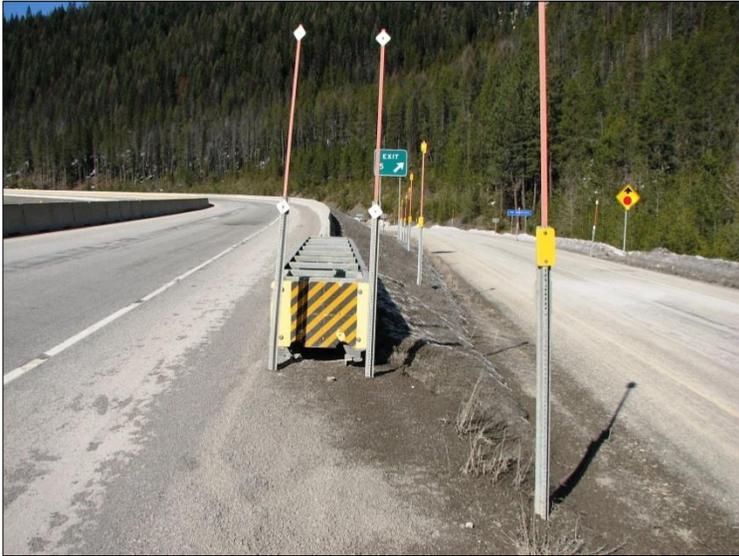
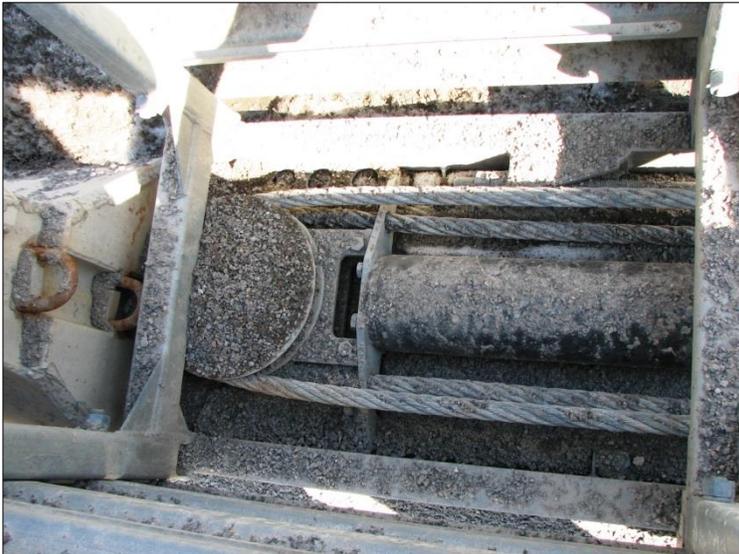
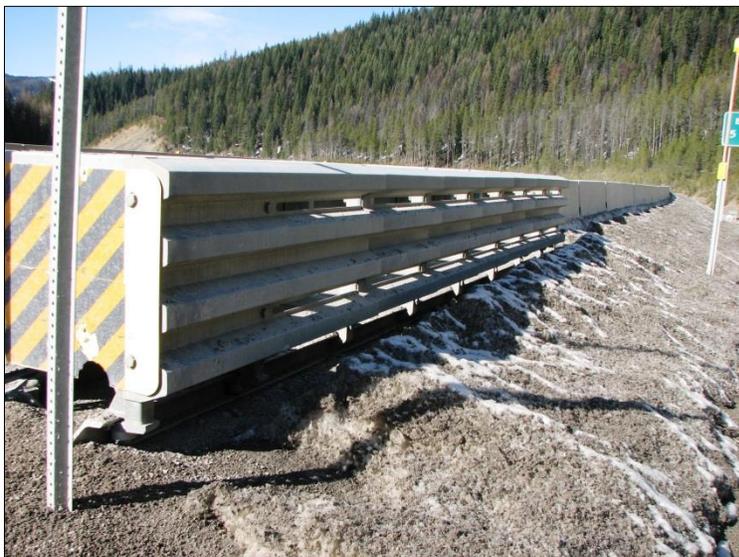
No impacts to the SCI units have occurred since installation. Conditions were dry and as reported in the 2014 inspection sanding debris and particulates have coated, at various levels, the cable sheaves and hydraulic porting.

↙ Westbound I-90 at approximate reference point 6. Exit 5 location of SCI unit.

These images represent the general condition of all of the SCI units on the project.

As documented in earlier inspections sand and grit accumulates in and around the cable, guides and cylinders systems.

If this effects the hydraulic porting during impact is unknown at this time.

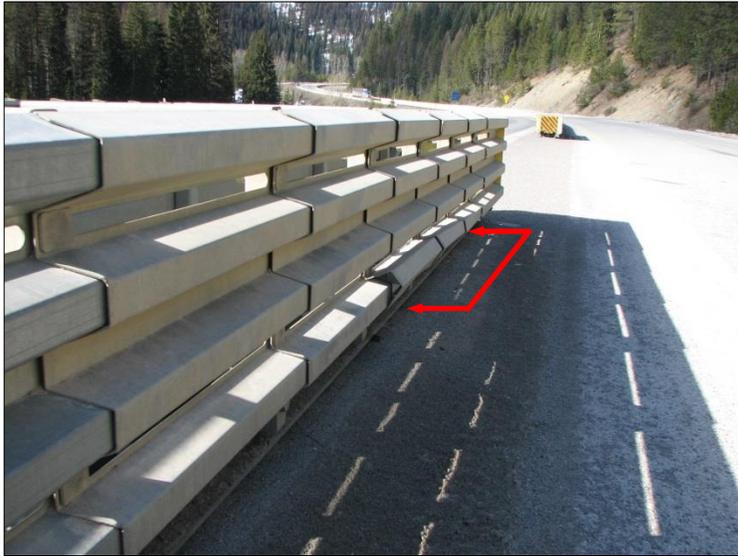
Damaged side panels were noticed on the east end crossover unit near reference point 7 located on the north side of the SCI. The side panels affected was the lower tier and involved two panels. What hit the panels or how this will affect the efficacy of the cable hydraulic porting unit is unknown.

↙ Westbound lane I-90 at approximate reference point 7: East end unit, north side.

Noticeable damage to a section of the bottom side panels (delineated by the red arrows).

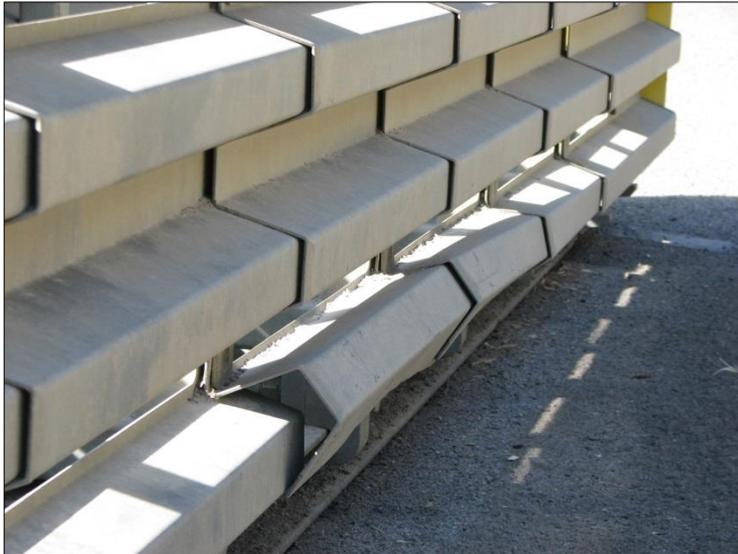
↙ Close-up of panel damage.

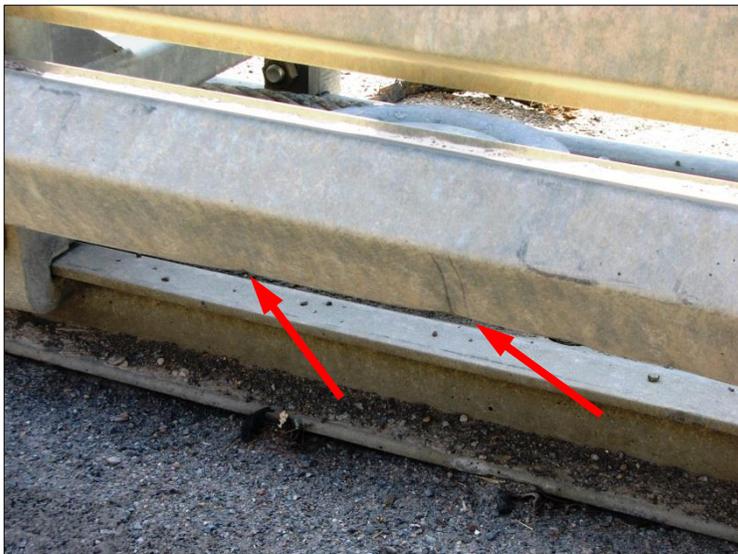
↙ Arrows show strike dents on the lower panel. It is difficult to determine if this type of damage will affect the performance of the unit.

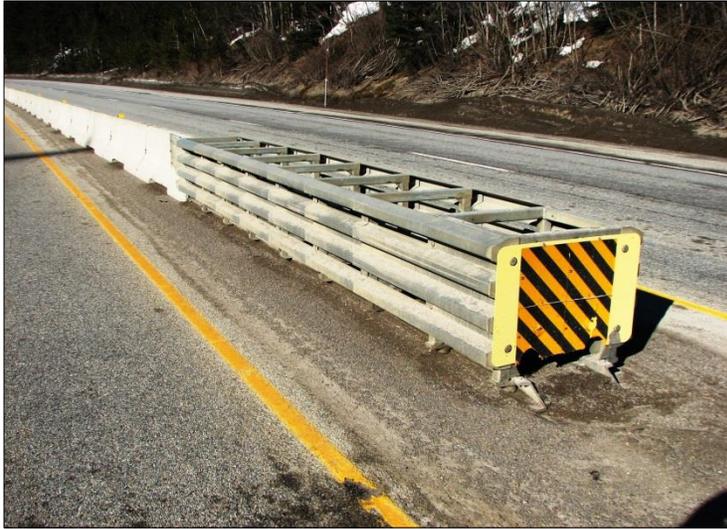
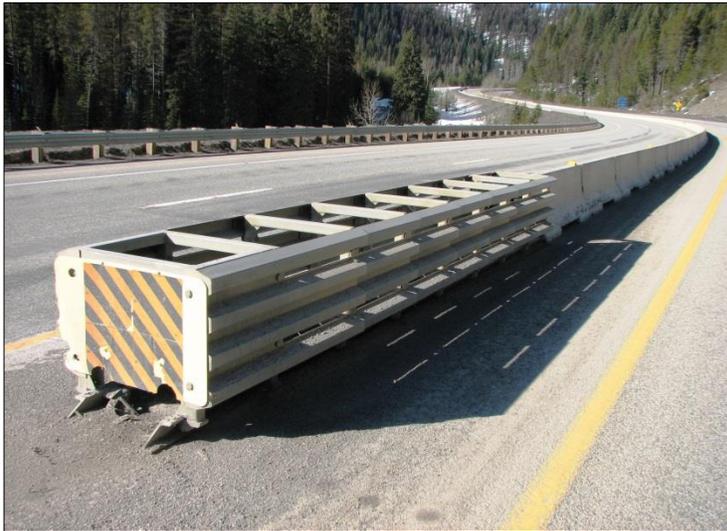
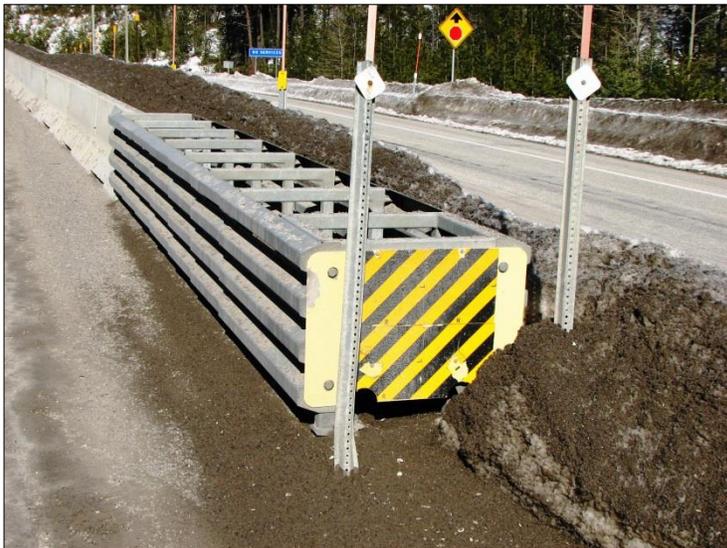
At this time the accumulation of material around the porting mechanism is not considered a detriment to the function of the SCI unit.

↙ Representative images of the SCI units at the three locations between references post 6-7.

As noted in previous inspections sanding grit accumulates in and around the hydraulic porting mechanism.

No information to date suggests the accumulated material will affect the unit's ridedown function.
