INSTALLATION REPORT/SITE INSPECTIONS

EVALUATION OF STAY-TUFF WOVEN FENCE

Project Name: I-15 Augusta Interchange to Craig (UPN 6531001)

Project Number: IM 15-4(129)229

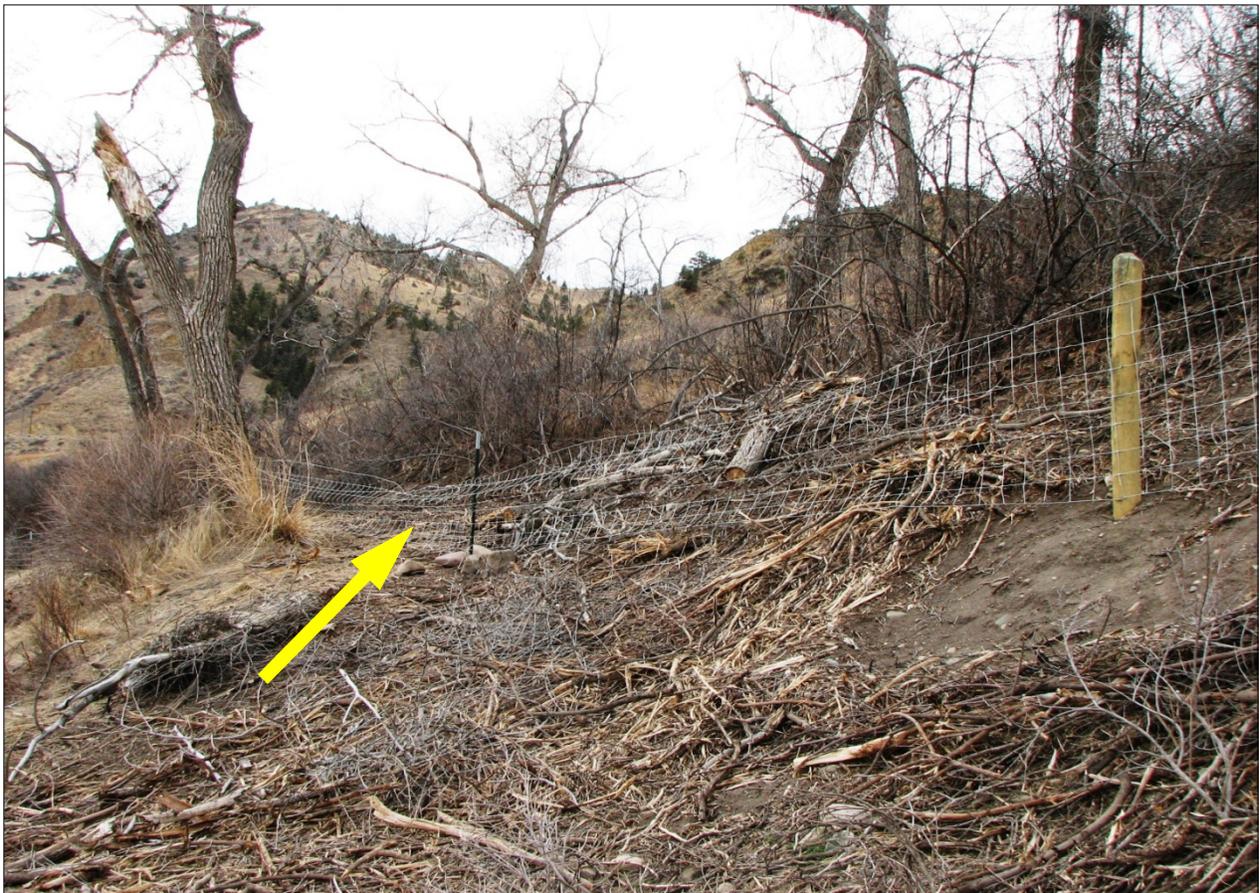
The image below shows the extent of damage by the fallen tree. The yellow arrow depicts the approximate location of where the main trunk hit the fence.

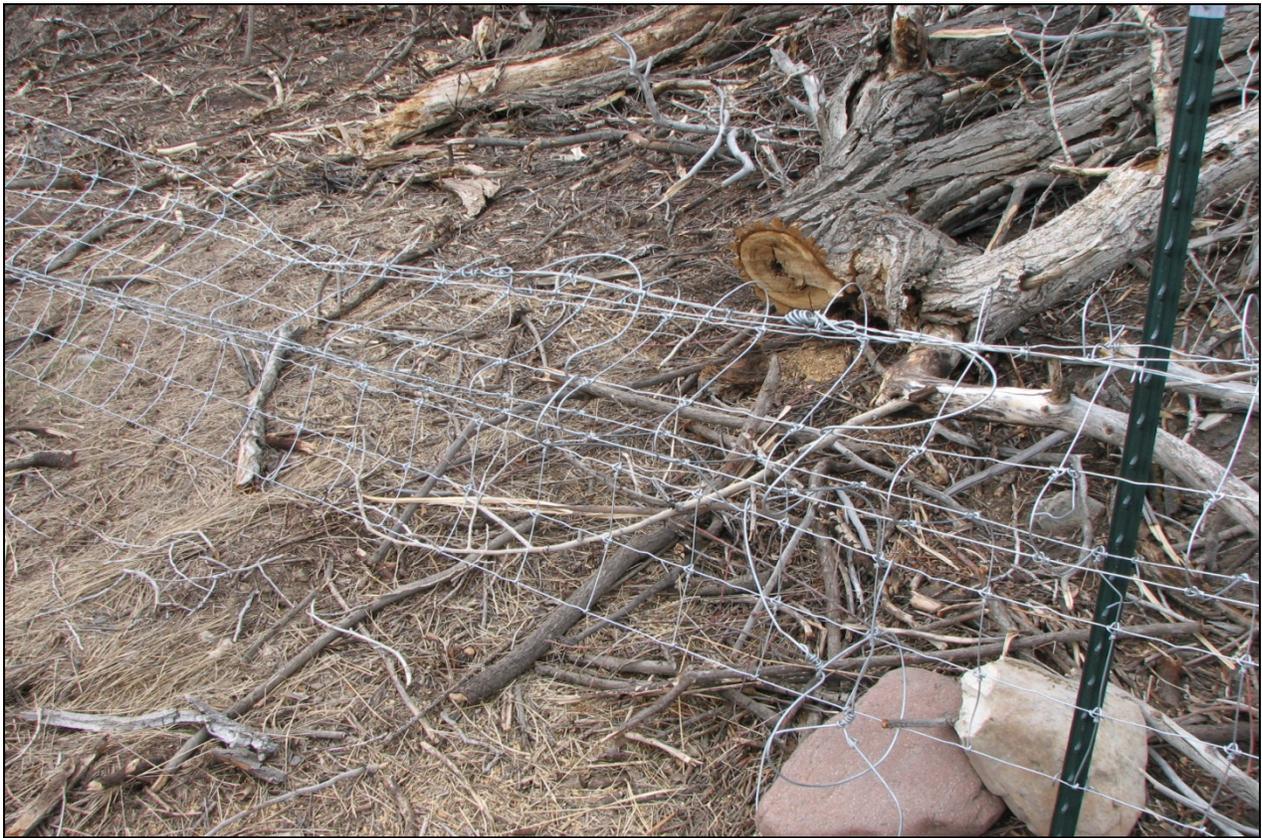
↑ Close-up of damaged fencing. Note that once the trunk was removed the woven fence recovered some flexibility as seen in its position relating to the metal post.

Maintenance stated no breakages of the wire strands were noticed.

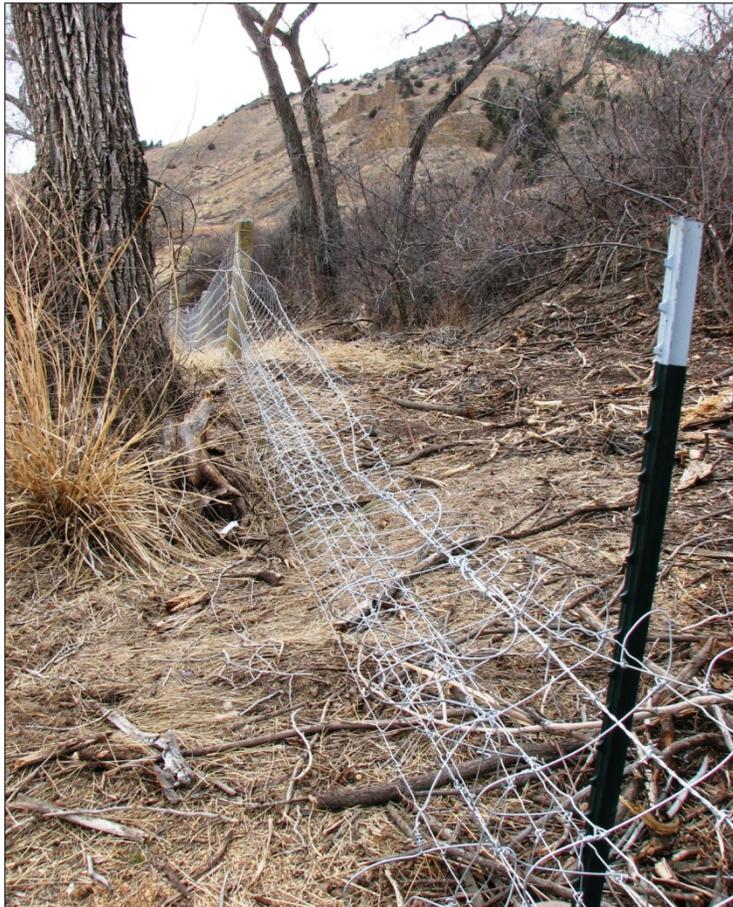
← South view of damaged fence section.

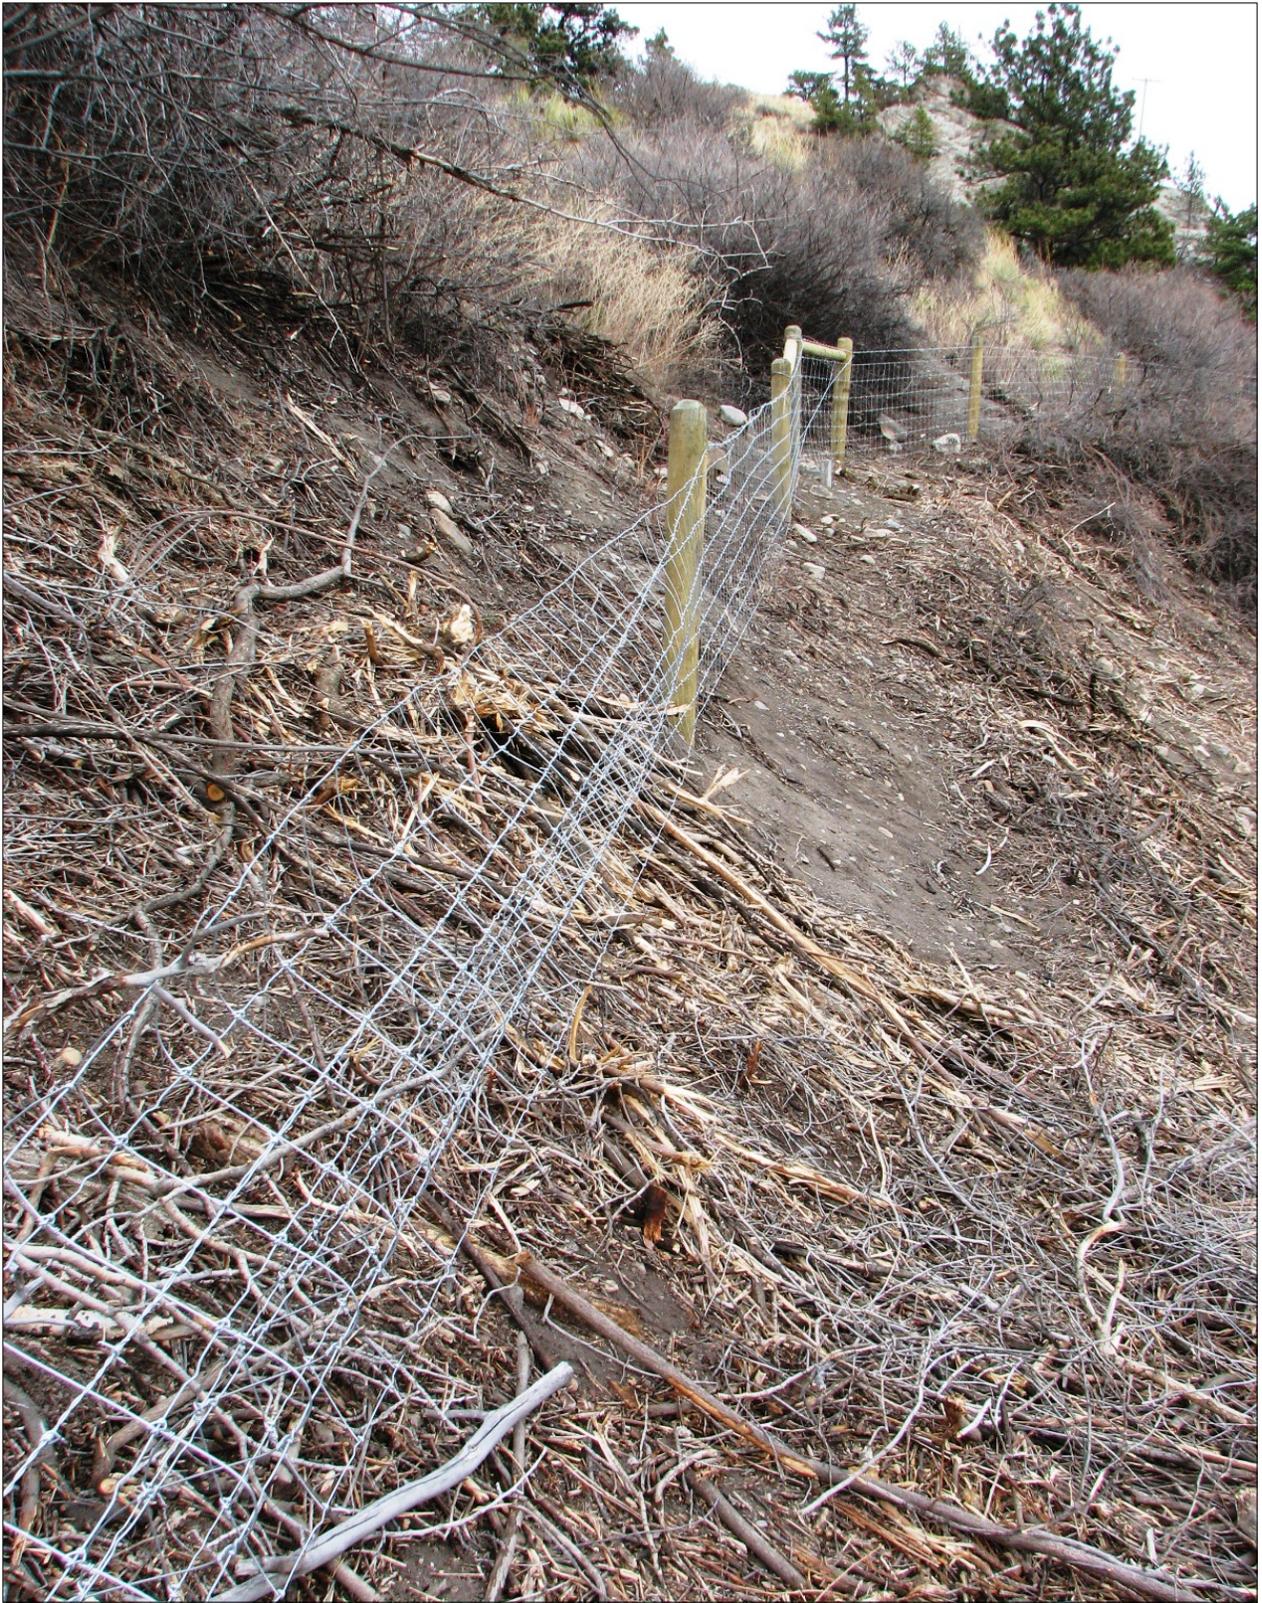
↑ View north of damaged fence section.

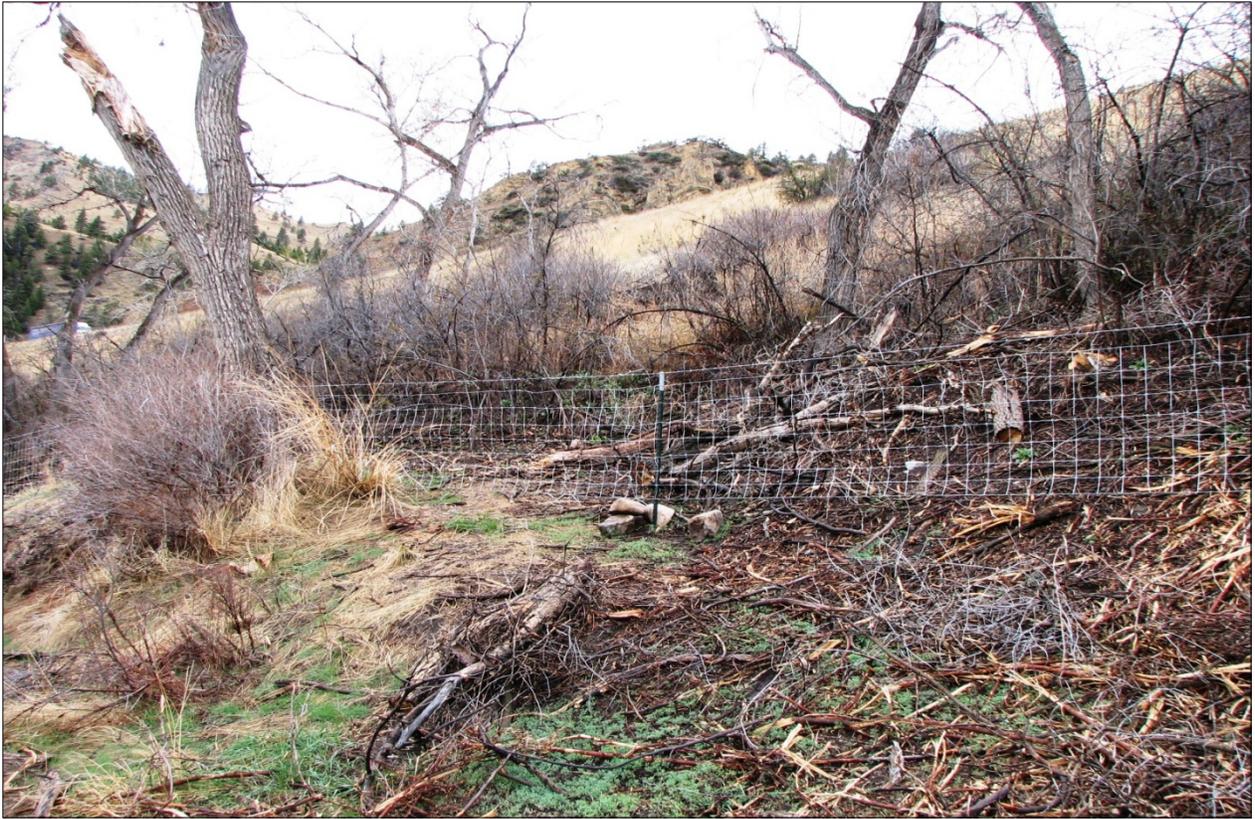
↑ Overview of repaired Stay-Tuff fence section.

The section was repaired in early April. Bob Cloninger (Great Falls Maintenance Staff who supervised the repair) stated that normally with this sort of damage (regardless of the type of fence) they would have cut that section out and installed new material. Since at the time the Stay-Tuff product was not available, and the fencing section seemed fairly intact, they elected to keep the existing fence section in place. Mr. Cloninger remarked that due to its apparent stiffness and rigidity the material adapted well in being refitted to the fence supports. At this time Maintenance will leave the current repair as is.

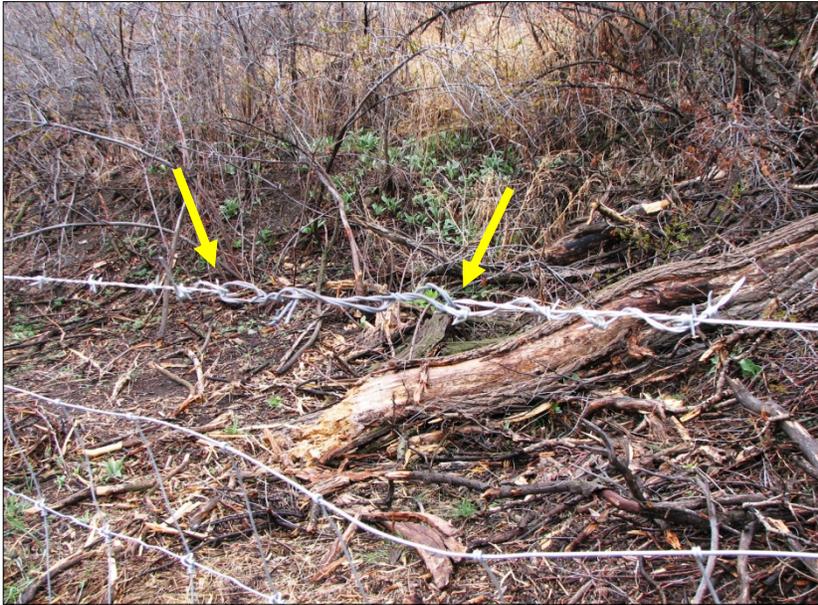
← Maintenance reported the top barbed wire strand had stretched and needed to be cut and retightened with a supplement wire.

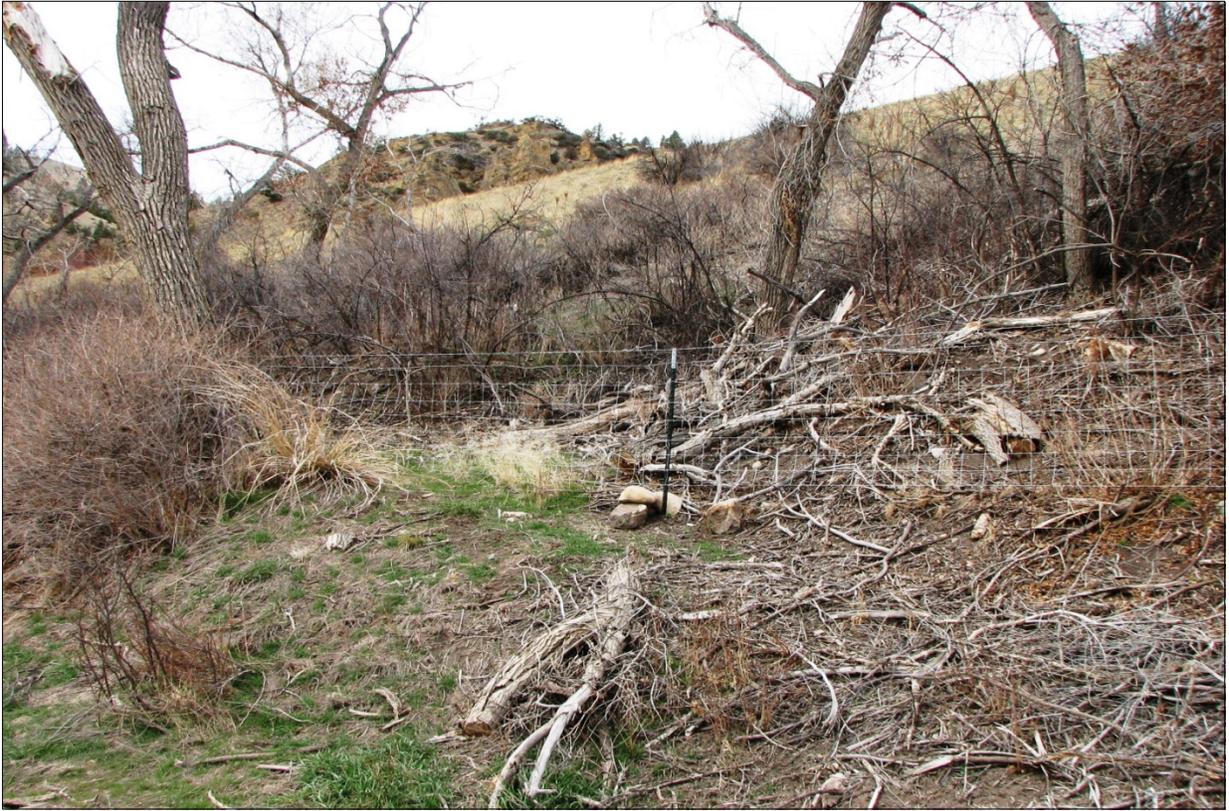
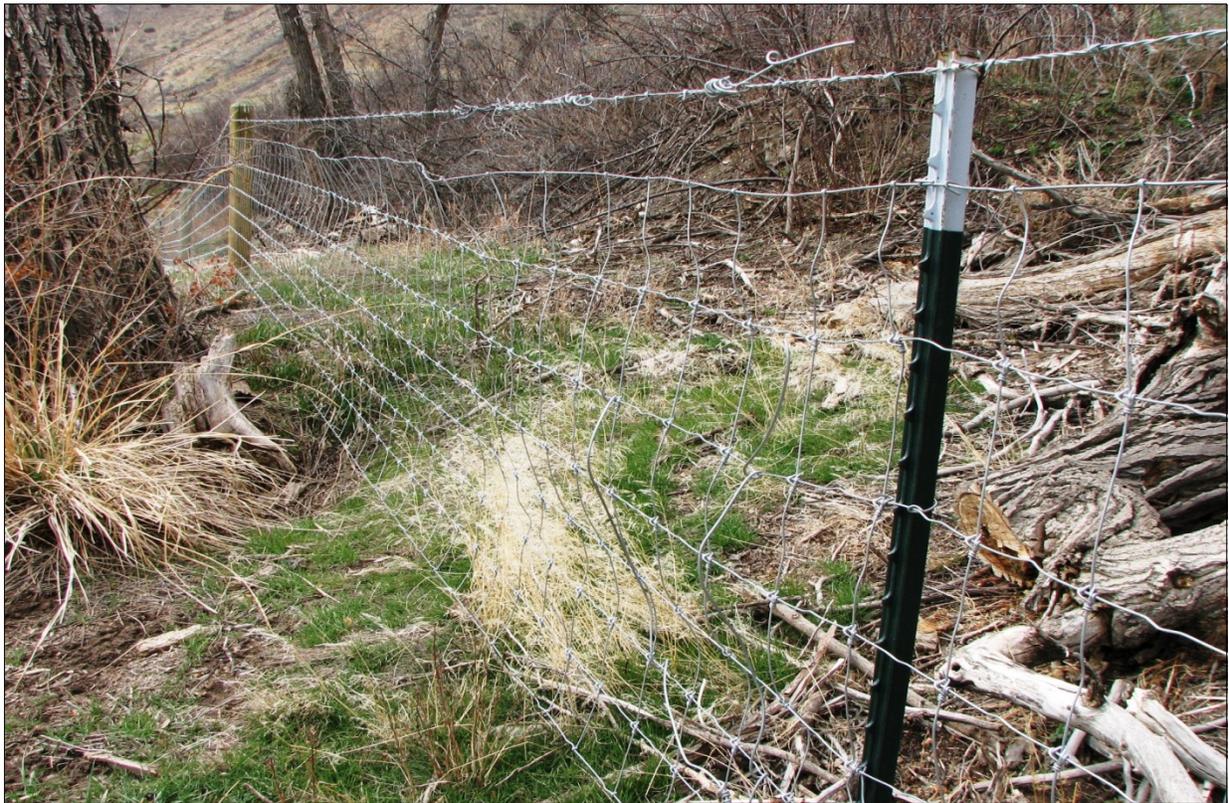
↑ ↓ Images of the repaired Stay-Tuff fence section as document in March 2012, (page eight (8)).

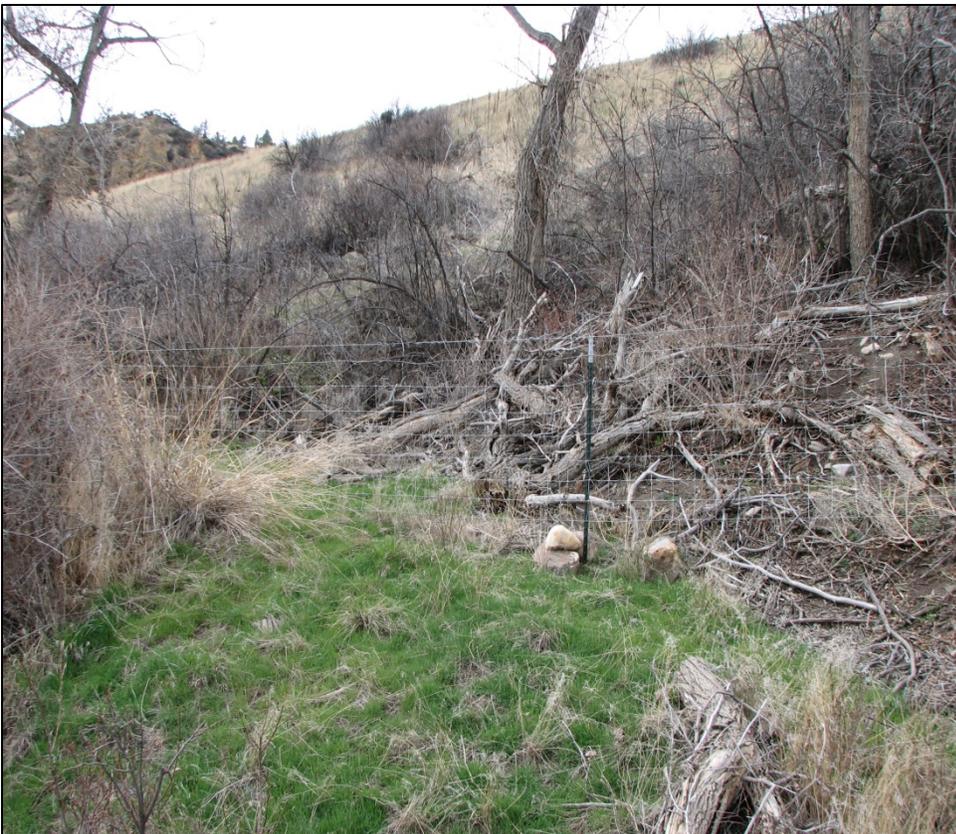
← Image of fence damaged in March 2012 (refer to page 8) in good condition as of April 2014.

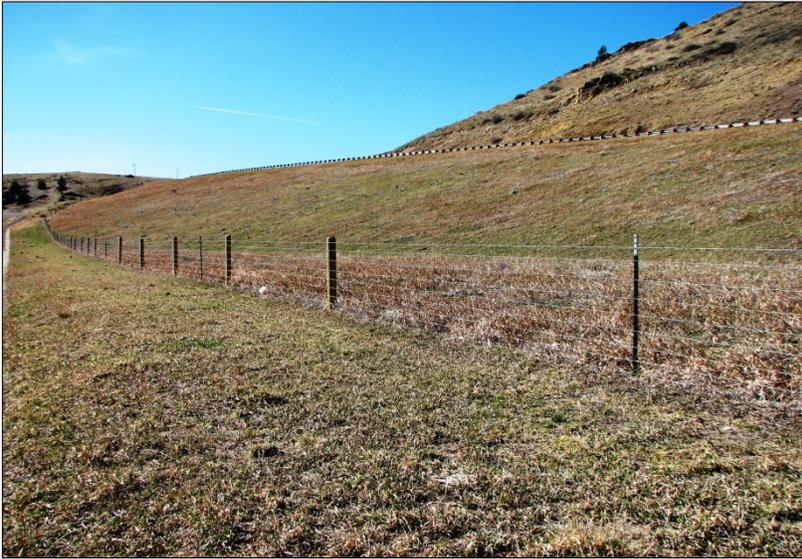
↙ Stay-Tuff Woven; general condition of the fencing throughout the project.

No performance issues reported to date.

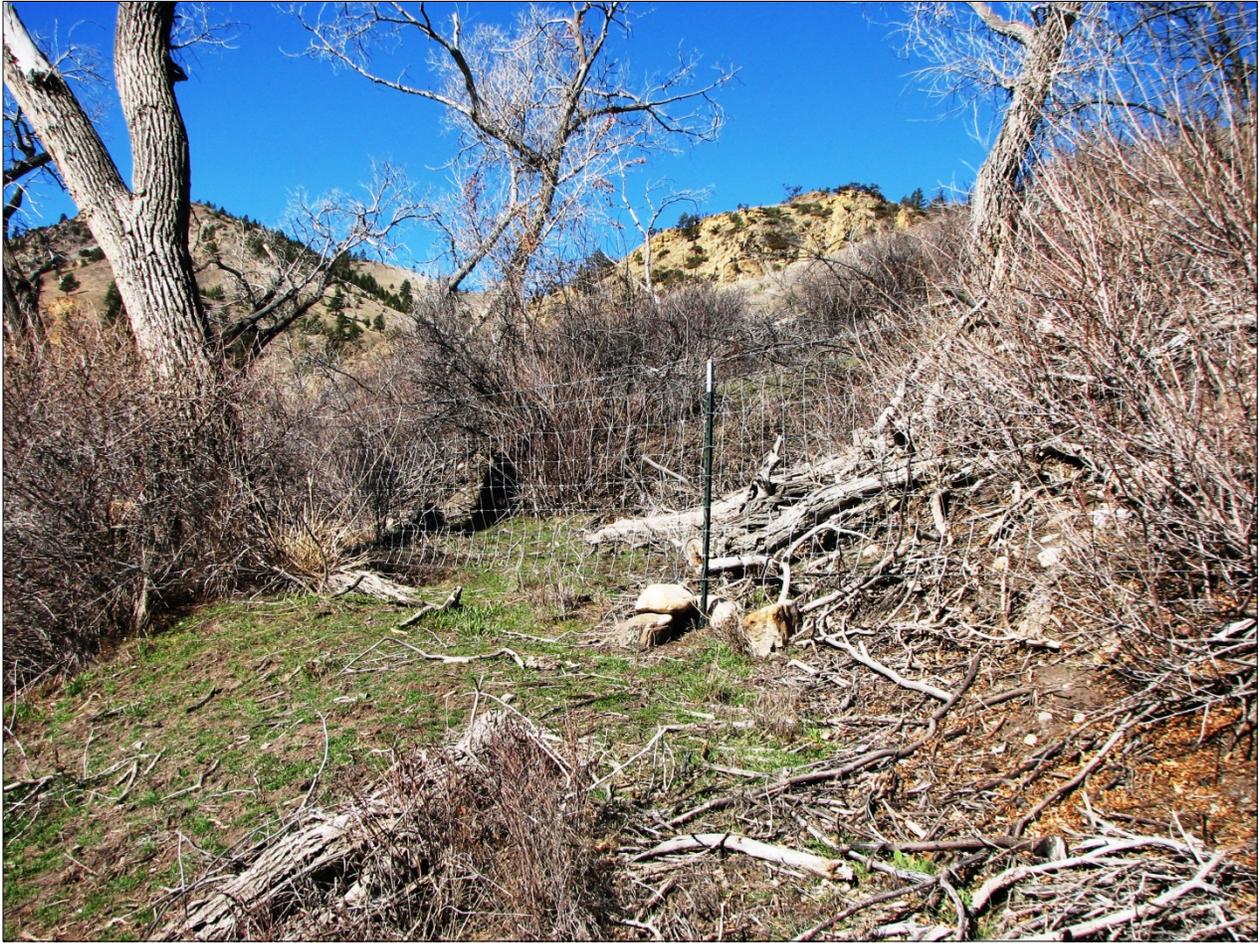
↑ Damaged section as reported in March 2012: No issues to report; repair still intact.
