EXPERIMENTAL PROJECT

**EVALUATION OF HOT-LAID THERMOPLASTIC PAVEMENT MARKINGS
PREPARATIONS PRIOR TO A SEAL COAT (SC) APPLICATION**

Installation-Annual Inspection & Analysis Final Report

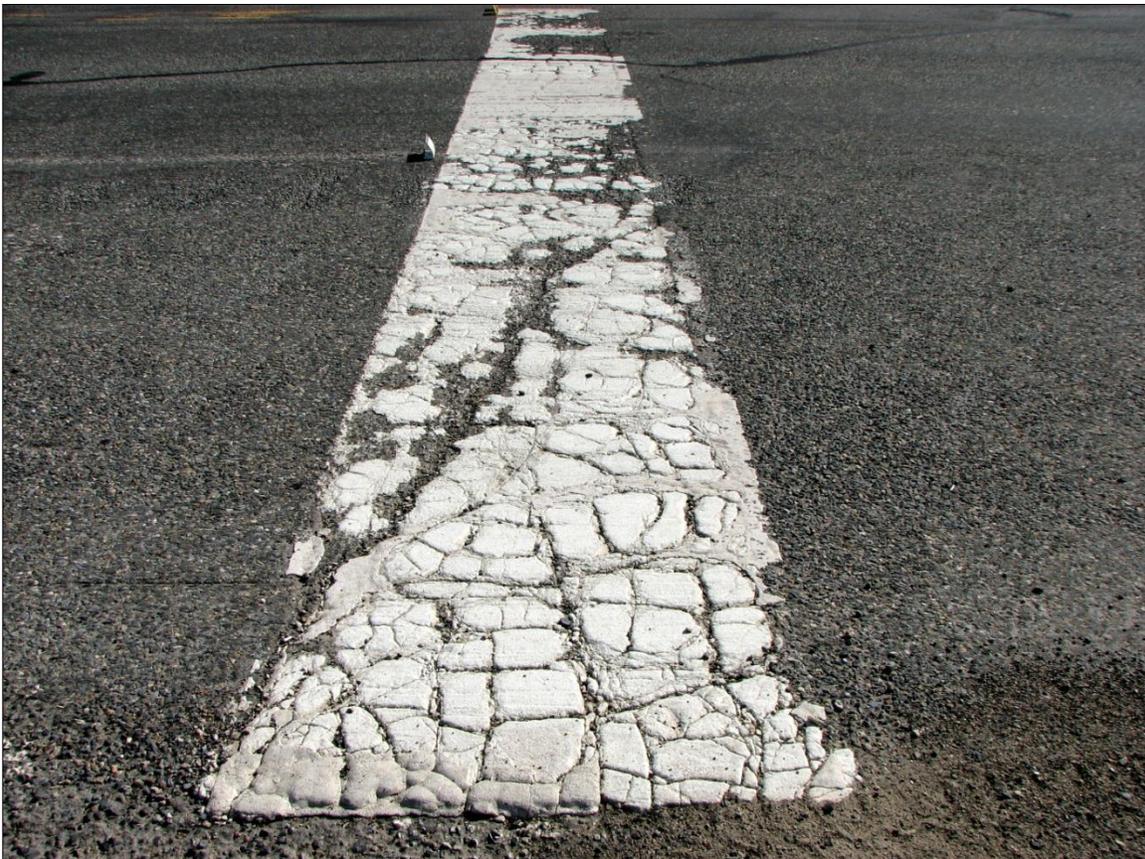
↑ Condition of eastbound stop bar prior to scarification.

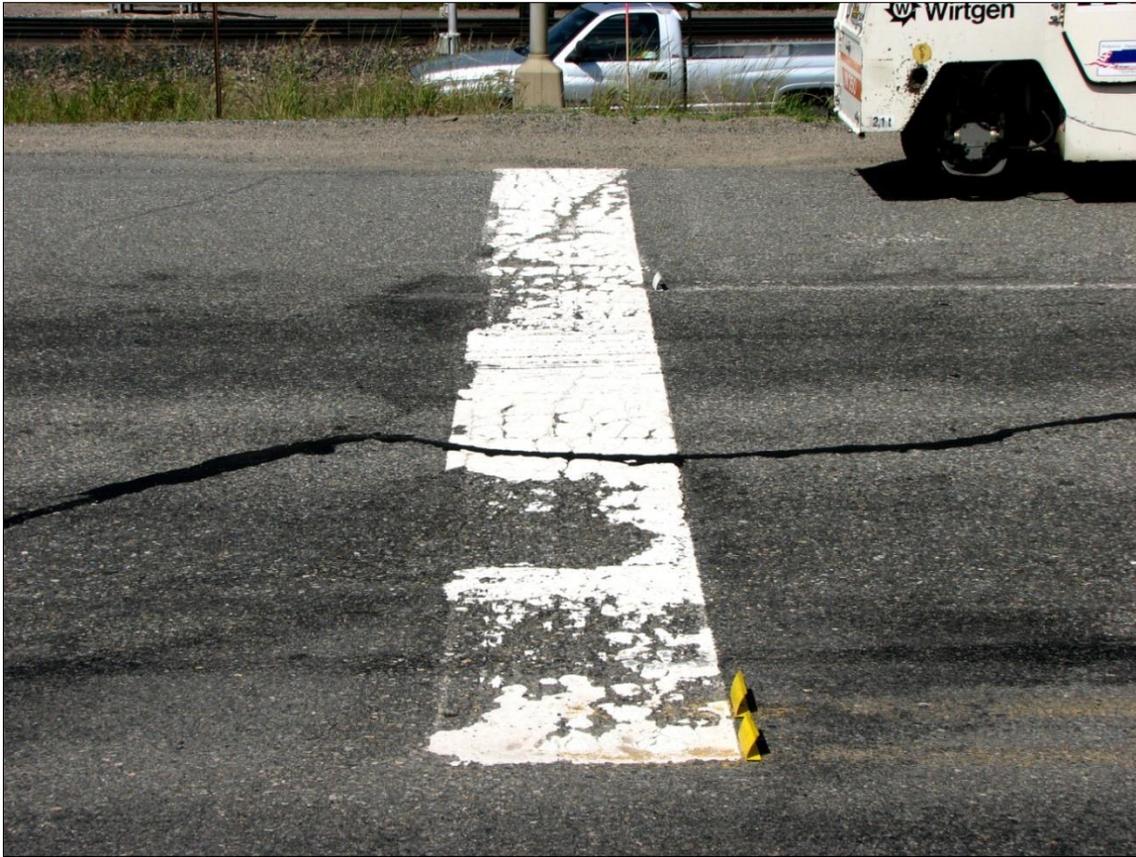
↑ Stop bar at westbound lane (east side of intersection). This was not scarified prior to the seal and cover.

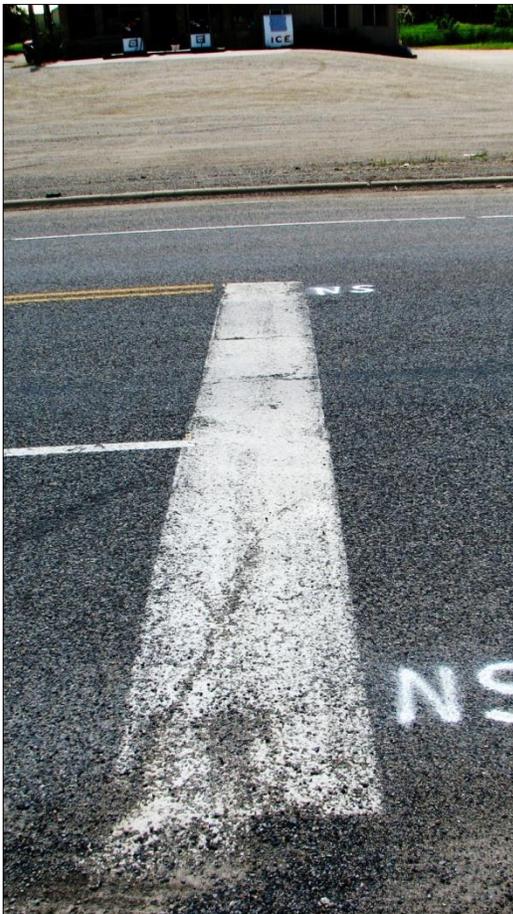
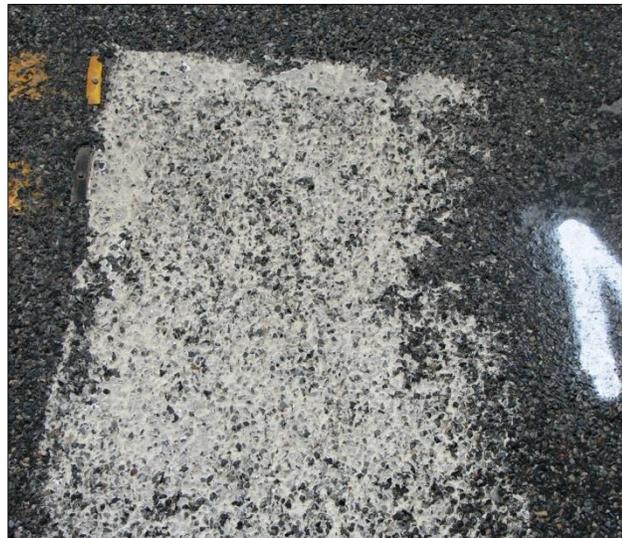
Both images show the condition of the non-scarified (westbound lanes) stop bar in 2009. Seal and cover is still intact, no evidence of debonding from chip seal to thermoplastic is apparent to date. Pavement marking is in fair condition.

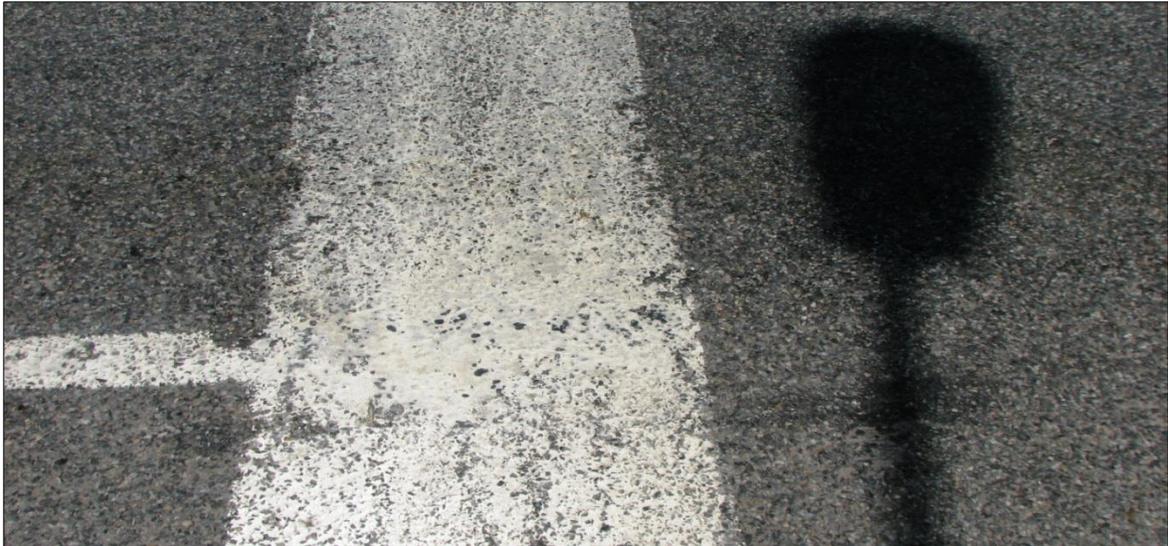
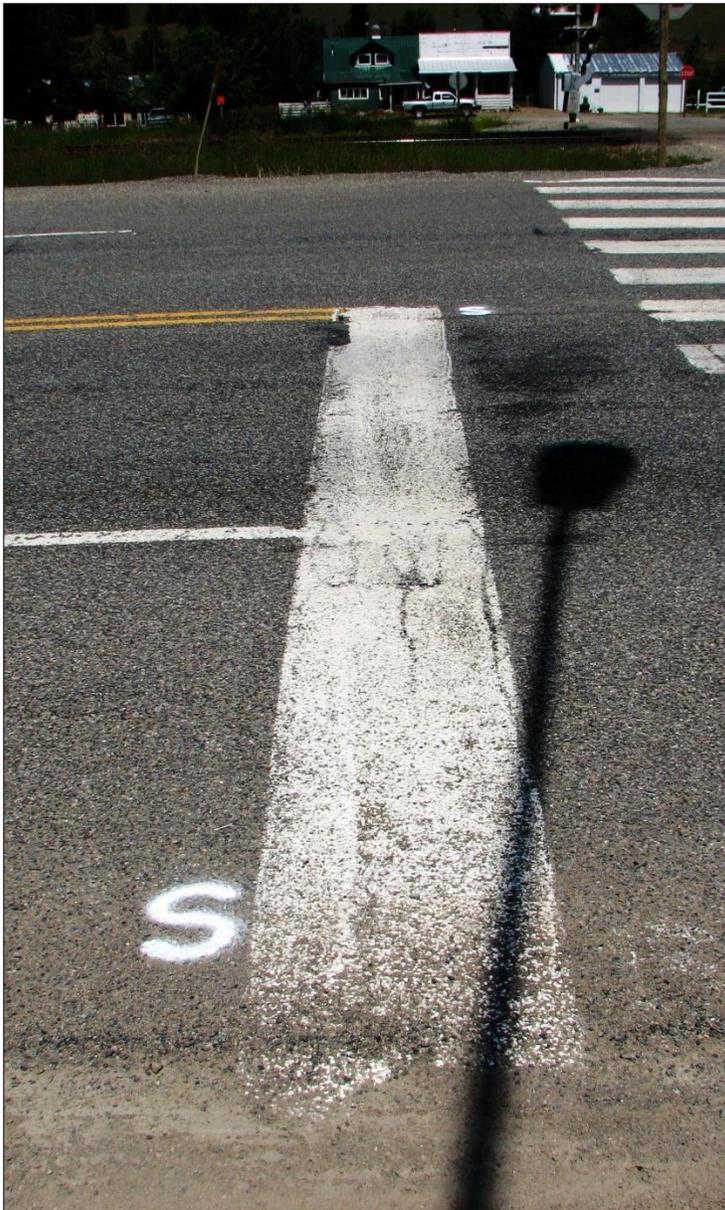
Overview and close-up of the eastbound (scarified) stop bar treatment in 2009. Seal and cover is still intact. Pavement marking in fair to poor condition.

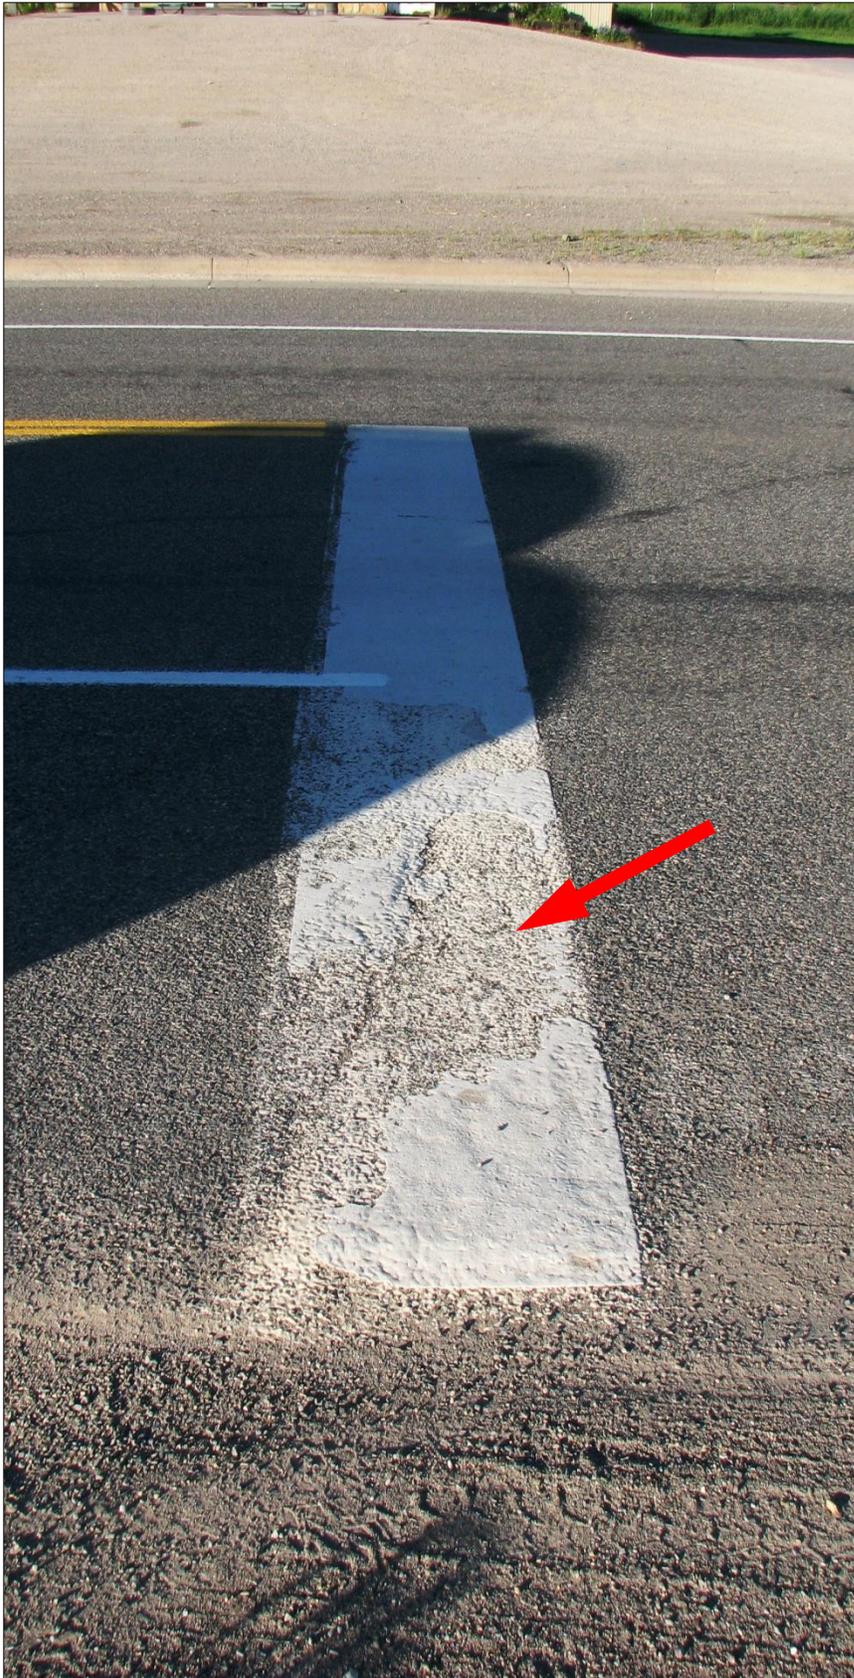
← Overview of westbound stop bar. Note that a type of thermoplastic sheet-style pavement marking was applied after the 2009 site visit. This type of marking is laid over the existing pattern and heat is used to adhere the product in place.

Notice that portions of the heat-applied marking are beginning to be removed (red arrow) most likely from plow passes.

Normally this type of pavement marking would be recessed to prevent this; however since it is applied atop the existing stop bar marker that is already over the existing thermoplastic has raised this sufficiently for passing plows to continue this condition.

Also note the seal and cover is still intact with no debonding noticeable.

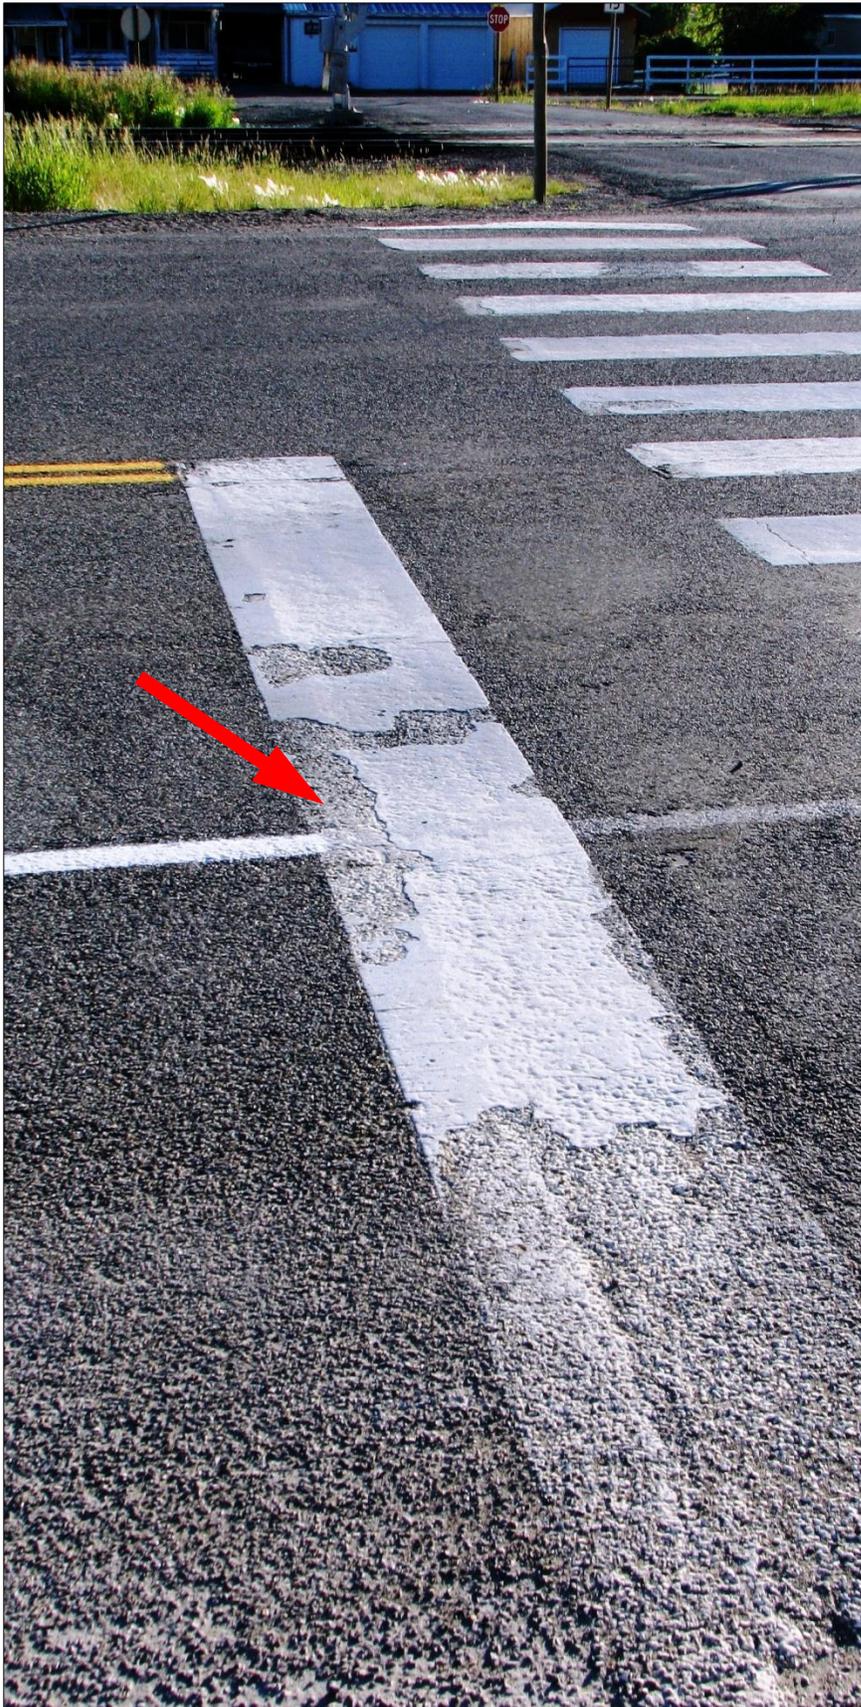
← East bound stop bar, west side of intersection.

As depicted in the west bound stop bar image, the same marking condition is seen here.

The top application of thermoplastic is being stripped presumably by plow action (Red arrow). The seal and cover is still intact

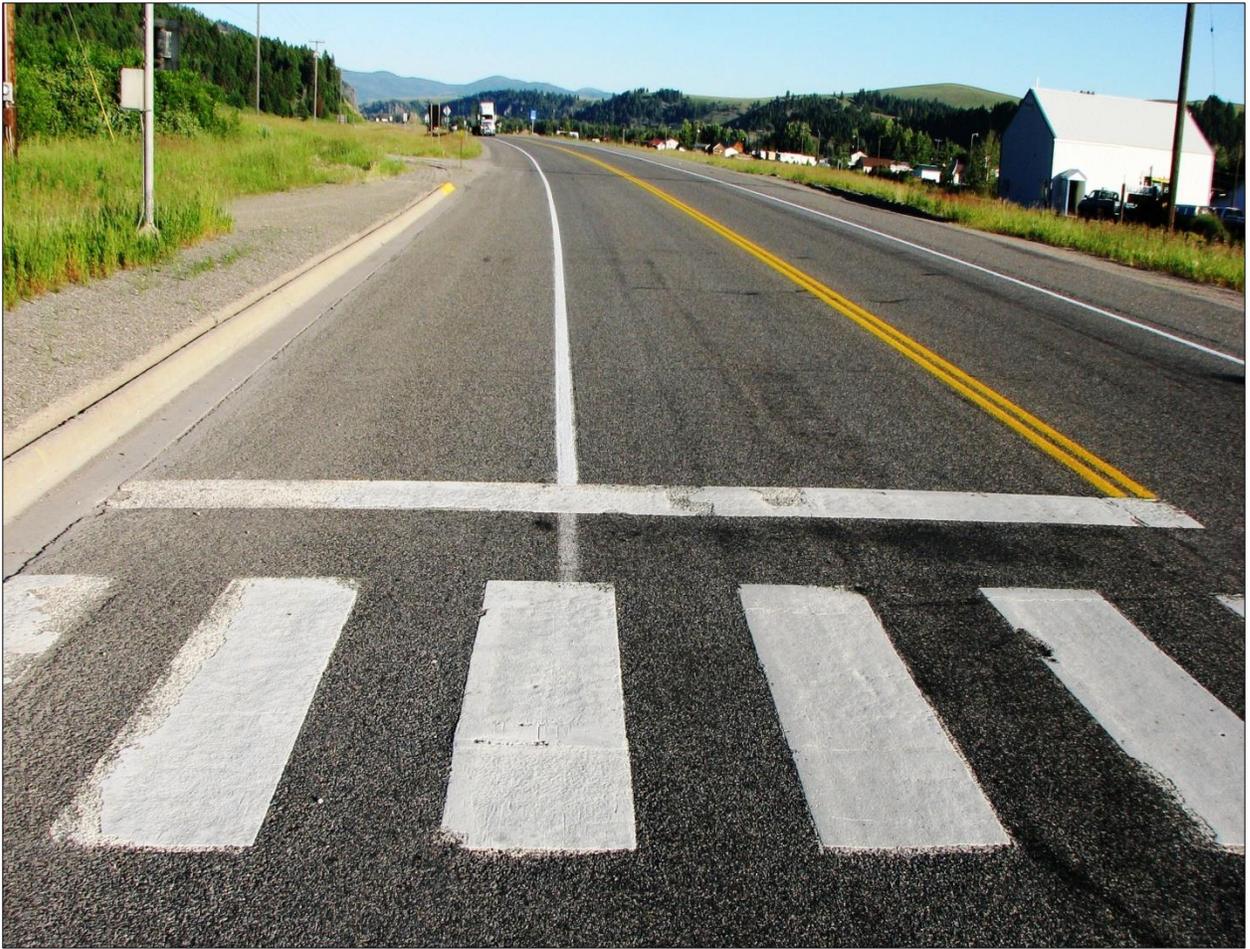
↑ Westbound view of eastbound intersection. The zebra walk displays less delamination of the heat-applied thermoplastic than the stop bars.

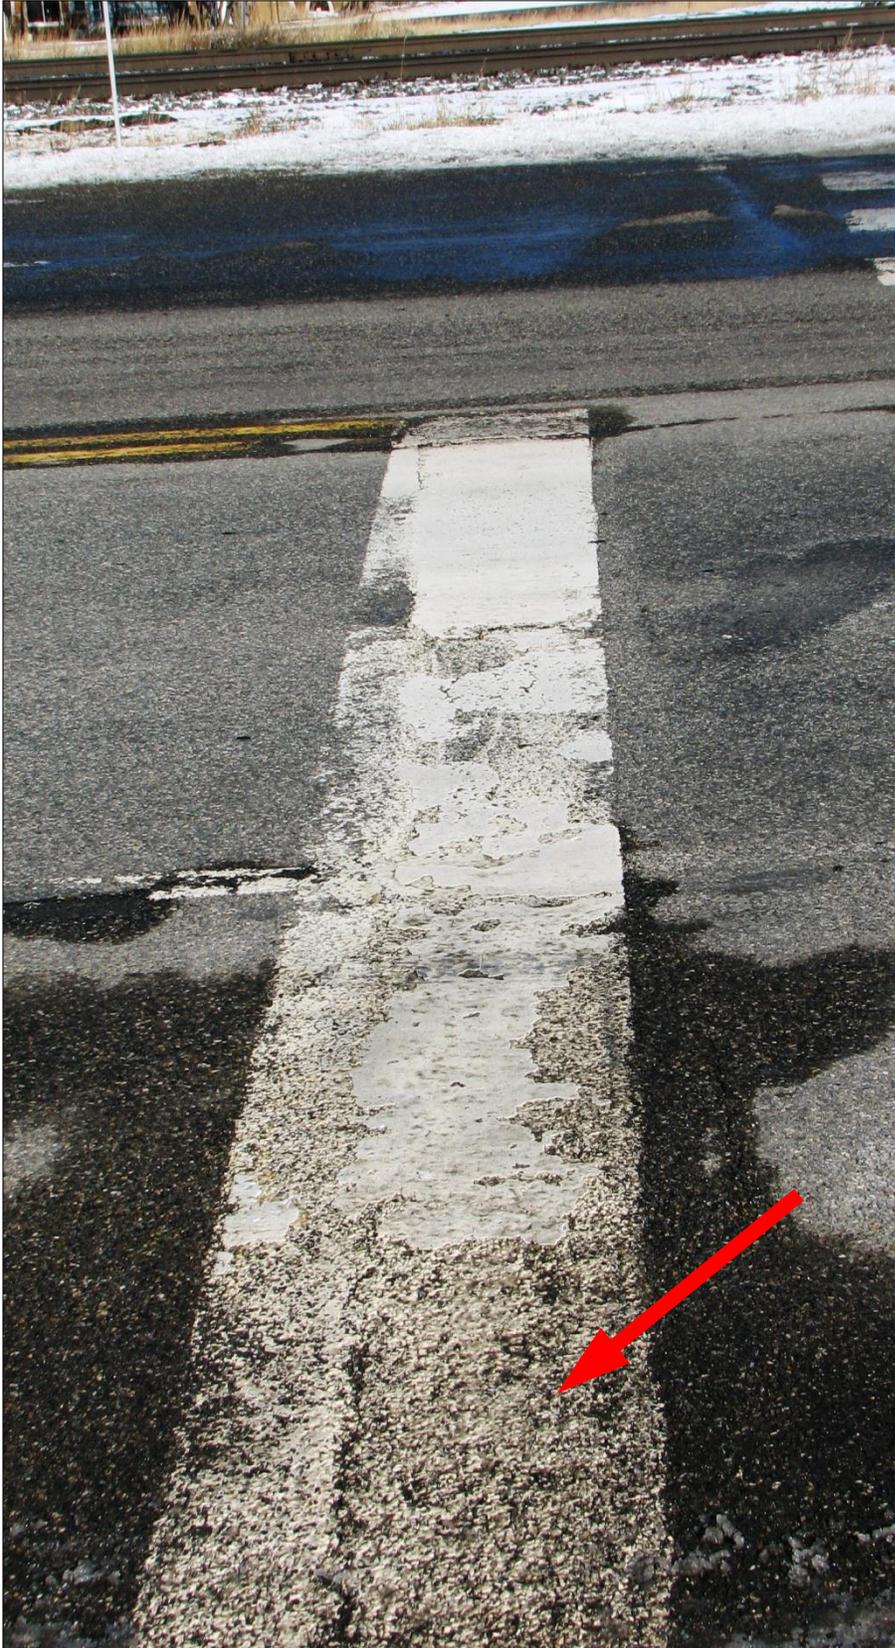
← East bound lane, west side of intersection stop bar. This was a scarified in 2008.

As reported during the 2010 site visit, the pavement marking was reapplied using a heat-applied thermoplastic after the 2009 inspection. In the image you can see the original pavement marking coating over the chip seal applied in 2008 (red arrow).

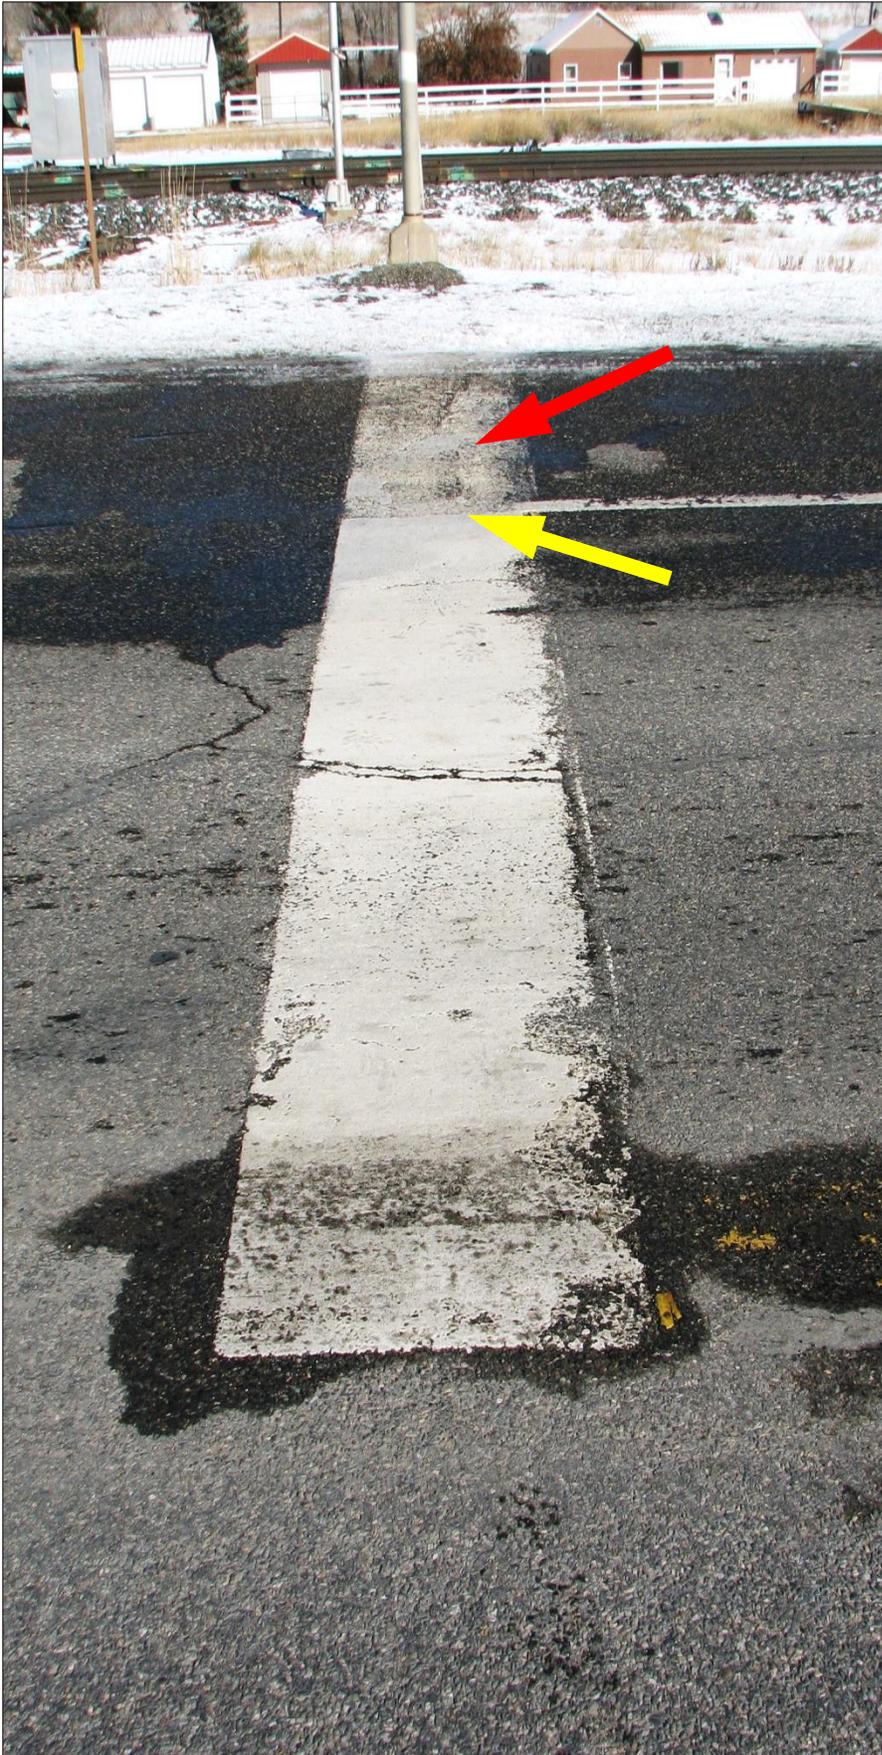
← West bound lane, east side of intersection stop bar. This did not receive a scarification.

In the image you can see a section of the seal and cover as applied in 2008 over the existing thermoplastic (red arrow). This section is completely sheared off. Since the line of delineation (yellow arrow) is precise at the shear off, it is assumed this was a separate sheet of heat-applied thermoplastic.

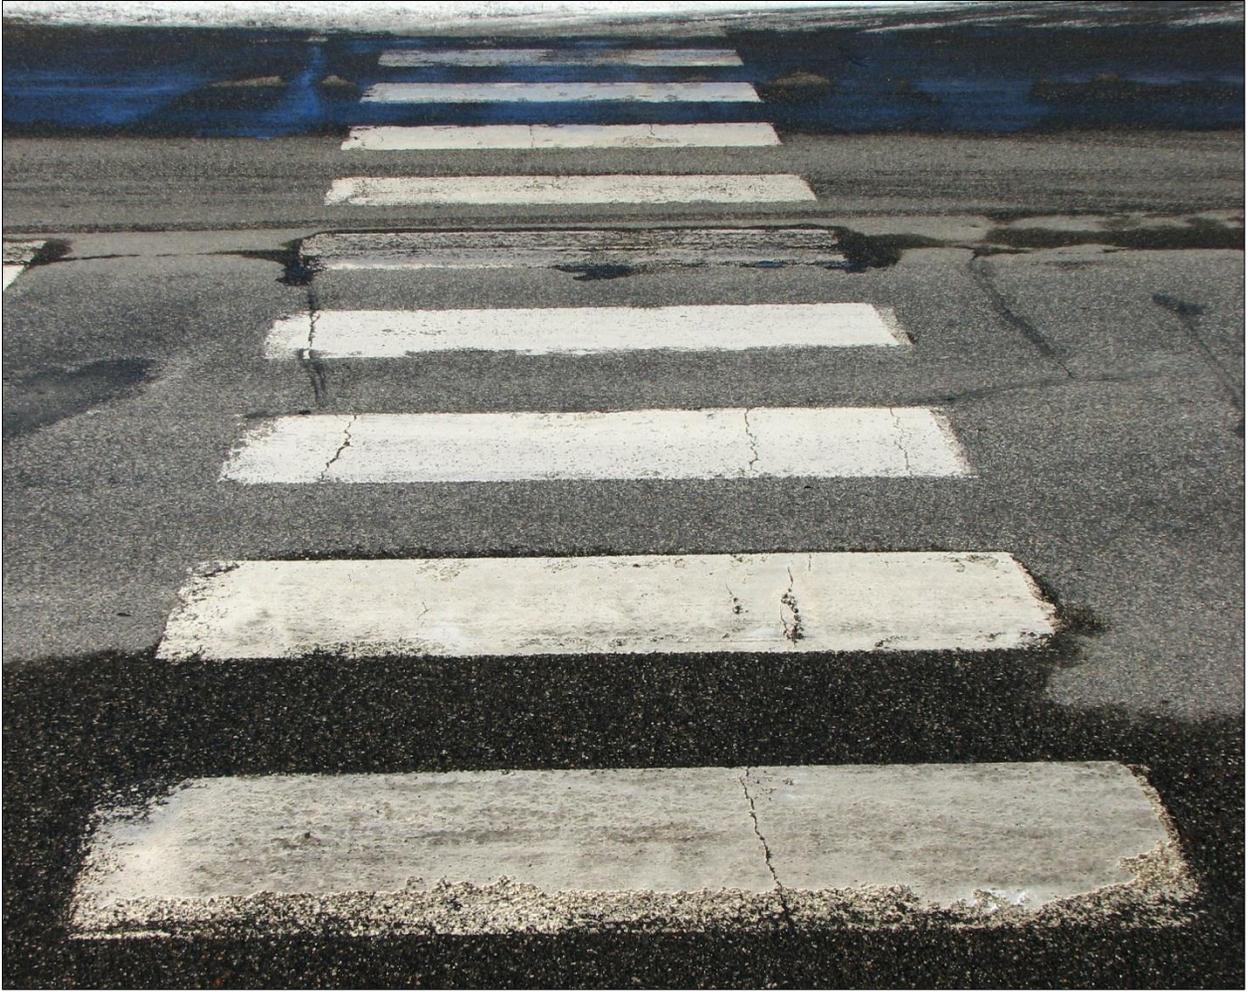
↑ Intersection crosswalk at Highway 12, west side. As in the previous images you can see the pavement markings applied over the existing thermoplastic in 2008 and the reapplied marking sometime after July 2009. The crosswalk received a scarification treatment.

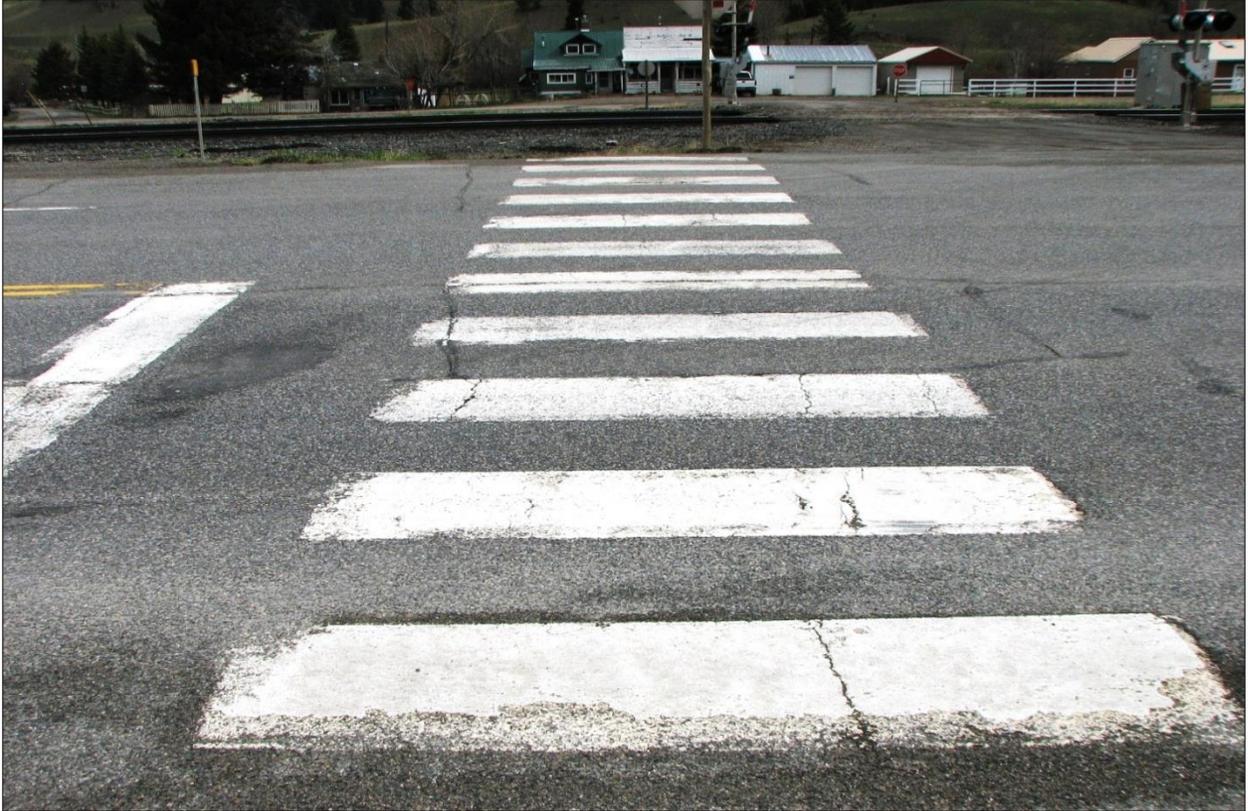
↑ The condition of the cross walk is the same as documented in 2011. The chip seal over the existing thermoplastic is intact. The additional layer of sheet-applied thermoplastic applied in 2010 continues to be worn off in areas.

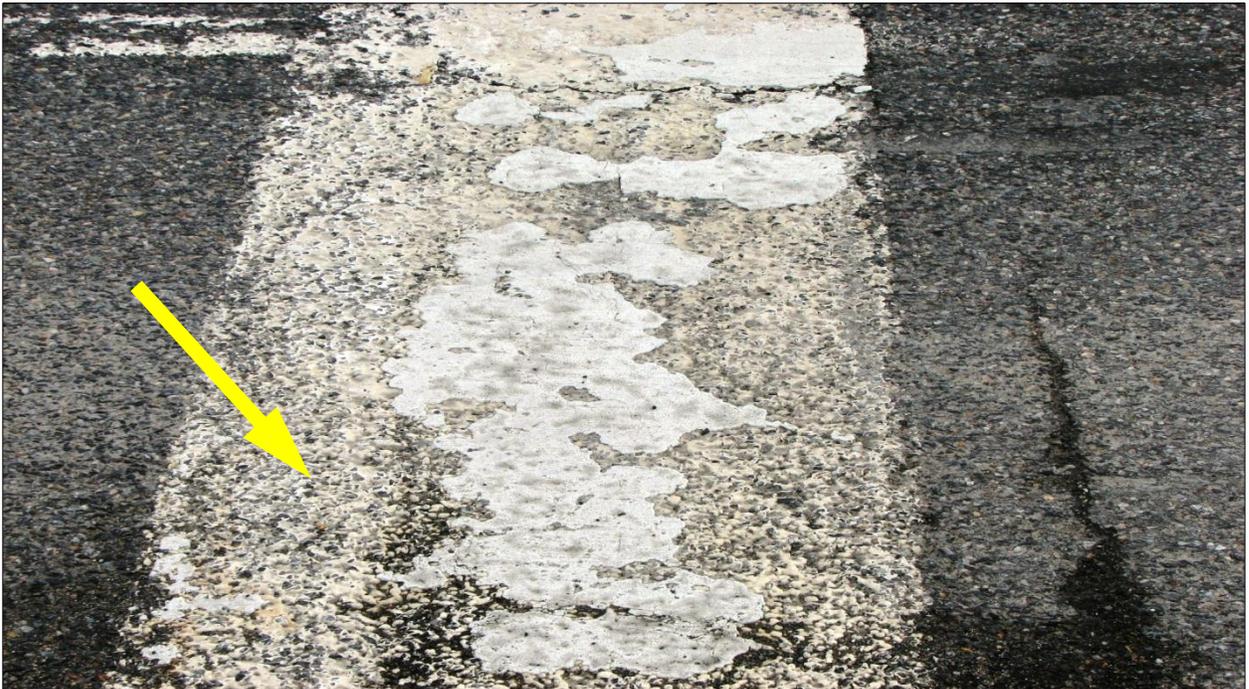
↑ Close-up of stop bar. Yellow arrow shows area and condition of the pavement marking as applied on the chip seal over existing thermoplastic in 2008.

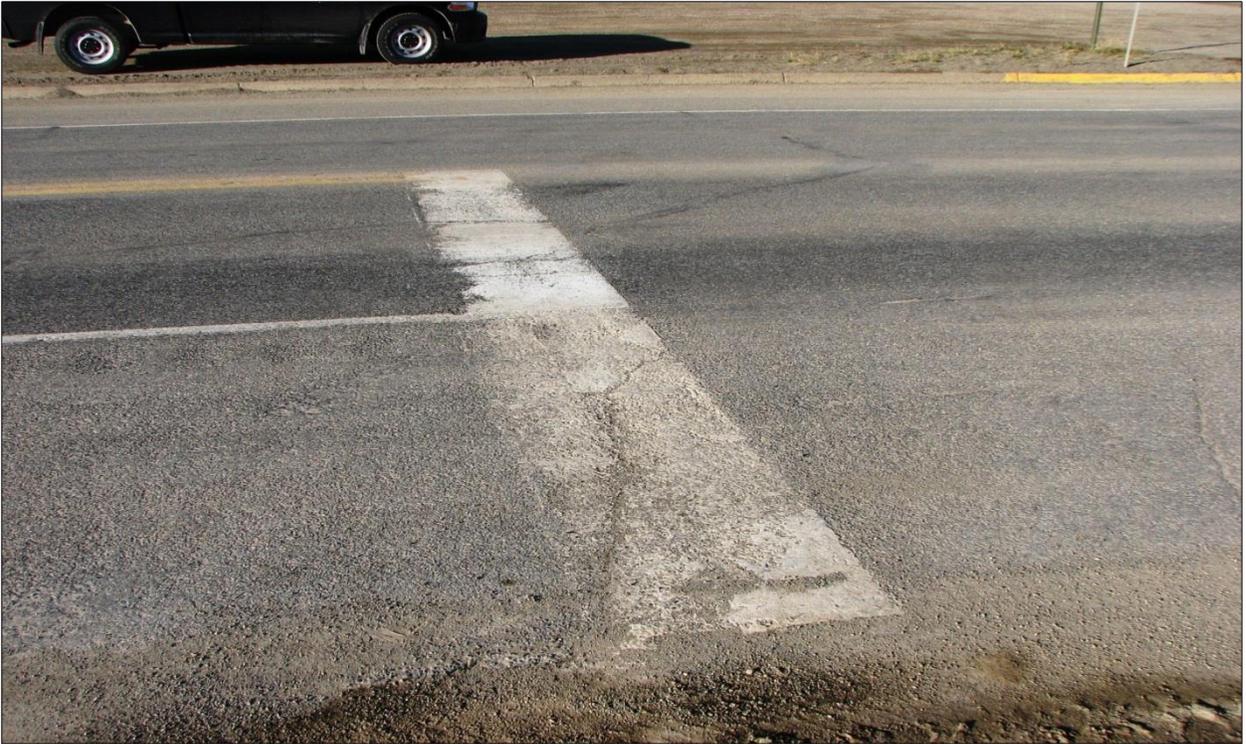
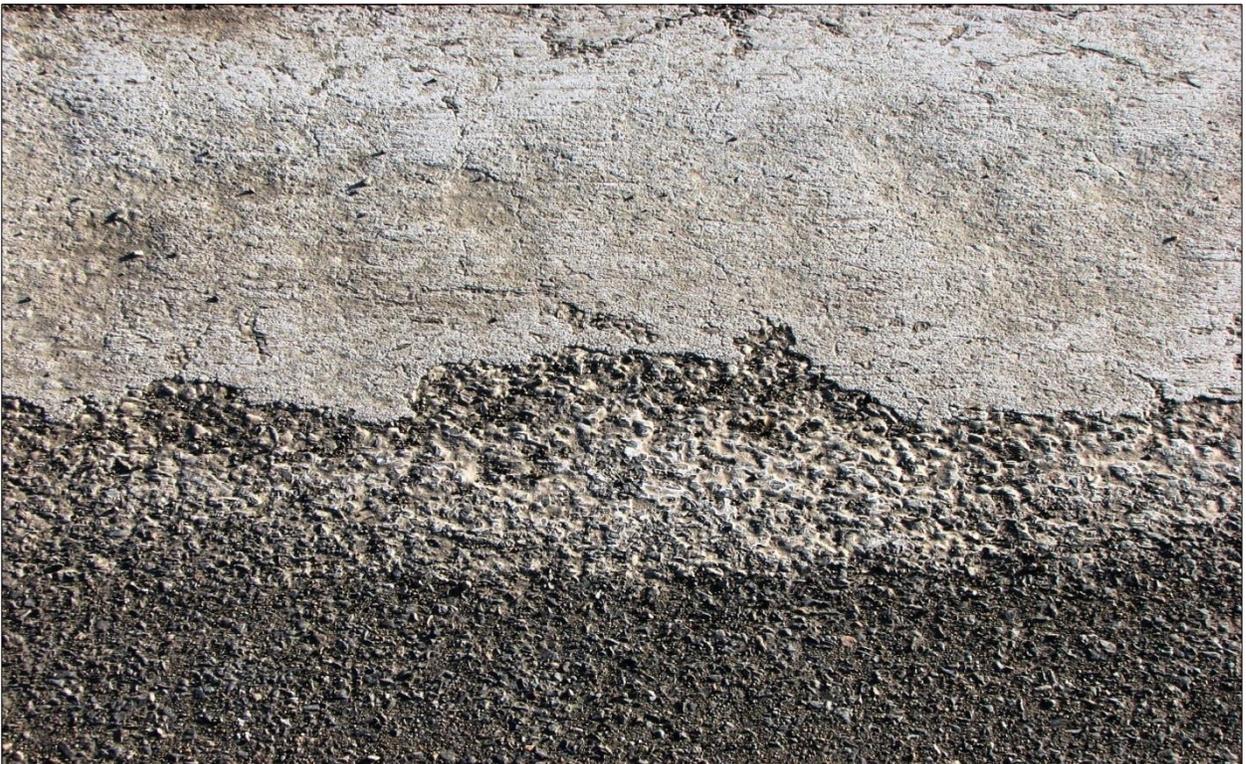
↑↓ The condition of the pavement markings is the same as documented in 2012. The chip seal over the existing thermoplastic is intact over both scar and non-scar treatments. The additional layer of sheet-applied thermoplastic applied in 2010 continues to be worn off in areas.

The original application of seal and cover (2008) over the existing (scarified and non-scarified) sections of the thermoplastic are intact and to date display no signs of debonding. Sometime after the July 2009 site visit, a heat-applied thermoplastic sheet was installed over the existing pavement markings. This layer of thermoplastic has steadily deteriorated over time and as stated above the seal and cover is still intact as of April 2013.

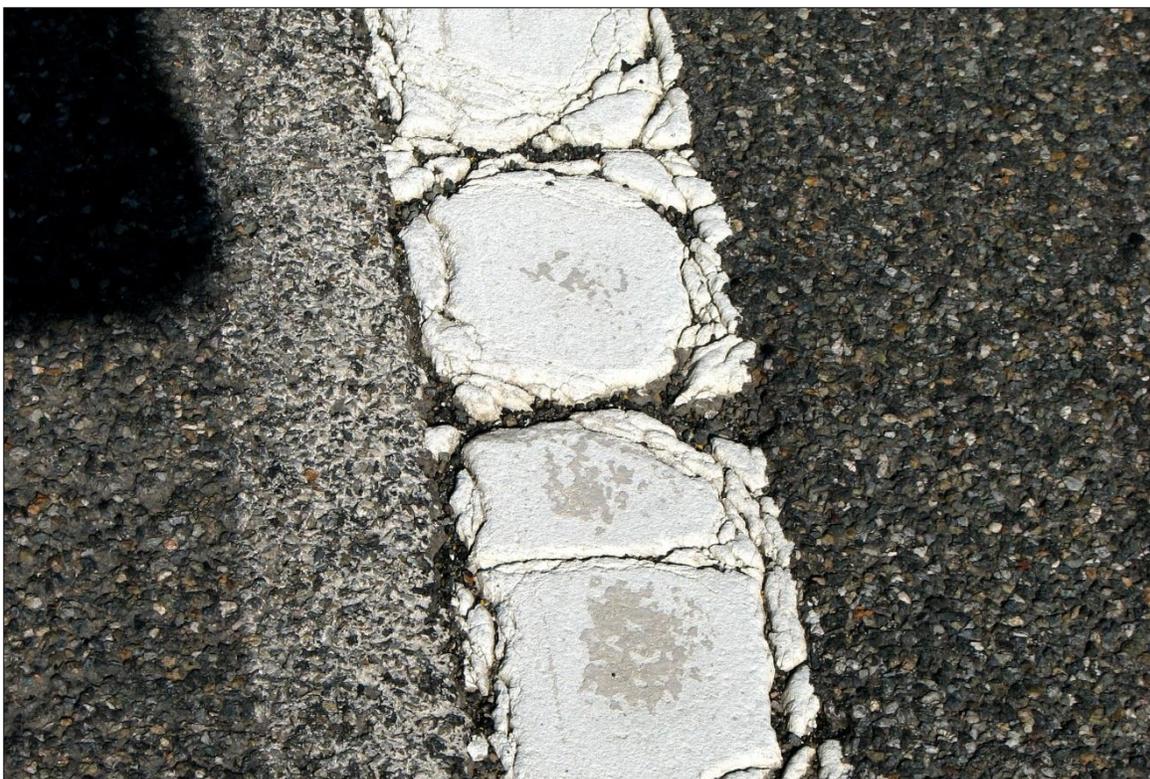
↑ Close-up shot of average condition of the thermoplastic.

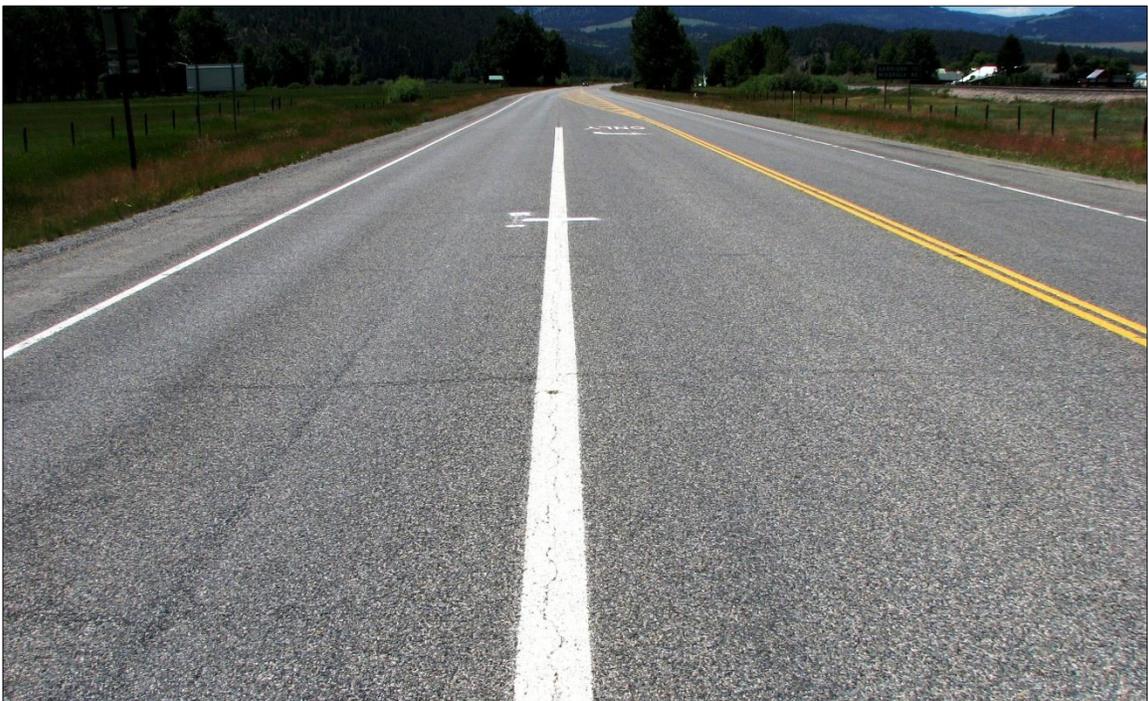
↑ Overview of lane divider as of August 2009 (view west). Pavement marking in good condition. No apparent debonding of the seal and cover to the thermoplastic on either the non-scarified or scarified sections.

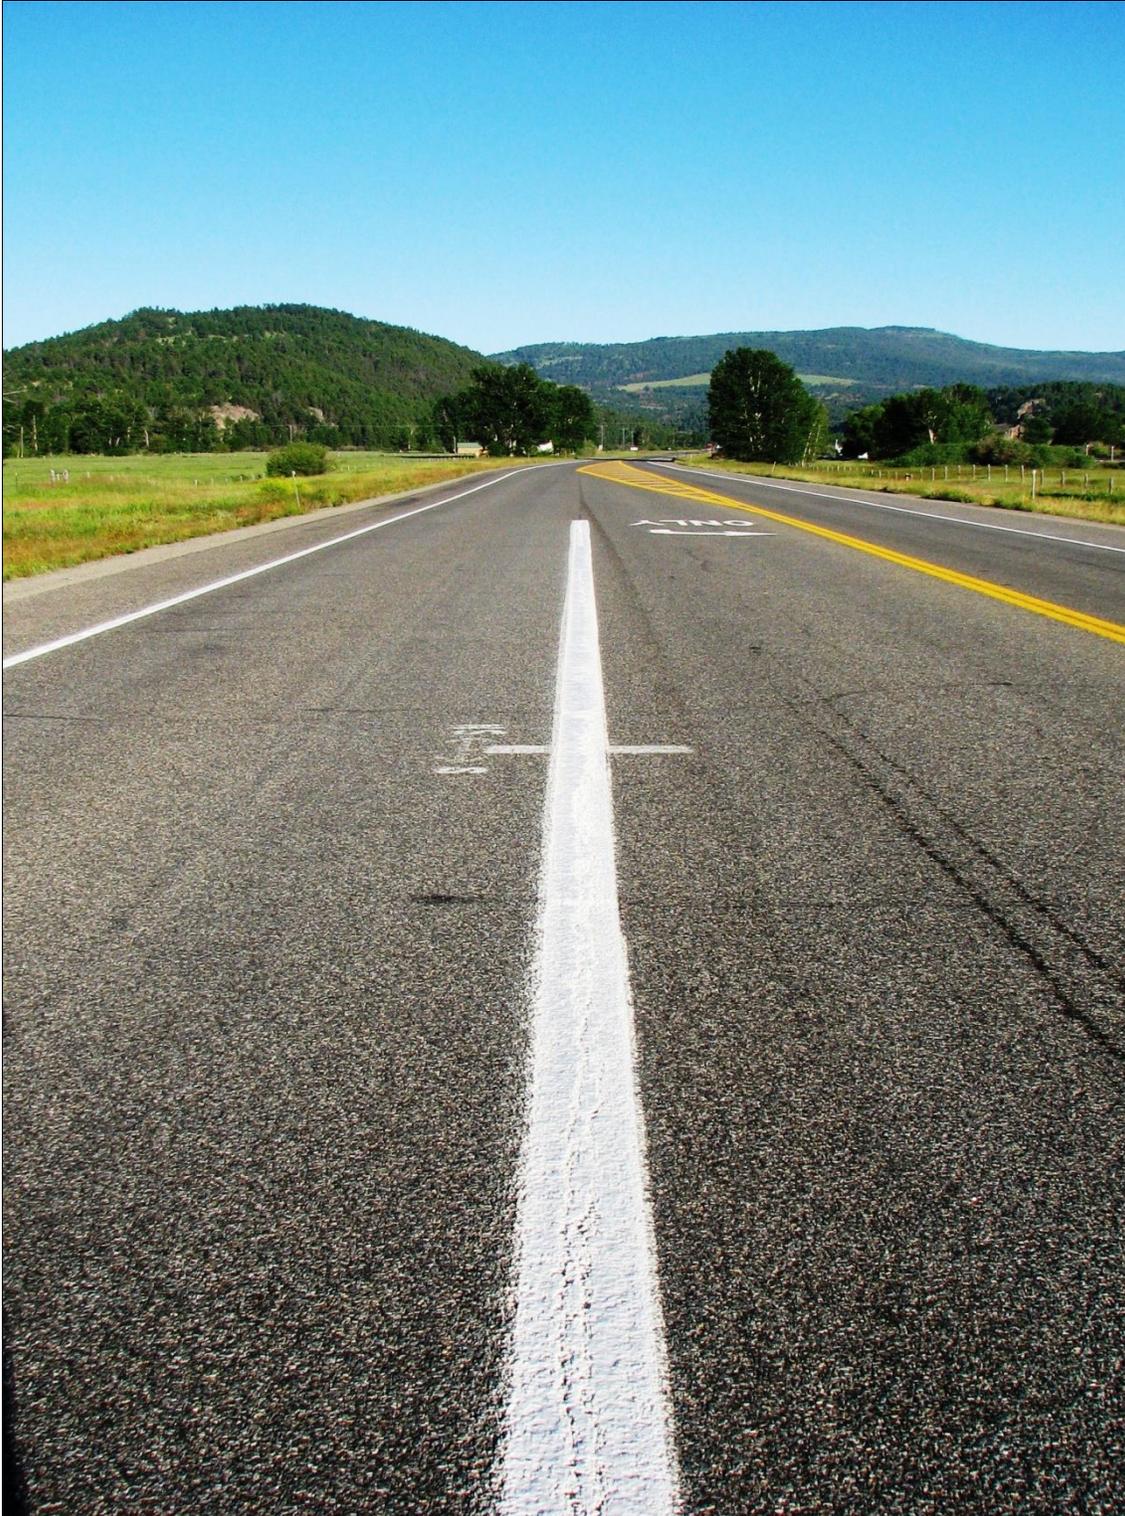
↑ Overview of lane divider stripe (view west). Visually the pavement marking was in very good condition, better than it was in the 2009 documentation. It appears this has been restriped. The mechanical bond between the seal and cover (chip seal) and underlying thermoplastic is intact.

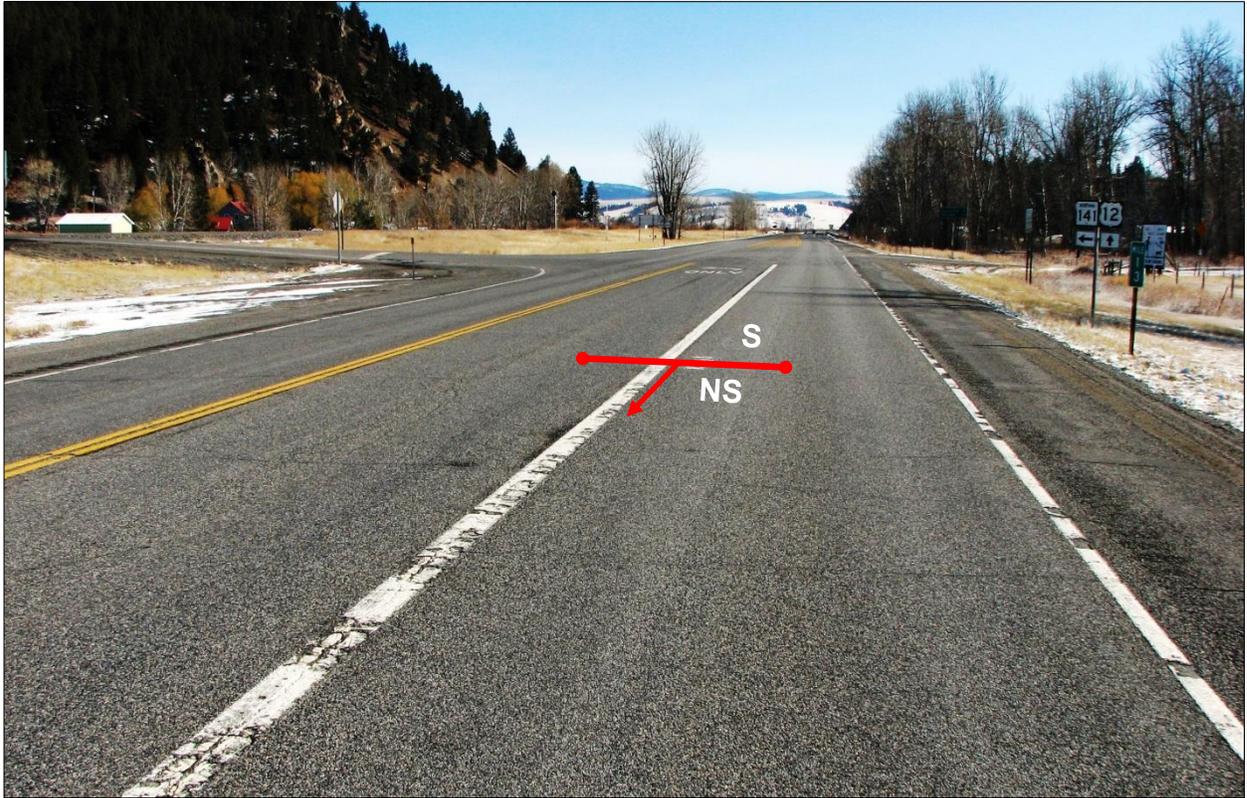
↑ View east. The non-scarified section (NS) is exhibiting debonding of the seal and cover (applied in 2008) from the existing thermoplastic on the longitudinal lane divider. The scarified portion of the lane divider (east half) is still intact.

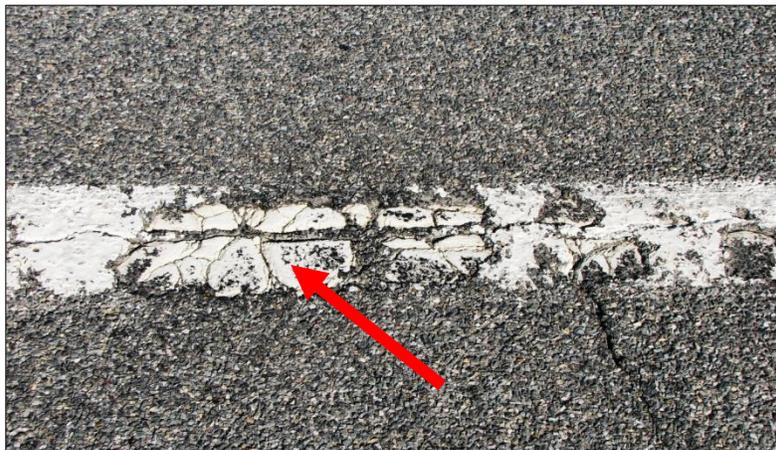
← Close-up of seal and cover debonding of the non-scarified marking exposing the underlying thermoplastic (red arrow).

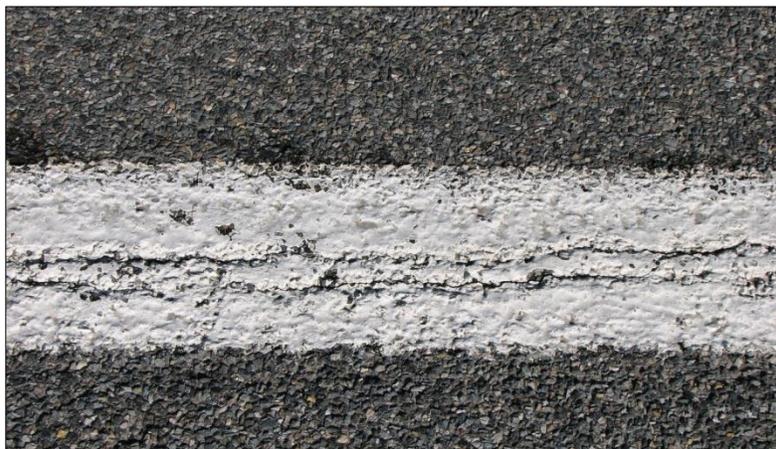
← Close-up of the average condition of the scarified portion of the longitudinal lane divider.
