EXPERIMENTAL PROJECT

**EVALUATION OF HOT-LAID THERMOPLASTIC PAVEMENT MARKINGS
PREPARATIONS PRIOR TO A SEAL COAT (SC) APPLICATION**

Installation-Annual Inspection & Analysis Final Report

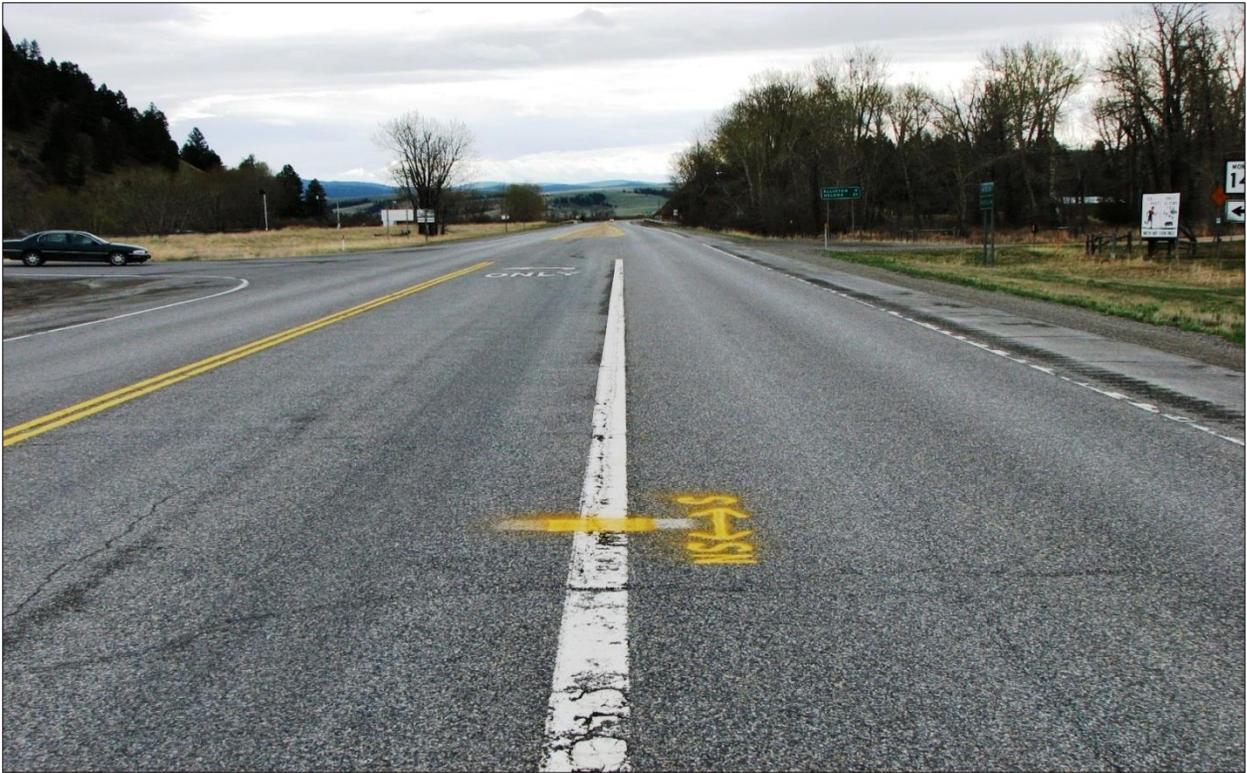
↑ The above image shows the condition of the scarified and non-scarified lane divider marking as it appeared in 2011.

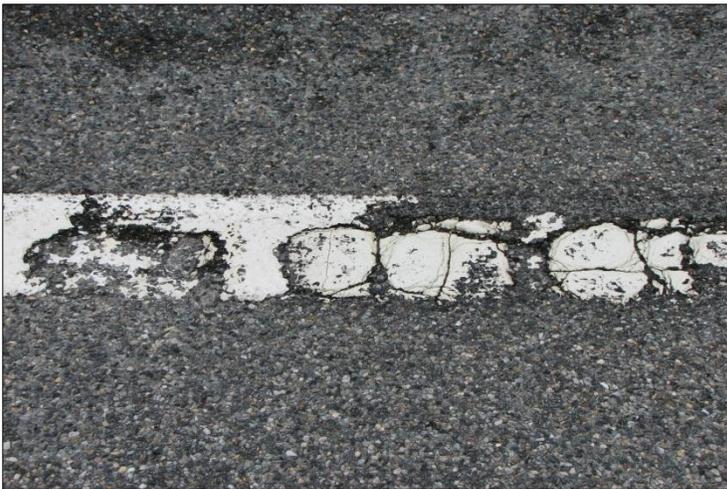
← Debonding of the seal & cover is still progressing on the non-scarified section of the lane divider.

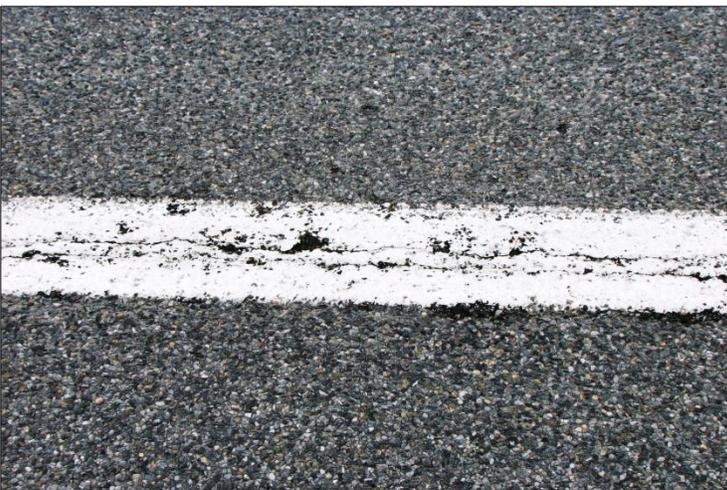
← The scarified section of the lane divider is in good shape with no debonding of the seal & cover to the underlying thermoplastic to date.

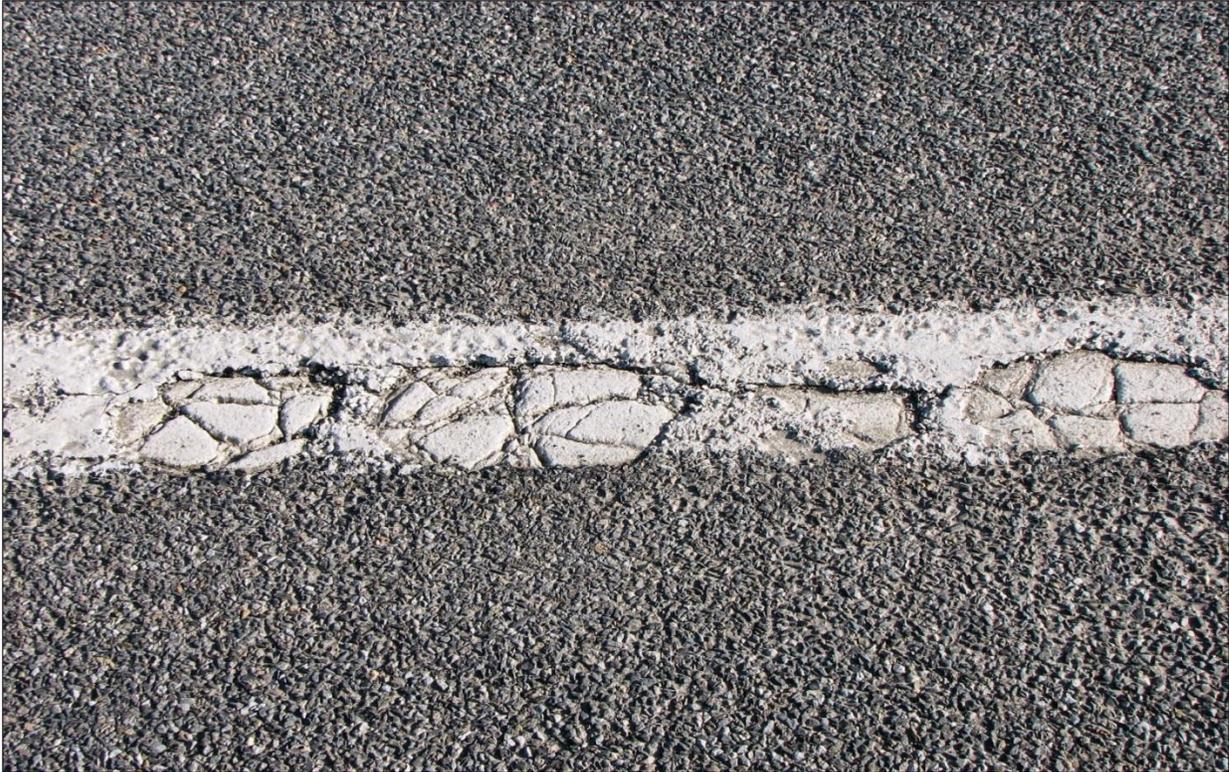
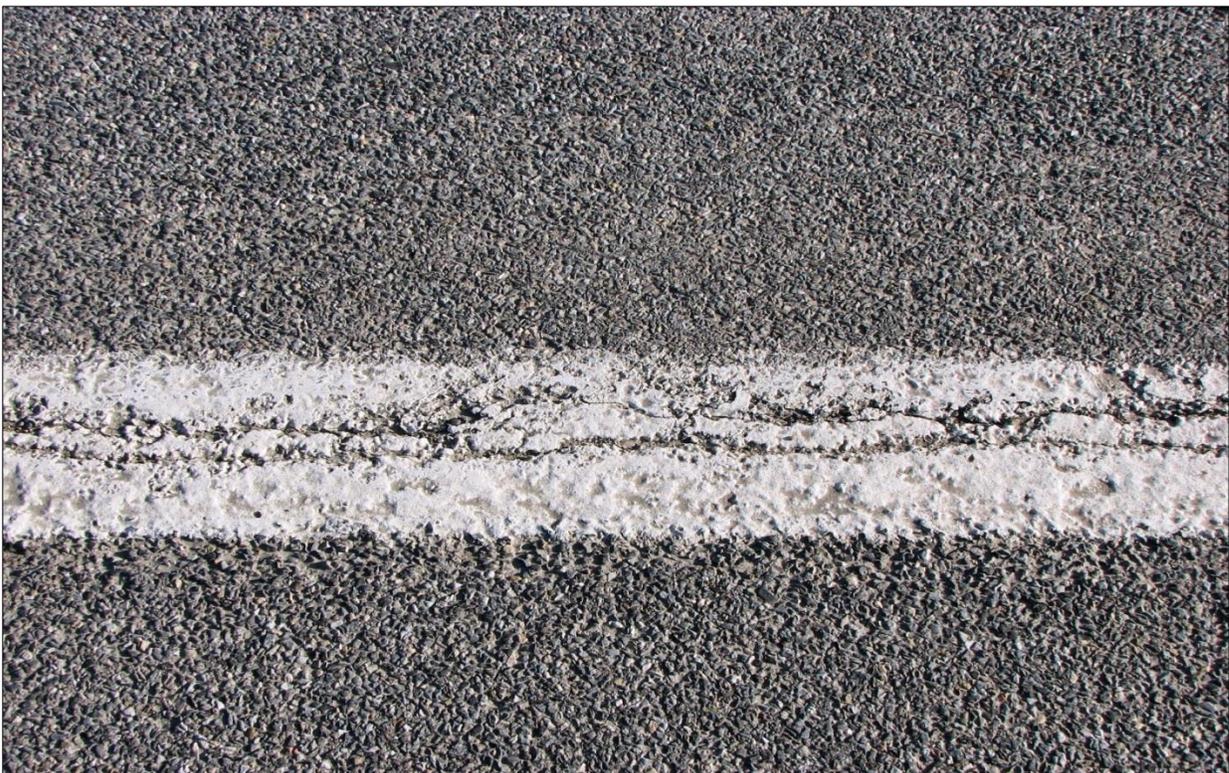
↑↓ Above sample image of the non-scarified longitudinal line showing areas of debonded chip seal to thermoplastic, below sample image is the scarified section of the marking. Condition is near to the same as documented in 2012.

The non-scarified section of the longitudinal lane divider (seal and cover applied in 2008) has exhibited debonding of the seal coating to the existing thermoplastic. Approximately 40% of the original thermoplastic is exposed, presumably from snow plowing. The scarified section is still intact as of April 2013.

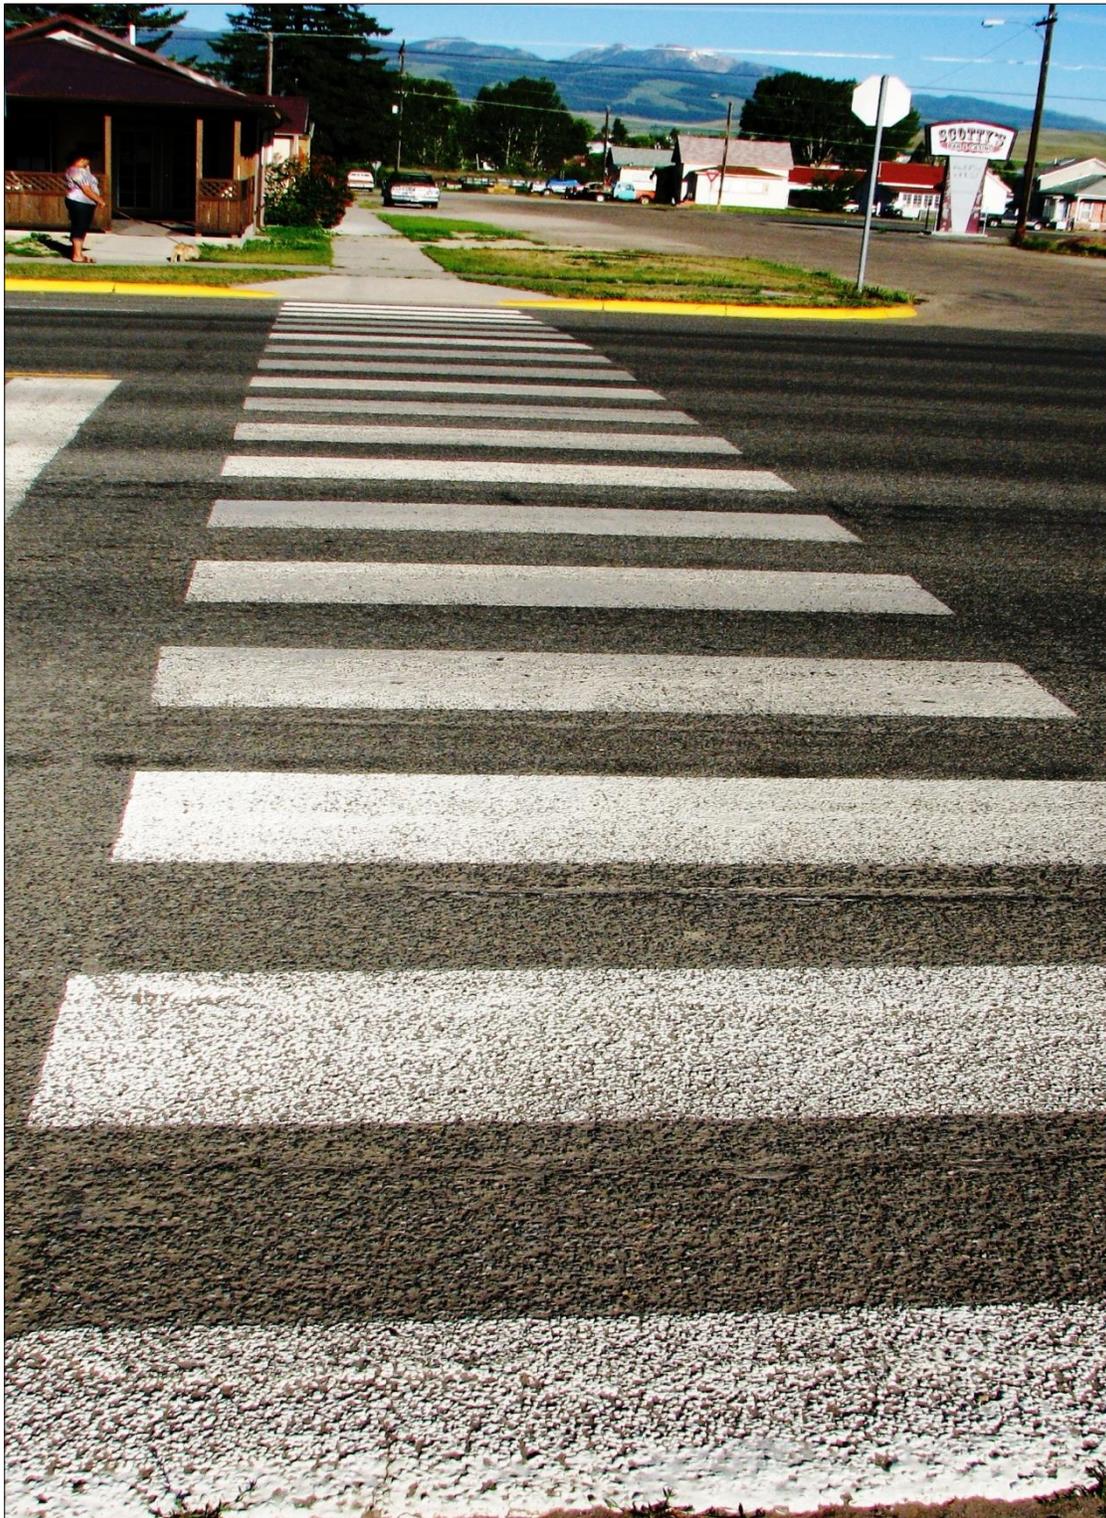
↑ Overview of intersection (view west). To date no evidence of lack of bond between the seal and cover and thermoplastic. Next inspection will be in the summer of 2011.

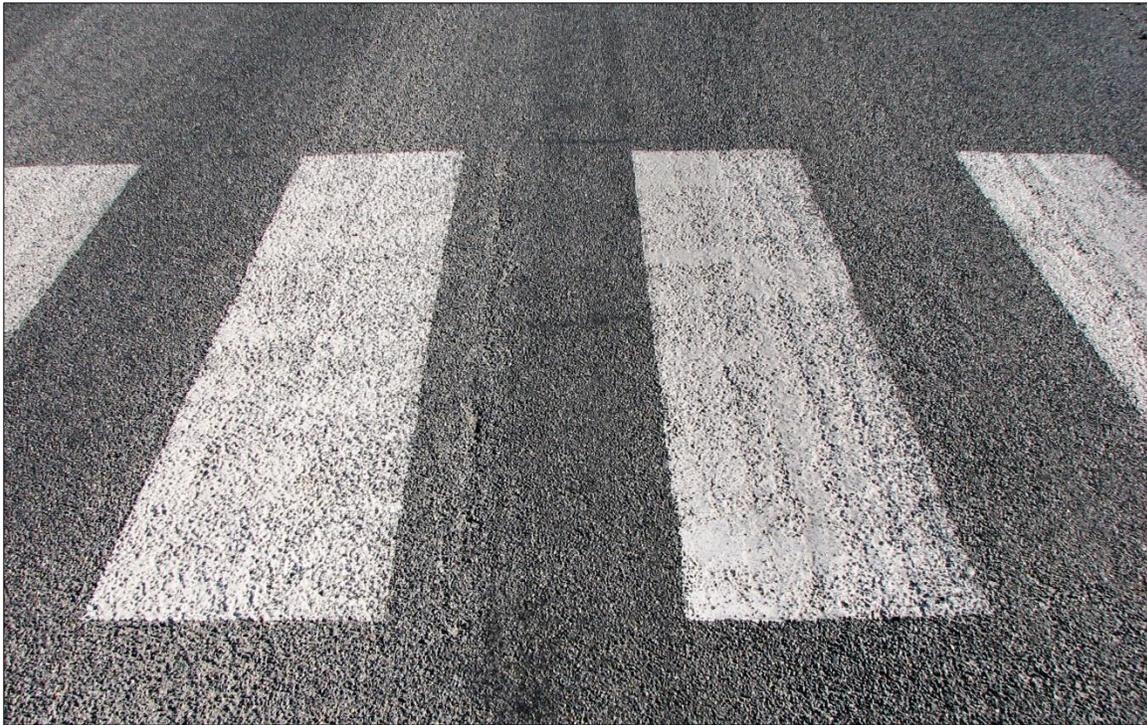
↑ Example image (July 2010) of northbound lane non-scarified treated thermoplastic with seal & cover. No debonding noted to date.

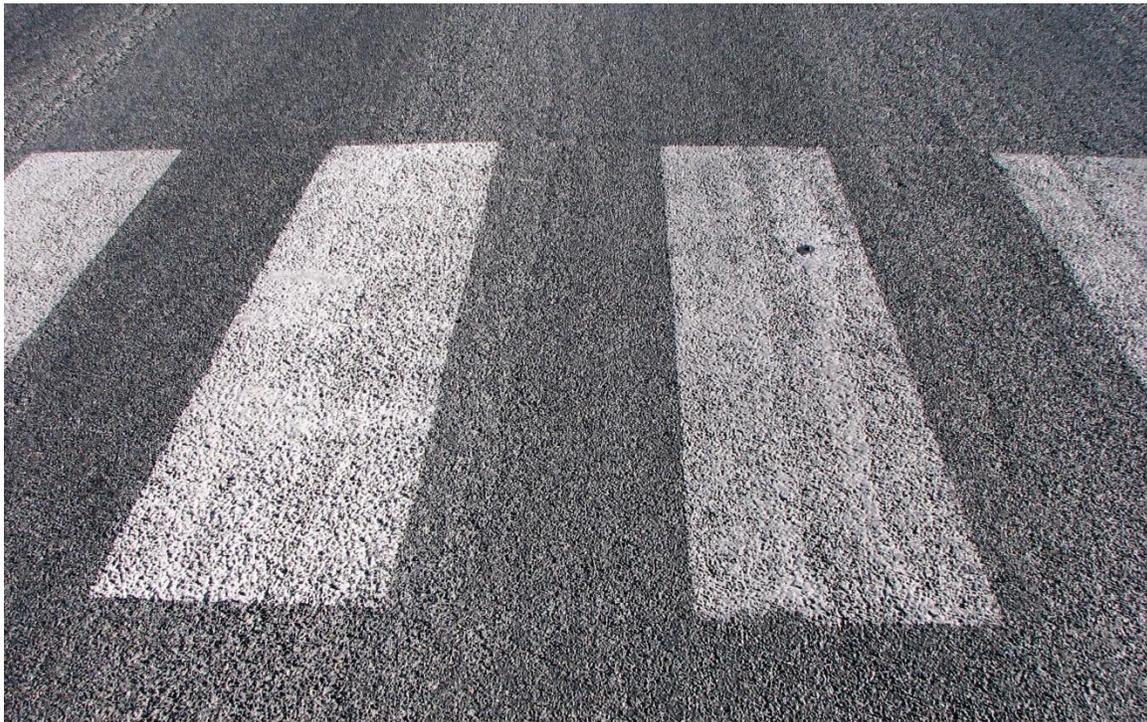
↑ Example image (July 2010) of southbound lane scarified treated thermoplastic with seal & cover. No debonding noted to date.

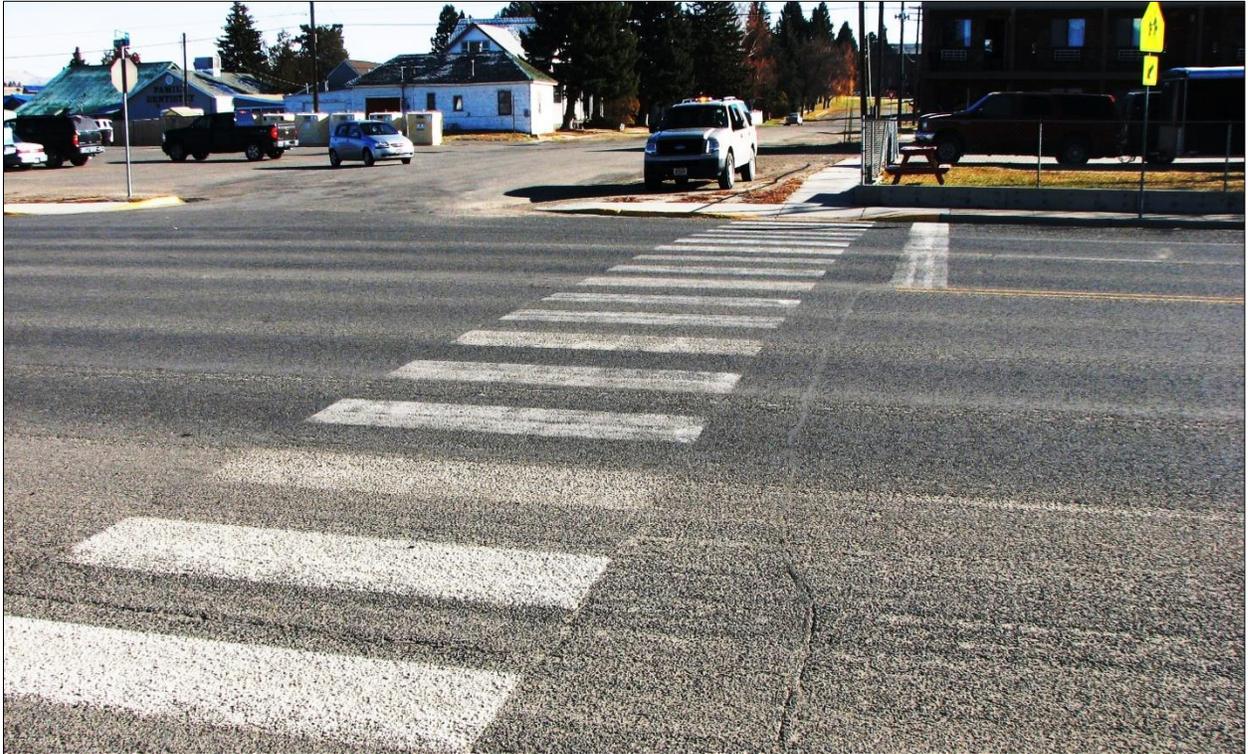
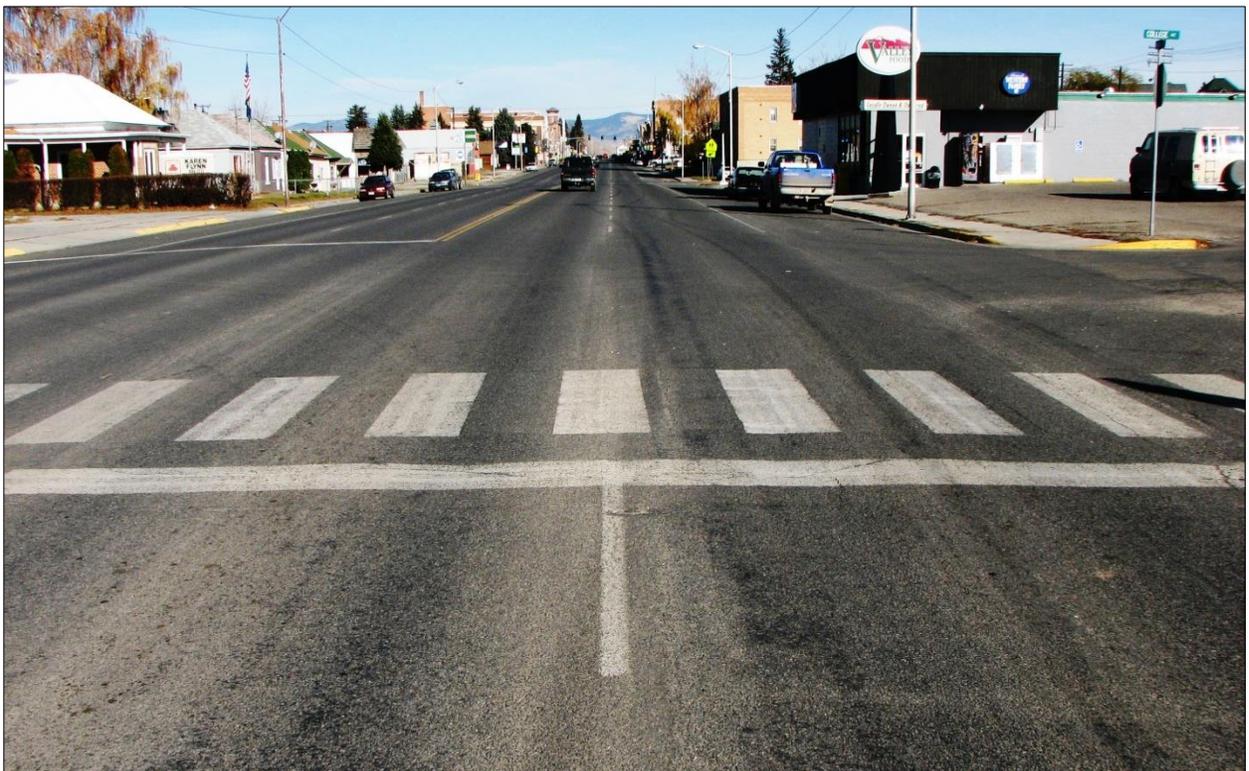
↑ The overall condition of the seal and cover to the existing thermoplastic was intact. No discernible difference between the scarified (southbound) and non-scarified (northbound) sections were noticed. Appearance of the current pavement markers relatively remained unchanged since the inspection of 2010.

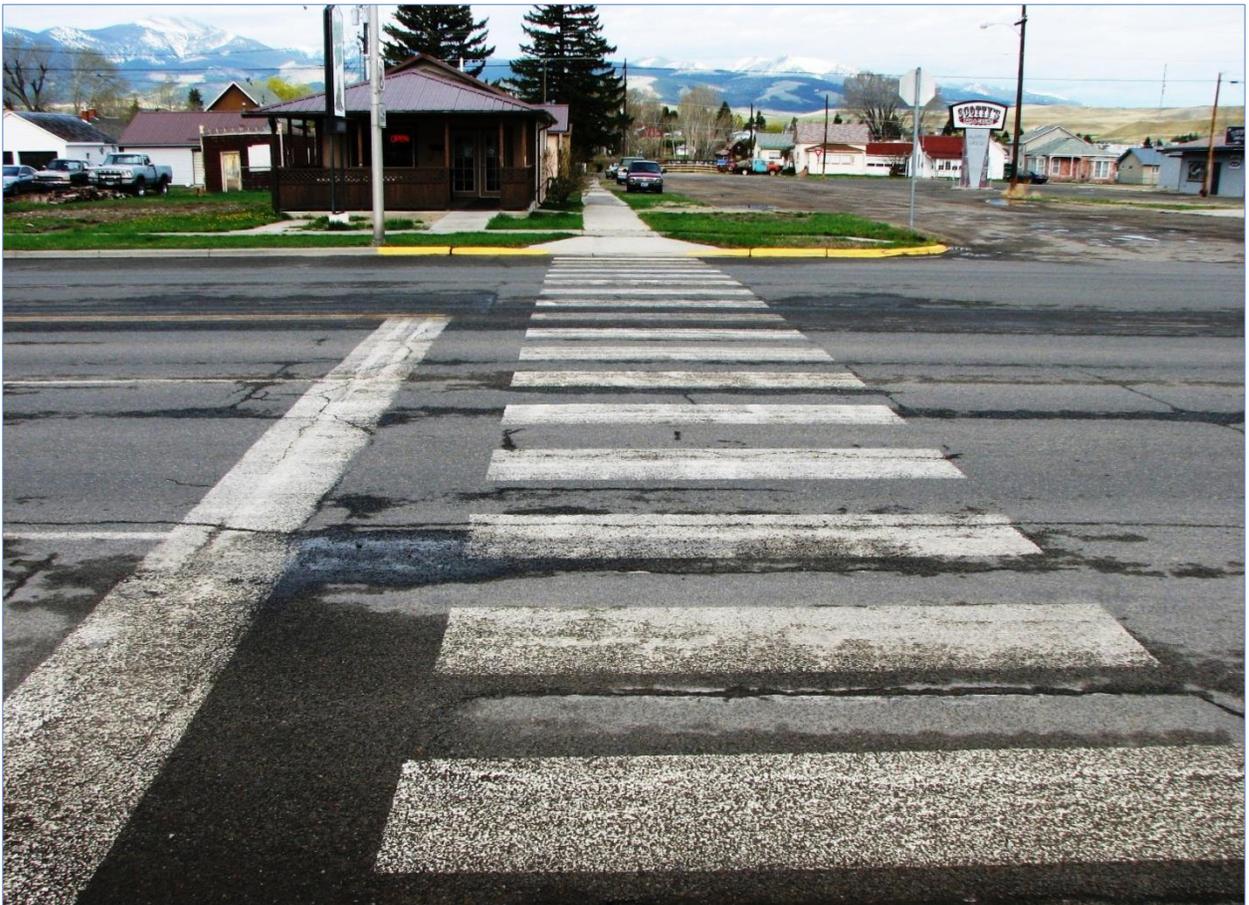
↑ The overall condition of the seal and cover to the existing thermoplastic was intact. No discernible difference between the scarified (southbound) and non-scarified (northbound) sections were noticed. Appearance of the current pavement markers relatively remained unchanged since the inspection of 2011 (view west).

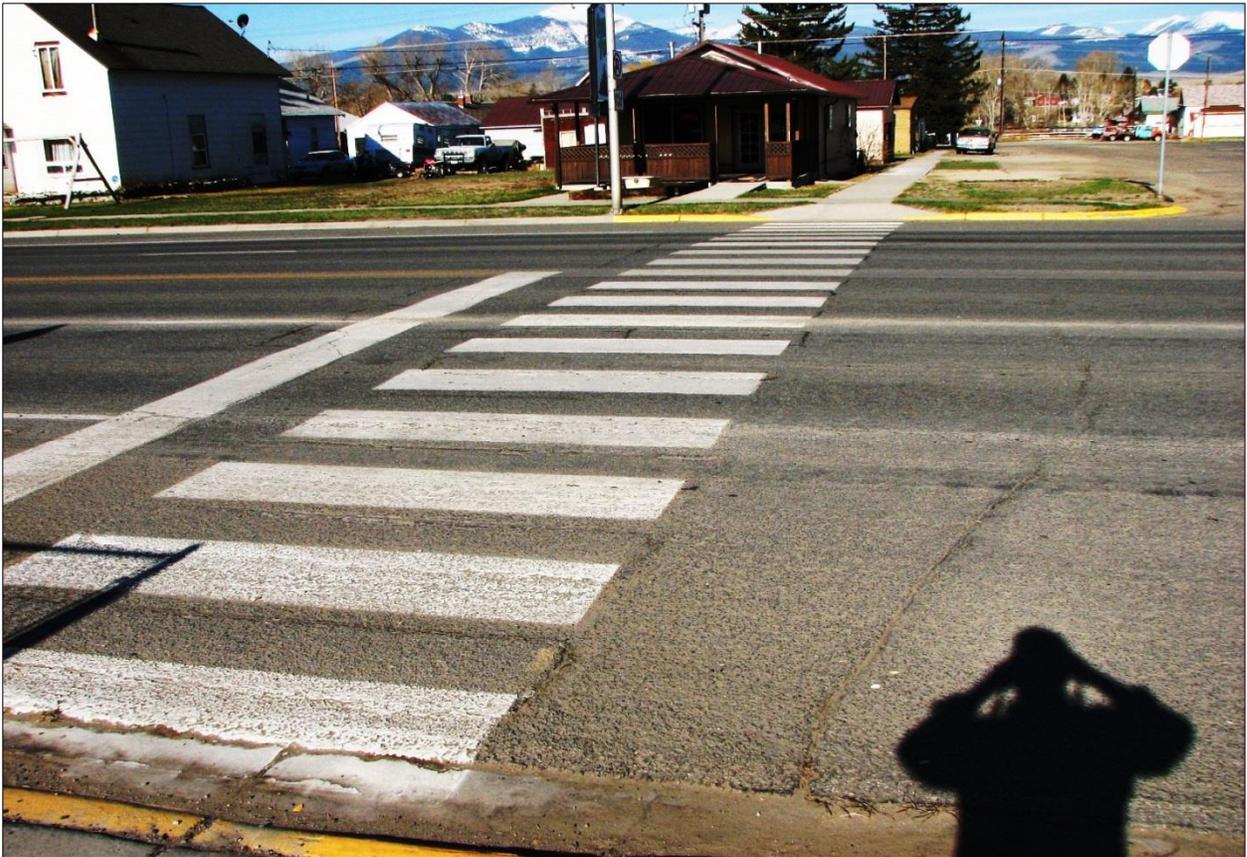
↑ Overview of intersection. Both scarified and non-scarified treatments are performing equally well. No evidence of chip seal to thermoplastic debonding was evident.

Both sections of the intersection (scarified and non-scarified) seal and cover (applied in 2009) to date show no indication of debonding on any of the treatments.
