**MONTANA DEPARTMENT OF TRANSPORTATION  
WETLAND MITIGATION MONITORING REPORT: YEAR 2006**

*Beaverhead Gateway  
Dillon, Montana*

December 2006

Project No: B43054.00 - 0202

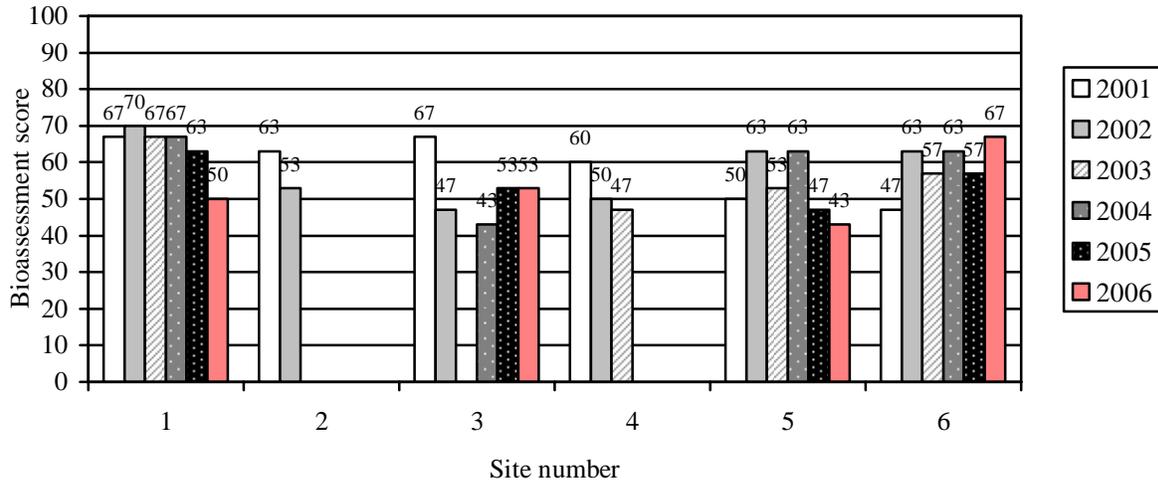
**Chart 5: Bioassessment scores for Beaverhead Gateway Wetland Mitigation Site from 2001 to 2006.**

**Beaverhead #5.** *In 2005, moderate richness of invertebrate taxa was accompanied by low abundance in the sample collected at this site. In 2006 however, very low taxa richness (4) and high abundance characterized the sample collected here. The sampled assemblage was overwhelmed by ostracods. Poor conditions are indicated; aquatic habitats were probably limited. Periodic dewatering or thermal stress cannot be ruled out.*

**Beaverhead #6.** *An assemblage dominated by snails in 2005 shifted to one dominated by mayflies (mainly *Caenis sp.*) and midges (especially *Dicrotendipes sp.* and *Paratanytarsus sp.*) by 2006. The invertebrate fauna collected at this site in 2005 suggests that macrophyte surfaces provided a large component of available habitats. Invertebrate taxa richness was relatively high and relatively stable over the studied years here. Assessment scores indicated sub-optimal conditions.*

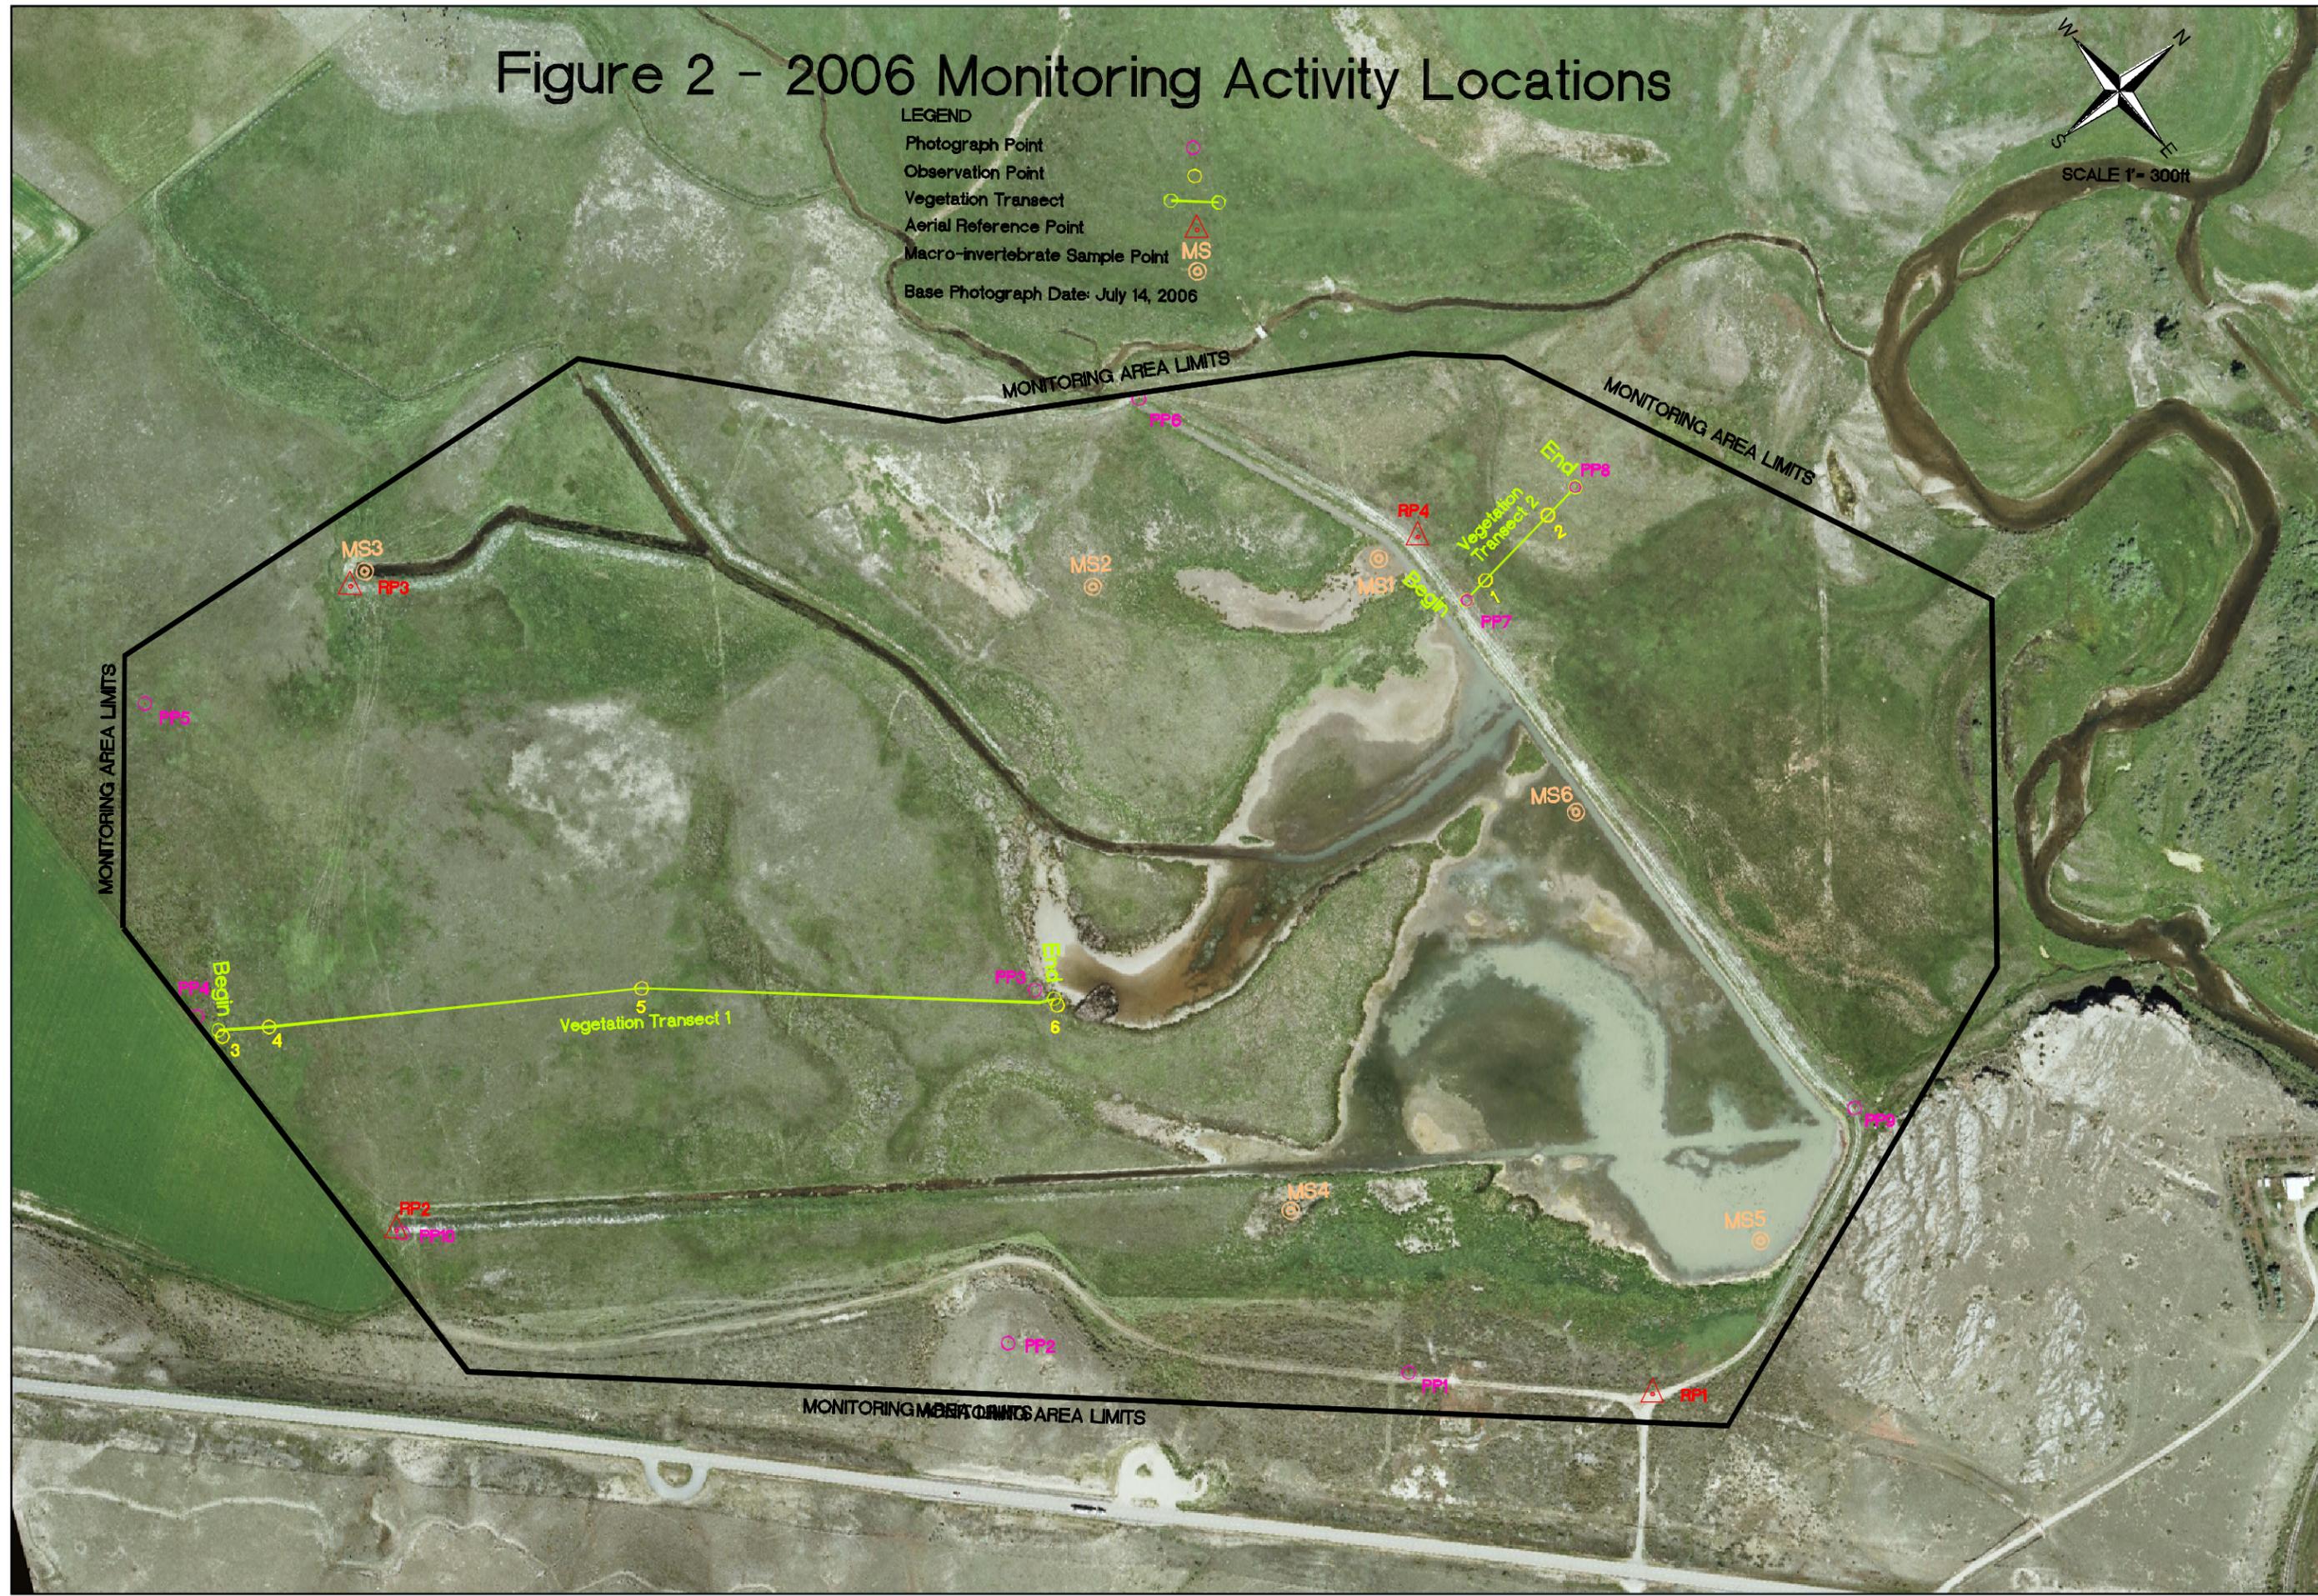
Two 10-foot wide belt transects established in 2001 were sampled during the mid-season monitoring event to represent the range of current vegetation conditions. Percent cover was estimated for each vegetative species within each successive vegetative community encountered within the “belt” using the following values: T (few plants); P (1-5%), 1 (5-15%); 2 (15-25%); 3 (25-35%); 4 (35-45%); 5 (45-55%) and so on to 9 (85-95%). The transect locations are illustrated on **Figure 2** in **Appendix A**. These transects are used to evaluate changes over time,

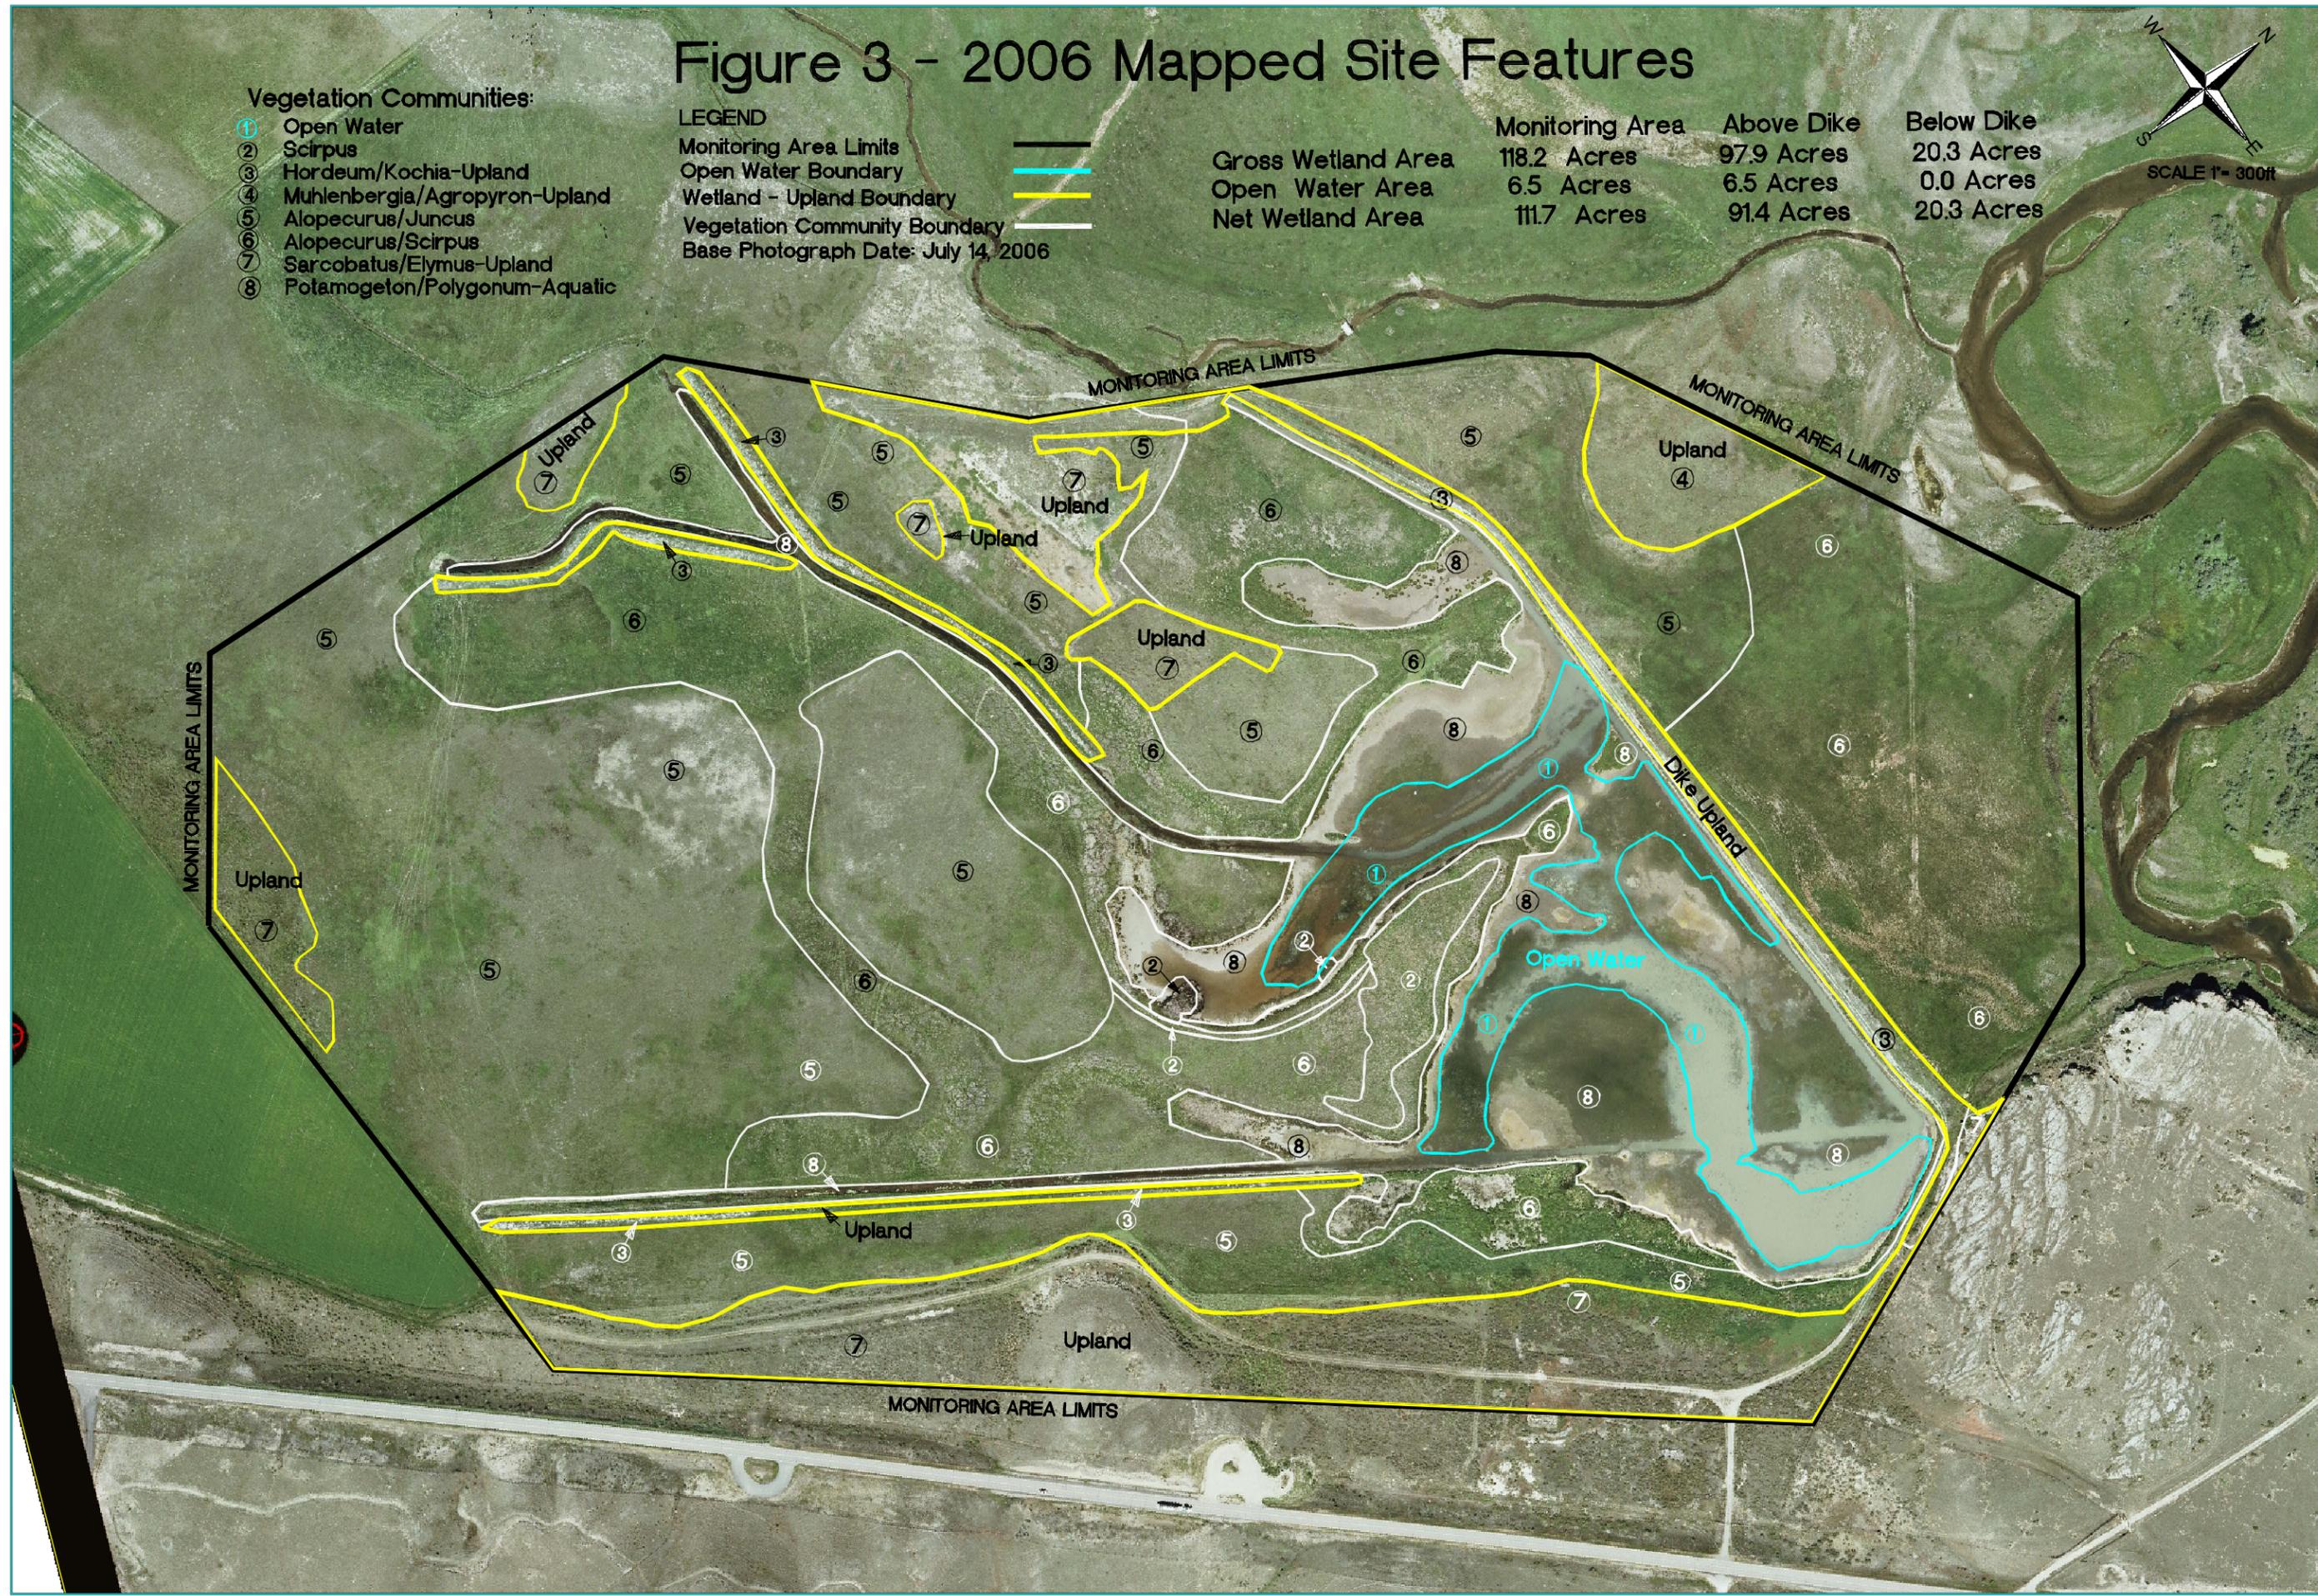
# Figure 3 - 2006 Mapped Site Features

The main source of hydrology seems to be upwelling groundwater and “springs” evident along the constructed channels (ditch/berms) leading south and west from the main open water area (**Figure 3** in **Appendix A**). Water was observed upwelling from the bottom of these channels.

Open water occurred across approximately 6.5 acres or 5% of the 118-acre wetland area (**Figure 3** in **Appendix A**) during the mid-season visit. Water depth at the open water/rooted vegetation boundary was approximately 1.5 feet. Inundation was observed during the mid-season visit across approximately another 5% of the wetland area which is similar to the last three years (2003-2005) but significantly less than in the two preceding years (2001 and 2002). Inundation was present throughout most of Community Type 2 (**Figure 3** in **Appendix A**), and portions of Type 8. Casual observations during the early season visit indicated complete inundation of Types 2 and 8 and more extensive inundation throughout Type 6.

Wetland conditions identified from monitoring from 2001 through 2006 are described in **Table 4**. Approximately 111.7 wetland acres and 6.5 open water acres occur within the 2006 monitoring area (**Figure 3** in **Appendix A**). The pre-construction wetland delineation reported 5.2 wetland and no open water acres. The net increase in wetland acres is  $111.7 - 5.2 = 106.5$  acres plus 6.5 acres of open water. Additional area may form with time and more normal precipitation around the low gradient portions of the current wetland area.

Monitoring Area	Above Dike	Below Dike
Gross Wetland Area	118.2 Acres	97.9 Acres	20.3 Acres
Open Water Area	6.5 Acres	6.5 Acres	0.0 Acres
Net Wetland Area	111.7 Acres	91.4 Acres	20.3 Acres

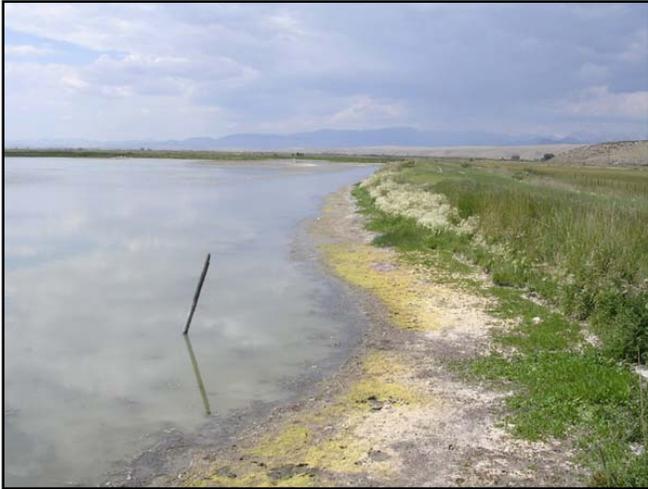
Photo Point No. 9: View looking west along dike shore and open water (270°).

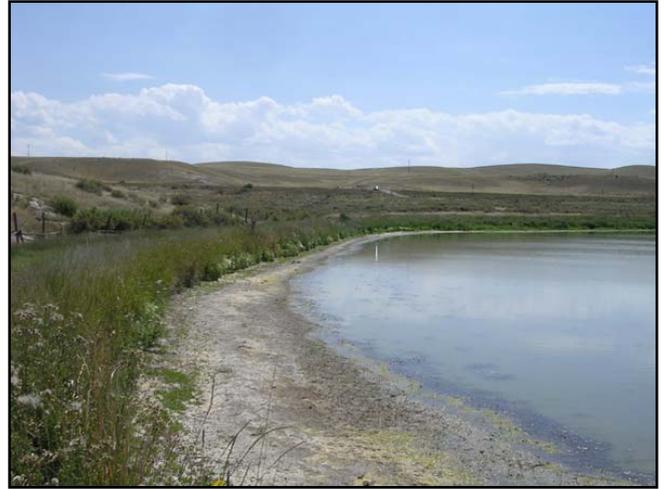
Photo Point No. 9: View looking along dike shore and open water (90°).

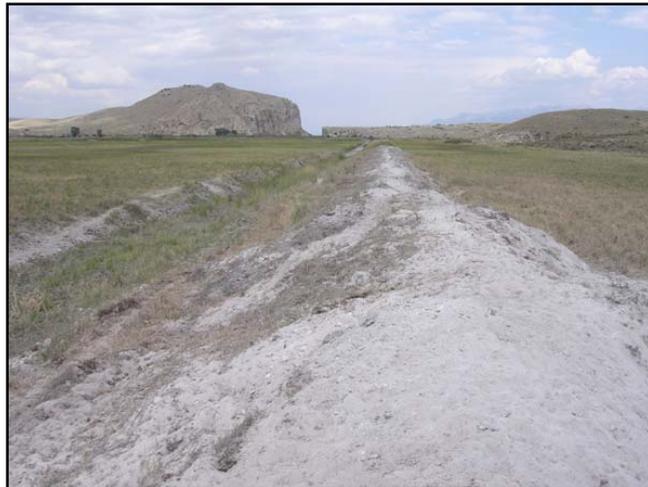
Spoil piles left from ditch excavation continue to create a weed problem, a wind and water erosion hazard and a sedimentation source. This same issue applies to portions of the dike and other poorly vegetated sites. A possible remedy would entail chemically treating weeds and re-seeding the spoil piles with desirable grasses.

Photo Point No. 10: View looking northeast along spoil pile dominated by a weedy plant community (45°).

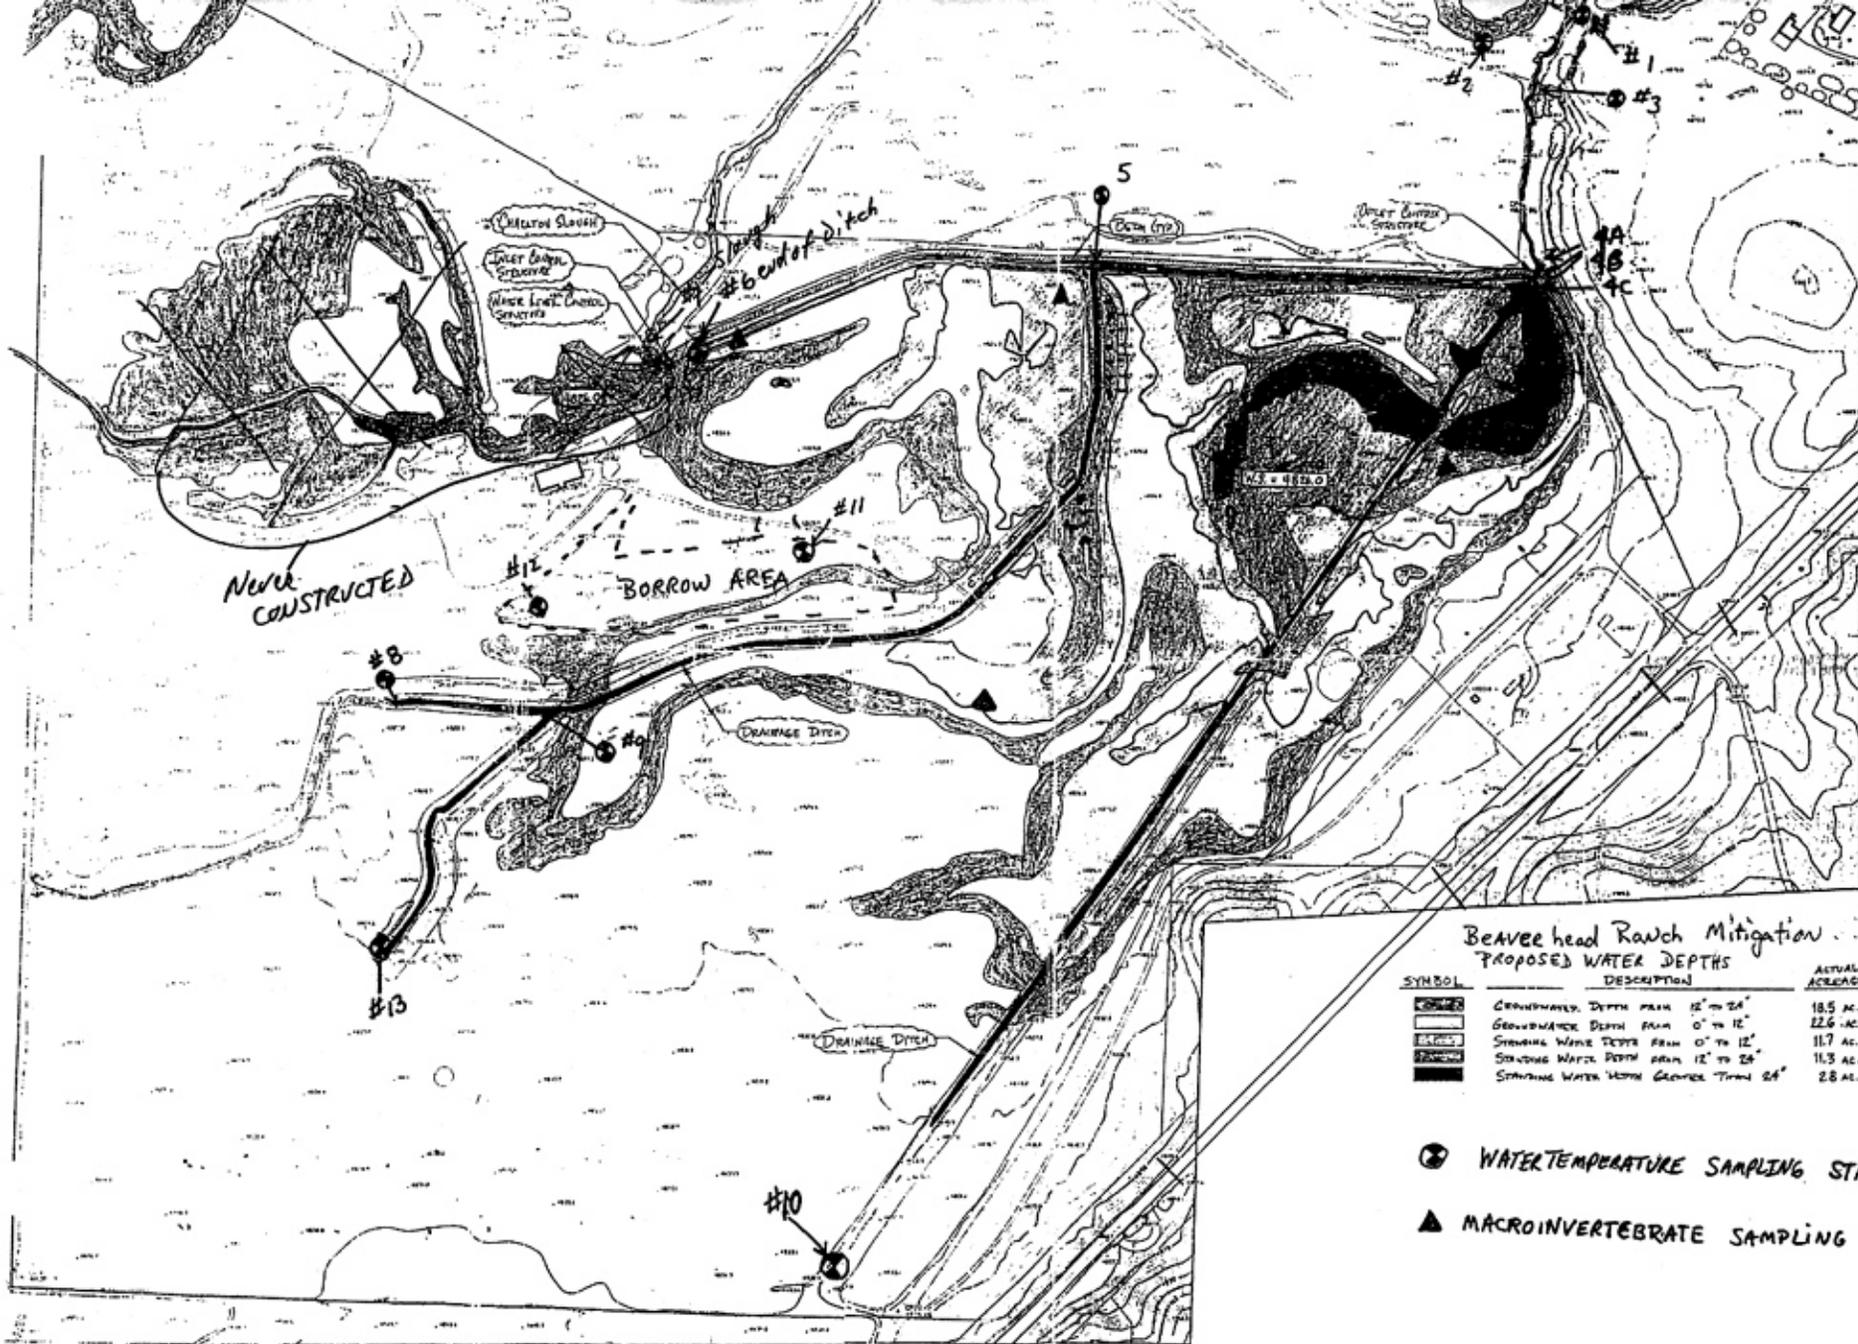
Beavee head Ranch Mitigation  
Proposed WATER DEPTHS

SYMBOL	DESCRIPTION	ACTUAL ACREAGE	CREDIT ACREAGE
	GROUNDWATER DEPTH FROM 15' TO 24'	18.5 AC.	4.7 AC.
	GROUNDWATER DEPTH FROM 0' TO 12'	22.6 AC.	22.6 AC.
	STANDING WATER DEPTH FROM 0' TO 12'	11.7 AC.	11.7 AC.
	STANDING WATER DEPTH FROM 12' TO 24'	11.3 AC.	11.3 AC.
	STANDING WATER WITH GREATER THAN 24'	2.8 AC.	2.8 AC.
			<b>53.1 AC.</b>

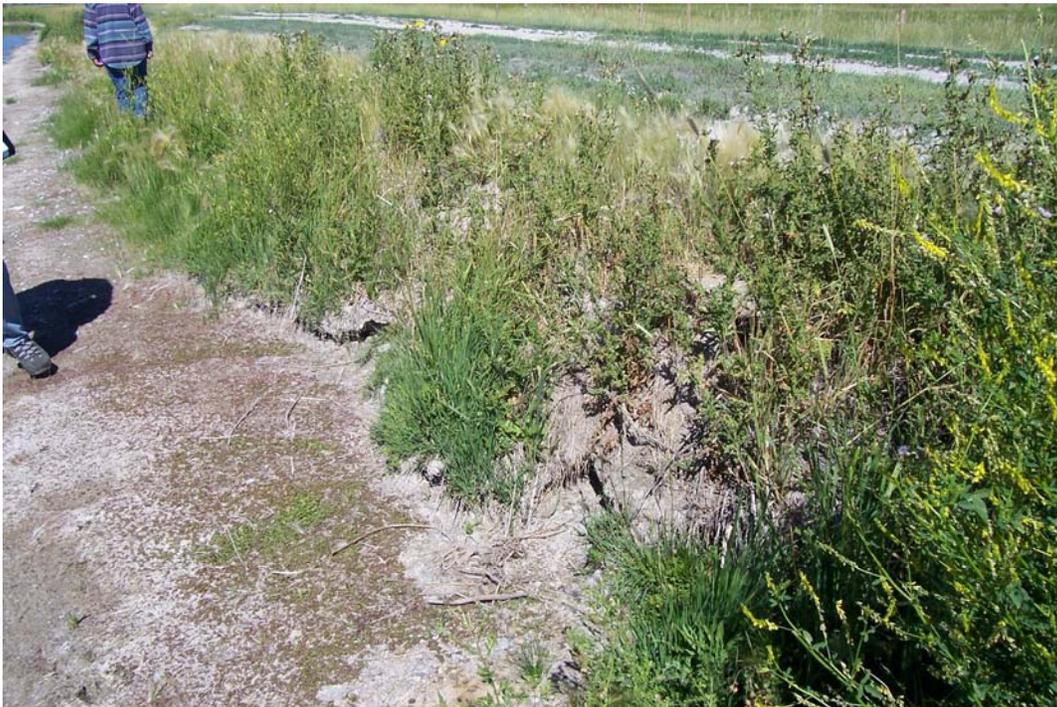
Figure 1. Erosion of upstream face, slowly moving toward crest of dike approximately 375 feet west of overflow structure. Note lack of vegetation on vertical slopes.

dam inspector in 2005, and the erosion was considered to be a maintenance issue, but not a dam safety concern (see letter in **Appendix D**). The DNRC recommended periodically adding fill to the face of the dike where breaching is taking place and vertical slopes are developing. Fill was added to the face of the dike in 2004 to replace eroded material, but has not yet vegetated. Additional examples of potential solutions to erosion problems include shoreline reinforcement, off-shore wave protection, protected off-shore plantings, shoreline plantings, and placement of vegetated sod mats.

I would recommend that the dike owner periodically add fill to the areas of the dike where beaching is taking place and vertical slopes are developing. The upstream face should be annually monitored, and a regular maintenance plan developed.

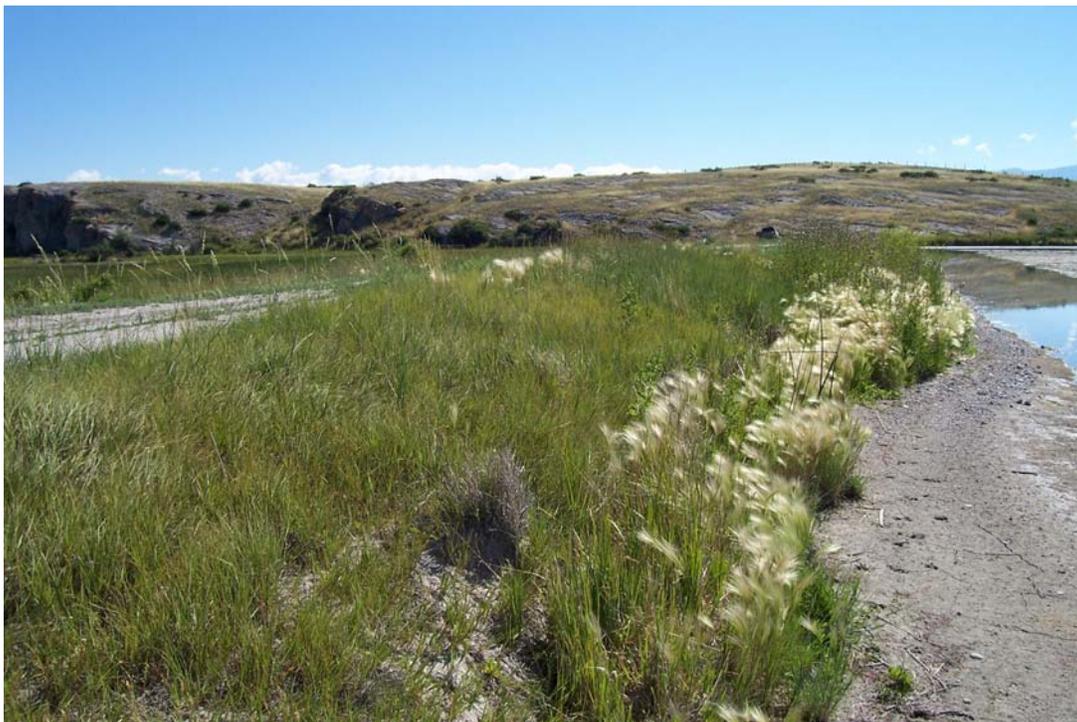
Figure 2. View of upstream face looking east. Note gentle slopes.

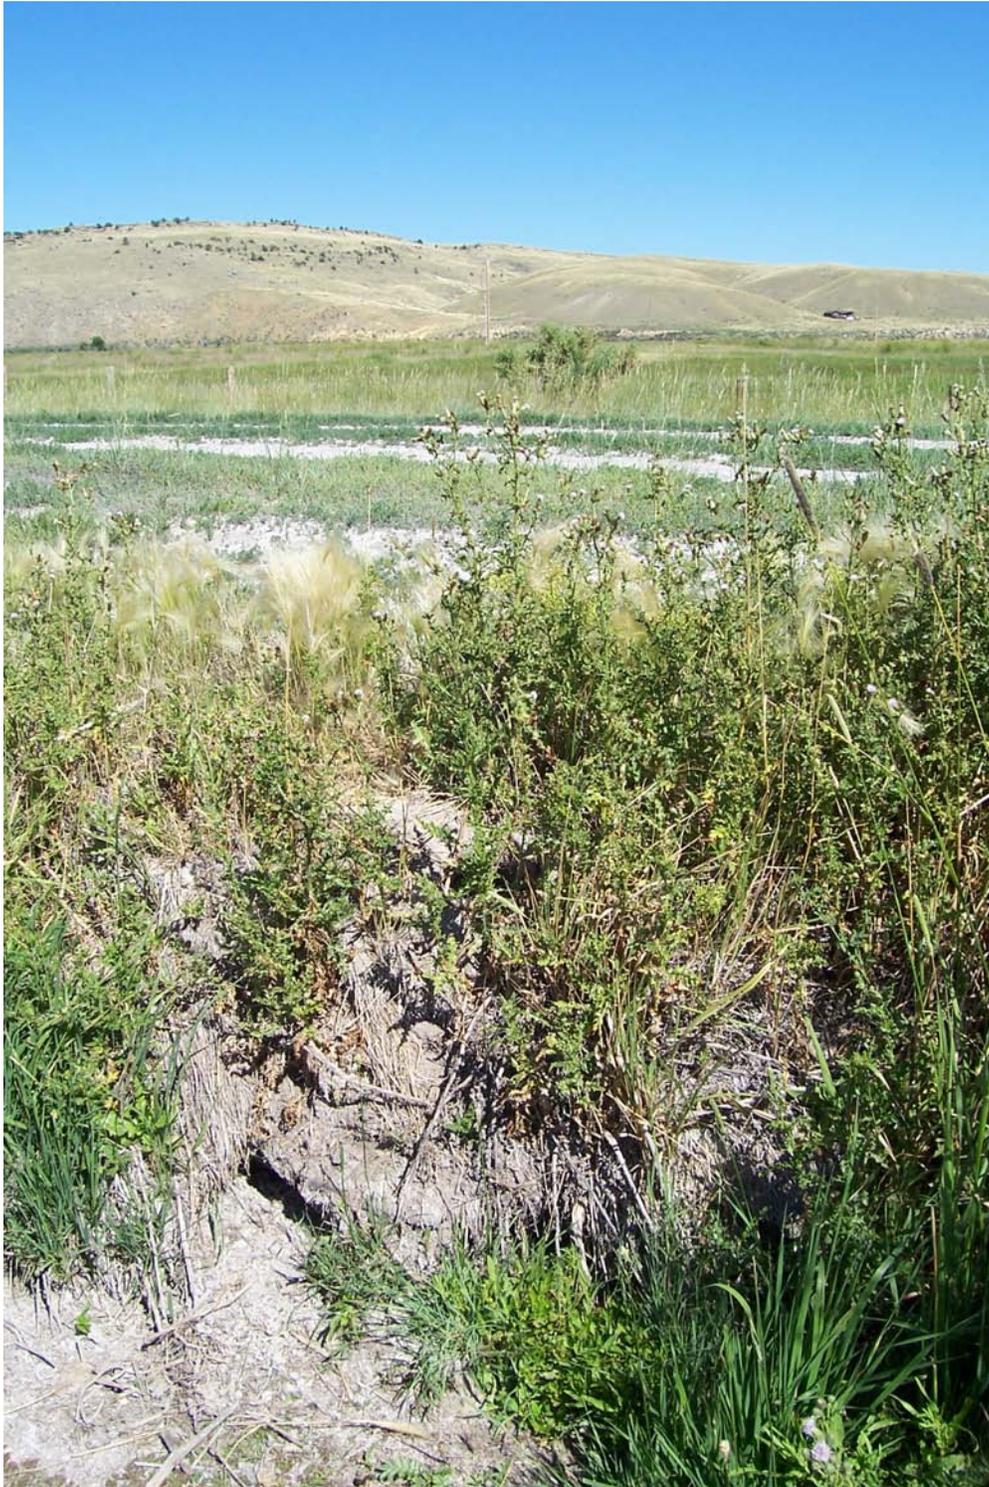
Figure 3. View of upstream face erosion approximately 870 feet west of overflow structure. Vegetation has a difficult time establishing on vertical slopes, so erosion will likely continue. Crest is still 3 feet away, and very wide in this location, so the erosion is not a threat to the safety and stability of the dam at this time.

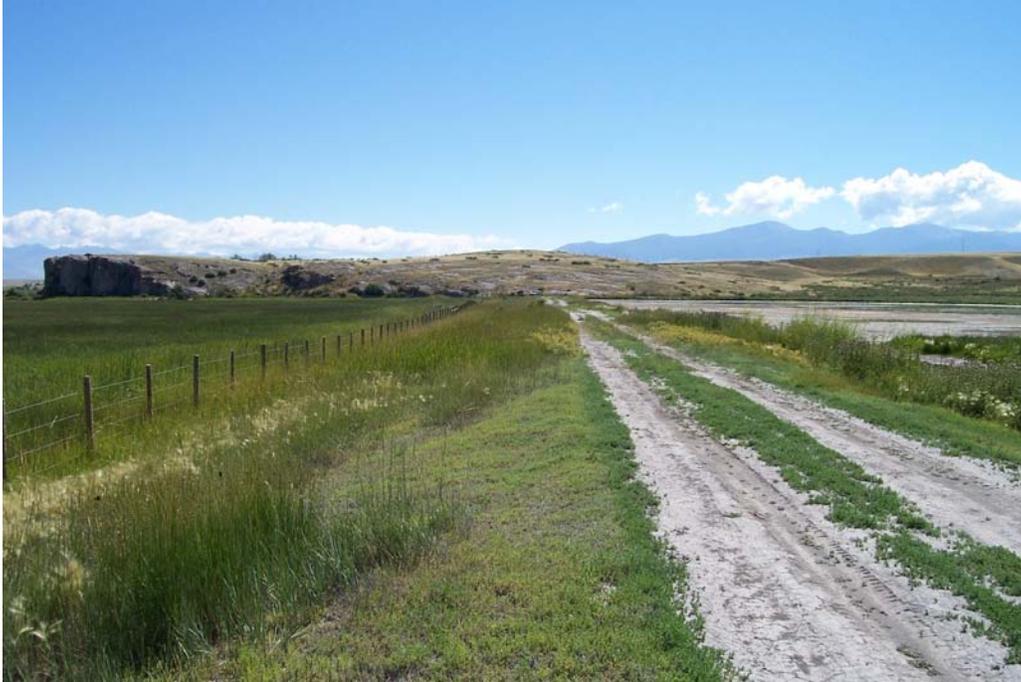
Third, the dike was constructed primarily with fat clays. Fat clays are generally non-erosive and resistant to failure.

Figure 4. Gentle downstream slopes make for a failure resistant structure.
