MONTANA DEPARTMENT OF TRANSPORTATION WETLAND MITIGATION MONITORING REPORT: YEAR 2012

*DH Ranch
Carbon County, Montana*

MDT Project Number NH-STPP 5(39)

CCI Project No: MDT.004

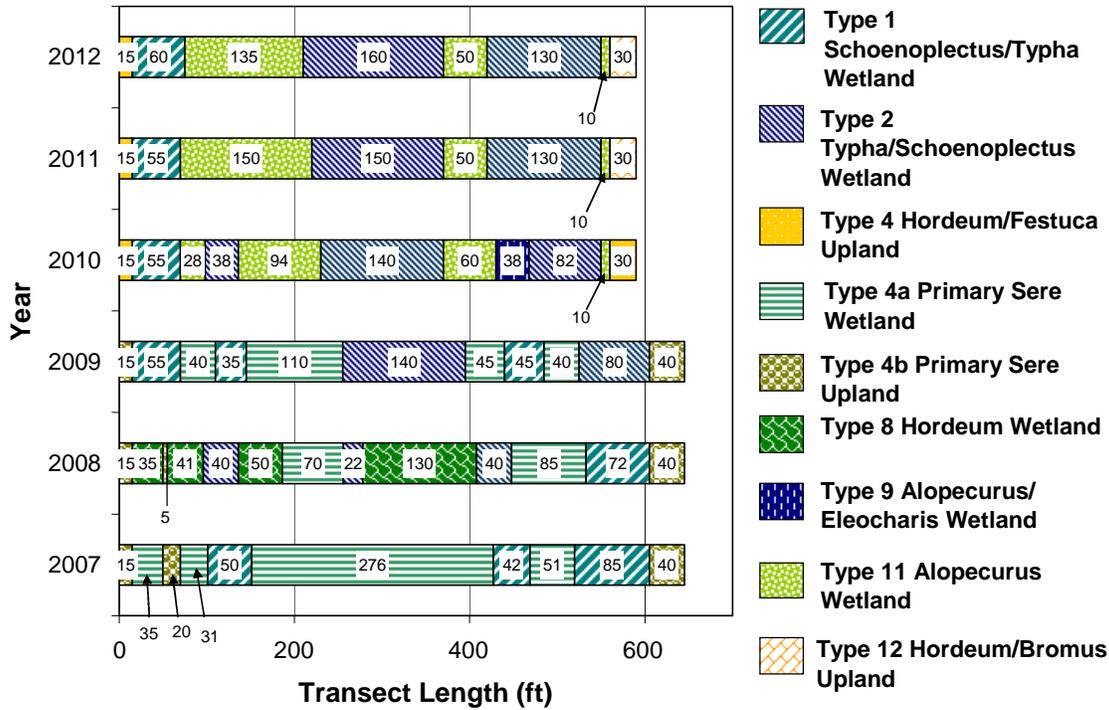
The transect traversed the site from east to west along the southern portion of the project area. Transect 1 intersected wetland community Types 1, 2, and 11 and upland community Types 4 and 12 (Appendix B). Hydrophytic species were present along 92.4 percent of the transect interval, the same percent as in 2011. The transect was inundated in several locations in 2012. The most notable change from 2011 to 2012 was a slight expansion of wetland community Type 2 – *Schoenoplectus/Typha* into wetland community Type 11 – *Alopecurus*. Type 2 community has been expanding since 2009. This shift potentially reflects a long-term shift to a wetter moisture regime dominated by irrigation return flow based on the indicator status of the dominant plants within this community.

Chart 1. Transect map showing vegetation communities from transect beginning (0 feet) to end (590 feet from 2010 to 2012, 645 feet from 2007 to 2009).

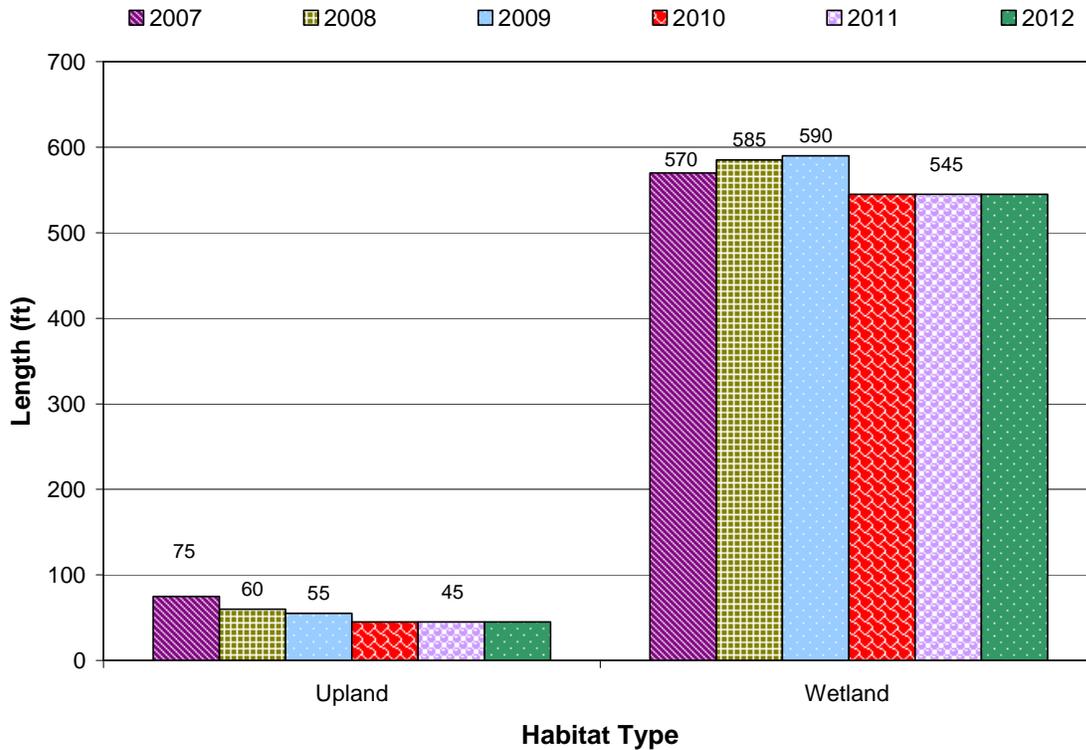
Chart 2. Length of upland/wetland communities within Transect 1 from 2007 to 2012.

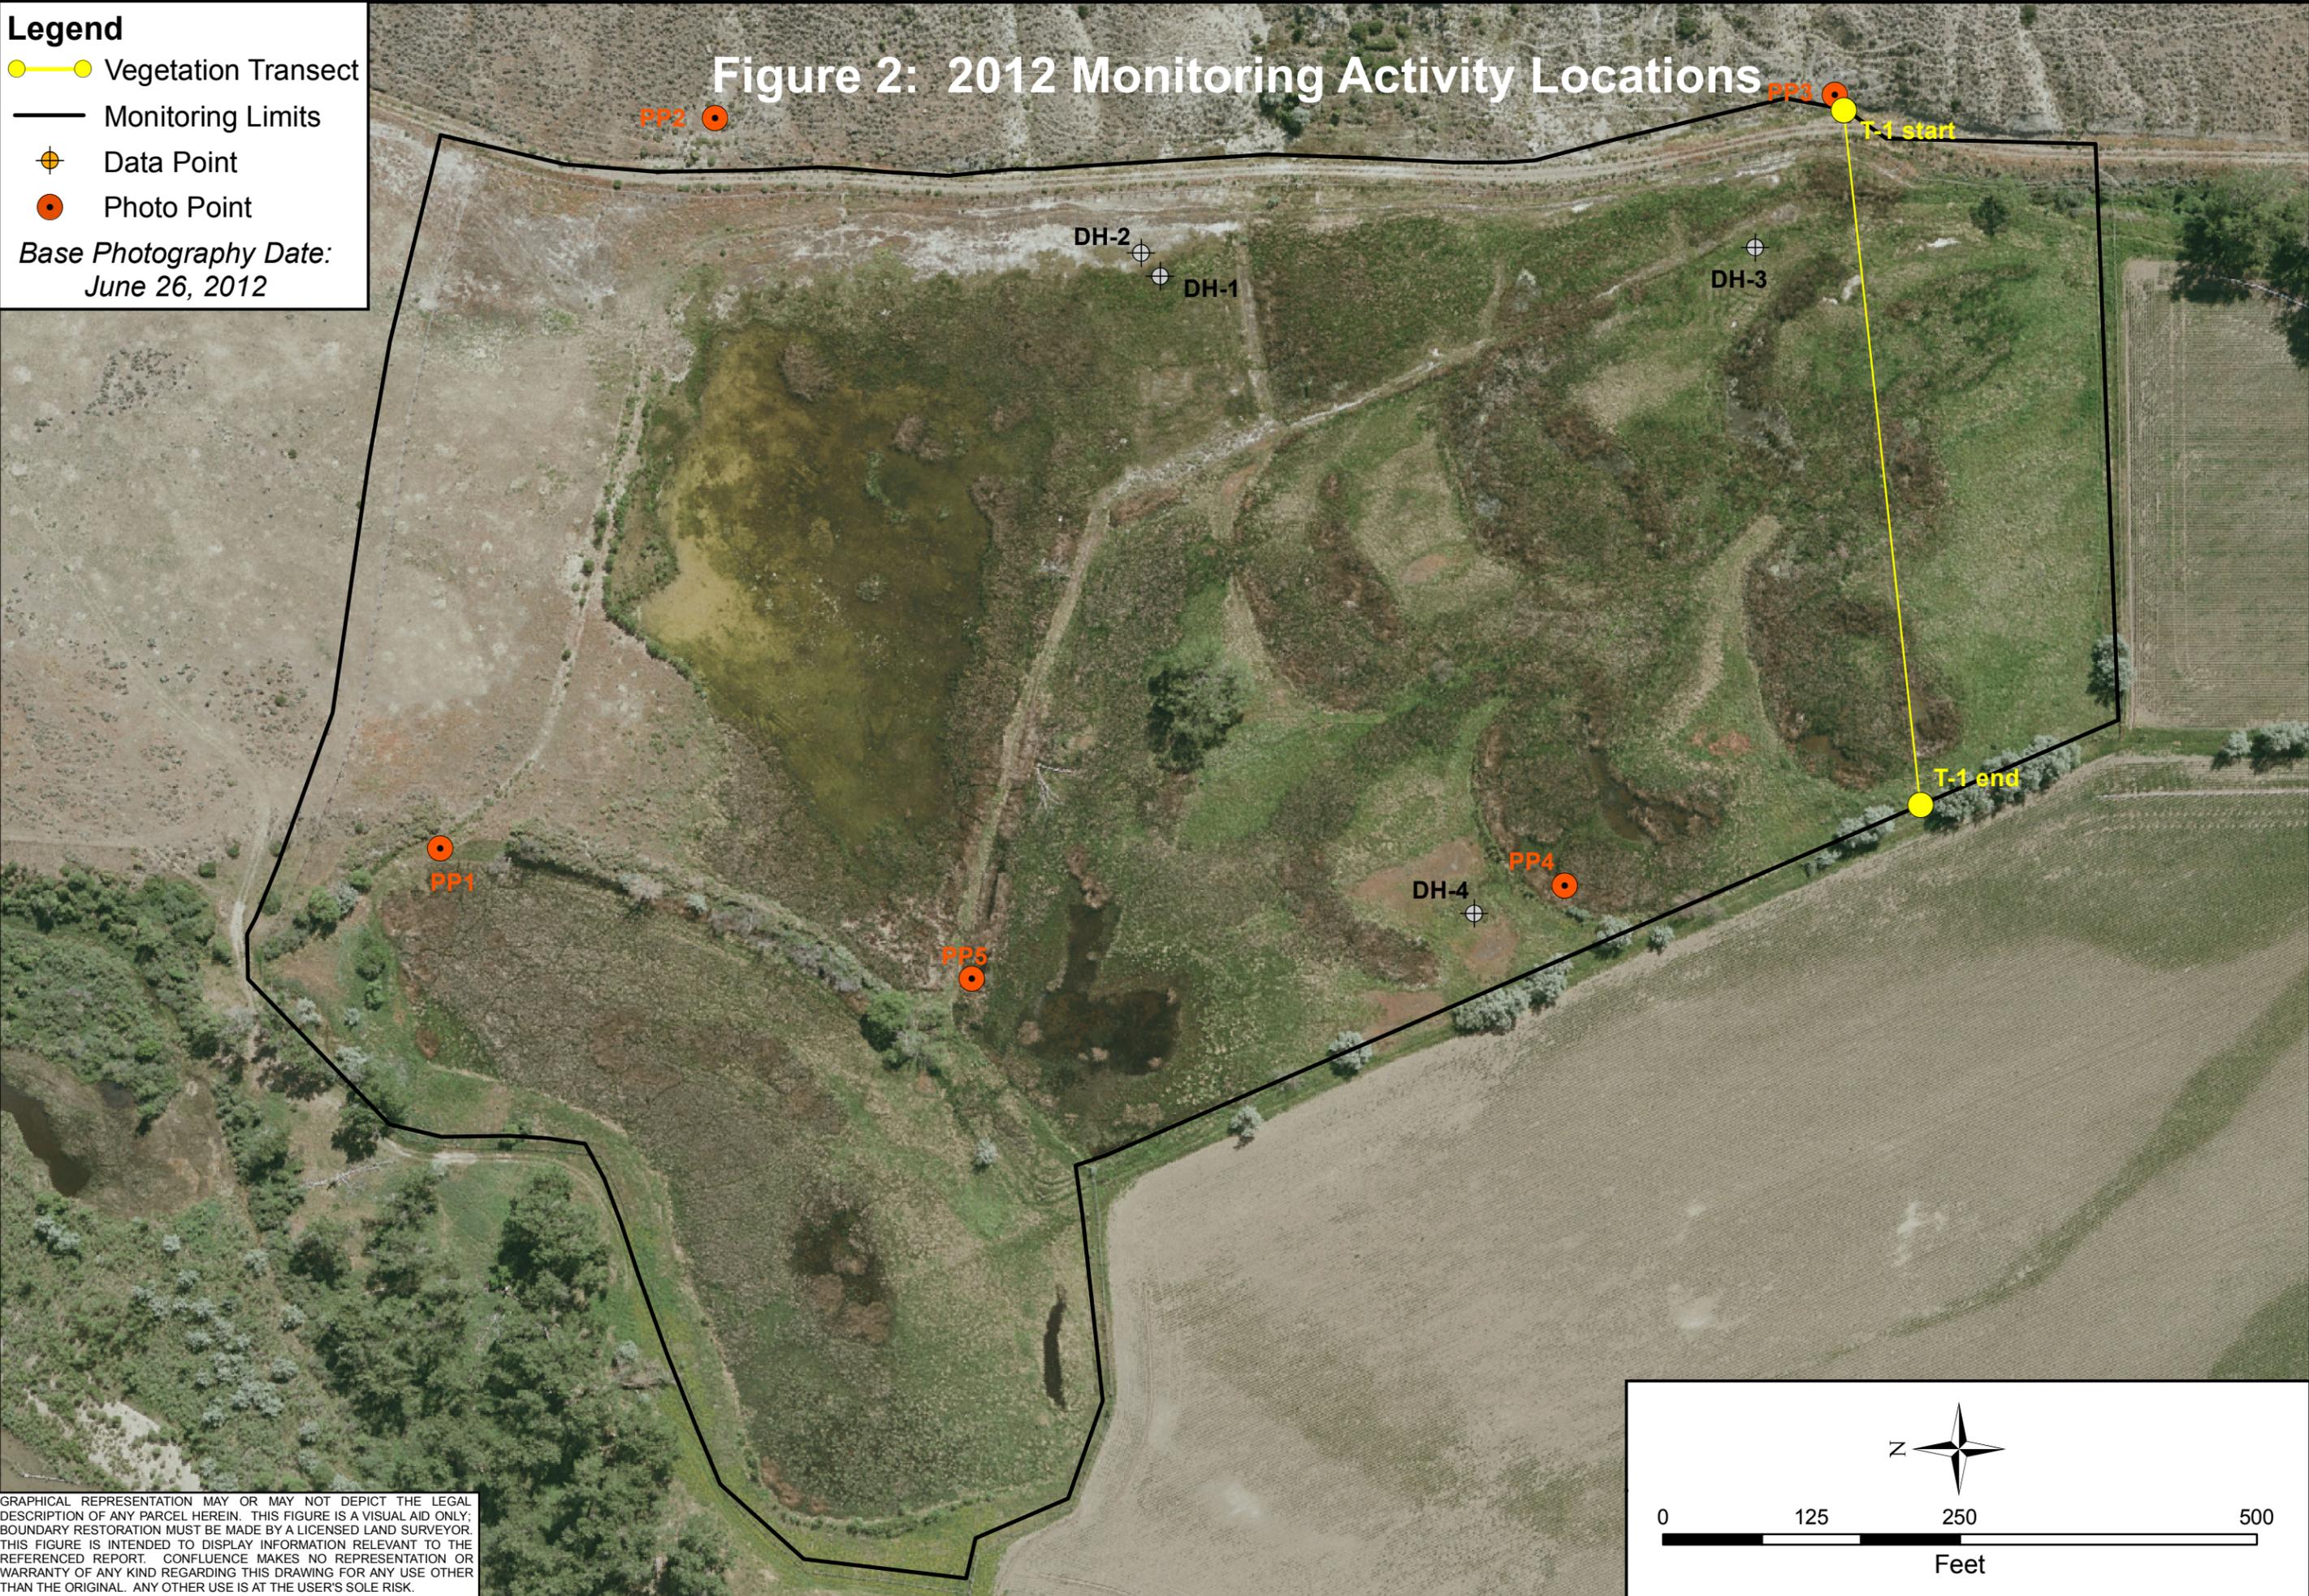
Figure 2: 2012 Monitoring Activity Locations

Monitoring at photo points provides supplemental information documenting wetland and upland conditions, trends, current land uses surrounding the site, and the vegetation transects. Photographs were taken at established photo points throughout the mitigation site during the site visit (Appendix C). Photo point locations were recorded with a resource grade GPS unit (Figure 2, Appendix A).

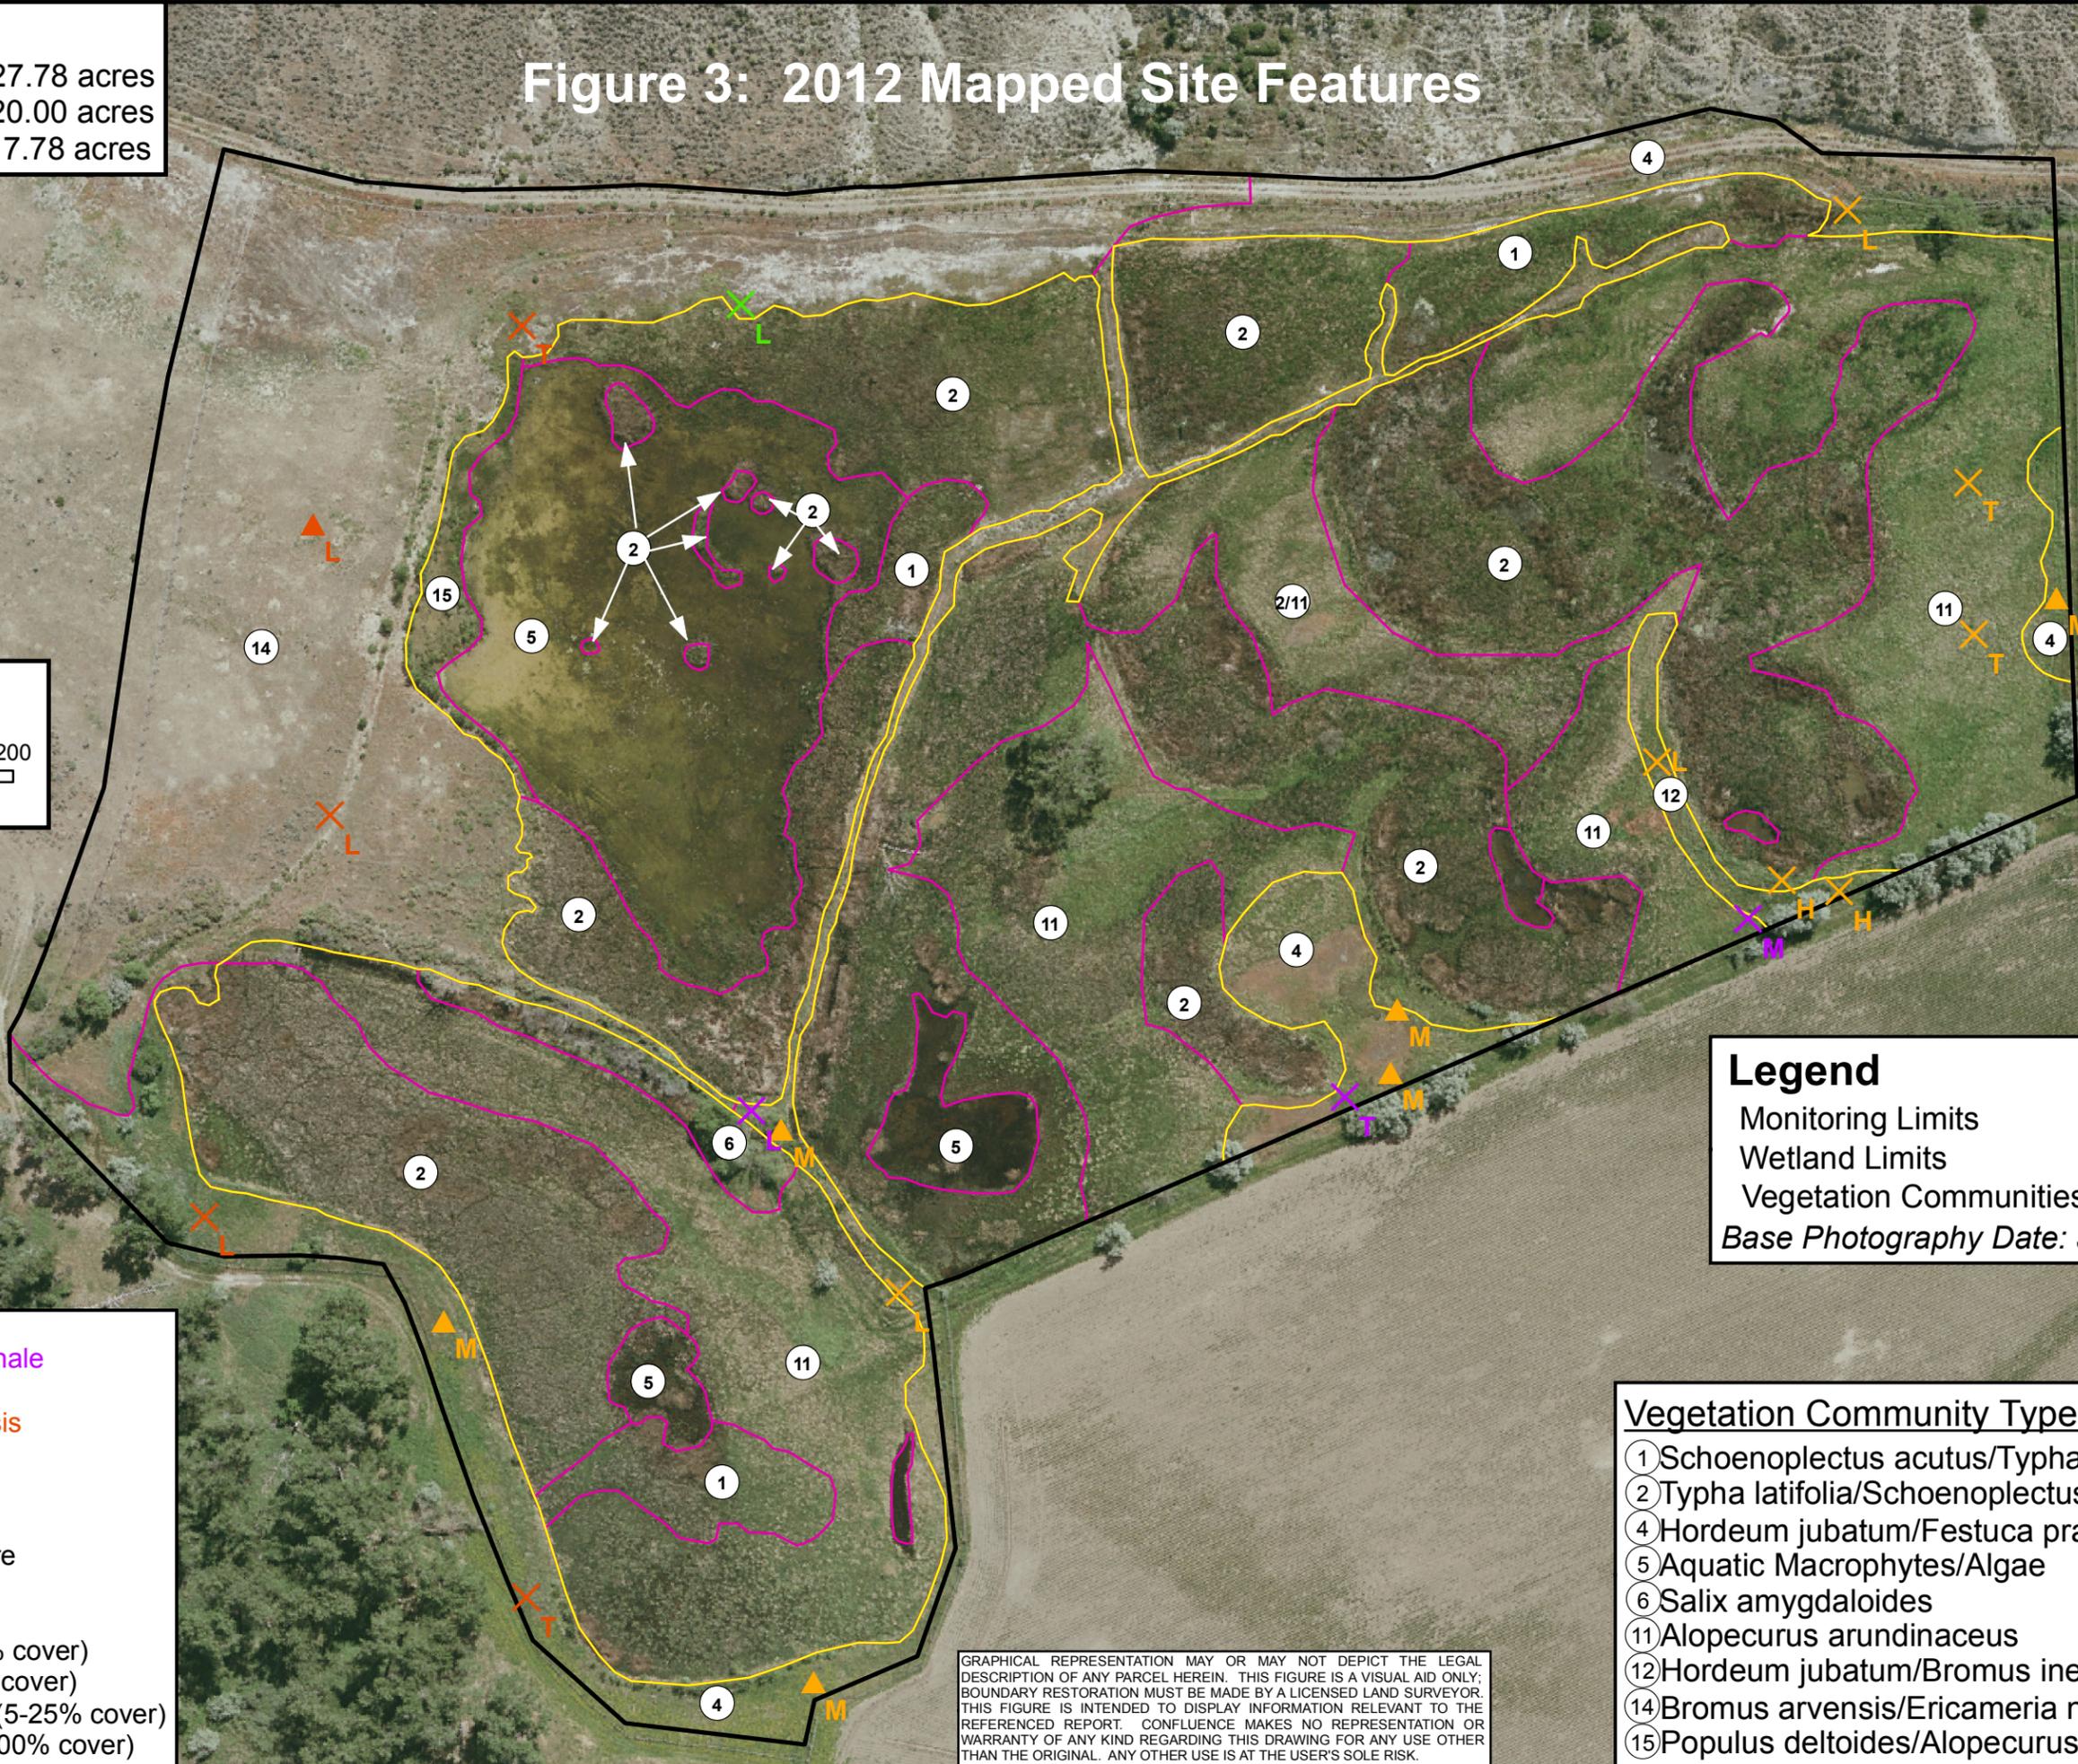
The location of infestations of Canadian thistle (*Cirsium arvense*), field bindweed (*Convolvulus arvensis*), houndstongue (*Cynoglossum officinale*), and salt cedar (*Tamarix* spp.), all Priority 2B weeds, were mapped on Figure 3 (Appendix A). Infestations of Canadian thistle were identified at 13 locations across the site, ranging in size from less than 0.1 acre to 1 acre. The weed cover within the infestations ranged from 1.0 percent to 100.0 percent. Field bindweed was identified in 4 separate infestations across the project site. The size of the infestations ranged from less than 0.1 acre to between 0.1 and 1.0 acre. The cover class was trace to low. Two infestations of houndstongue were observed on the west boundary. The size was less than 0.1 acre and the cover class ranged from less than 1.0 percent to 25.0 percent. A single stem of salt cedar was found along the northeast edge of the project area. Removal of the salt cedar was attempted unsuccessfully.

The location of infestations of Canadian thistle (*Cirsium arvense*), field bindweed (*Convolvulus arvensis*), houndstongue (*Cynoglossum officinale*), and salt cedar (*Tamarix* spp.), all Priority 2B weeds, are presented on Figure 3 (Appendix A). Infestations of Canadian thistle were identified at 13 locations across the site. Field bindweed was identified in 4 separate infestations. Two infestations of houndstongue were observed on the west boundary and a single stem of salt cedar was found along the northeast edge of the project area. Removal of the salt cedar was attempted unsuccessfully. The MDT has an ongoing weed control program including an annual assessment of weed management needs. This site was not sprayed in 2011.

LOCATION: Carbon Co., MT	PROJECT NO: NH-STPP 5(39)	FILE: DHRanch/Veg2012.mxd
Project Name: DH Ranch Mitigation Site		
Drawing Title: 2012 Mapped Site Features		
DRAWN: BCS	CHECKED: BV	APPROVED: JU
SCALE: Noted		
Drawn: August 29, 2012		
PROJ MGR: B Sandefur		
Figure 3		
REV -

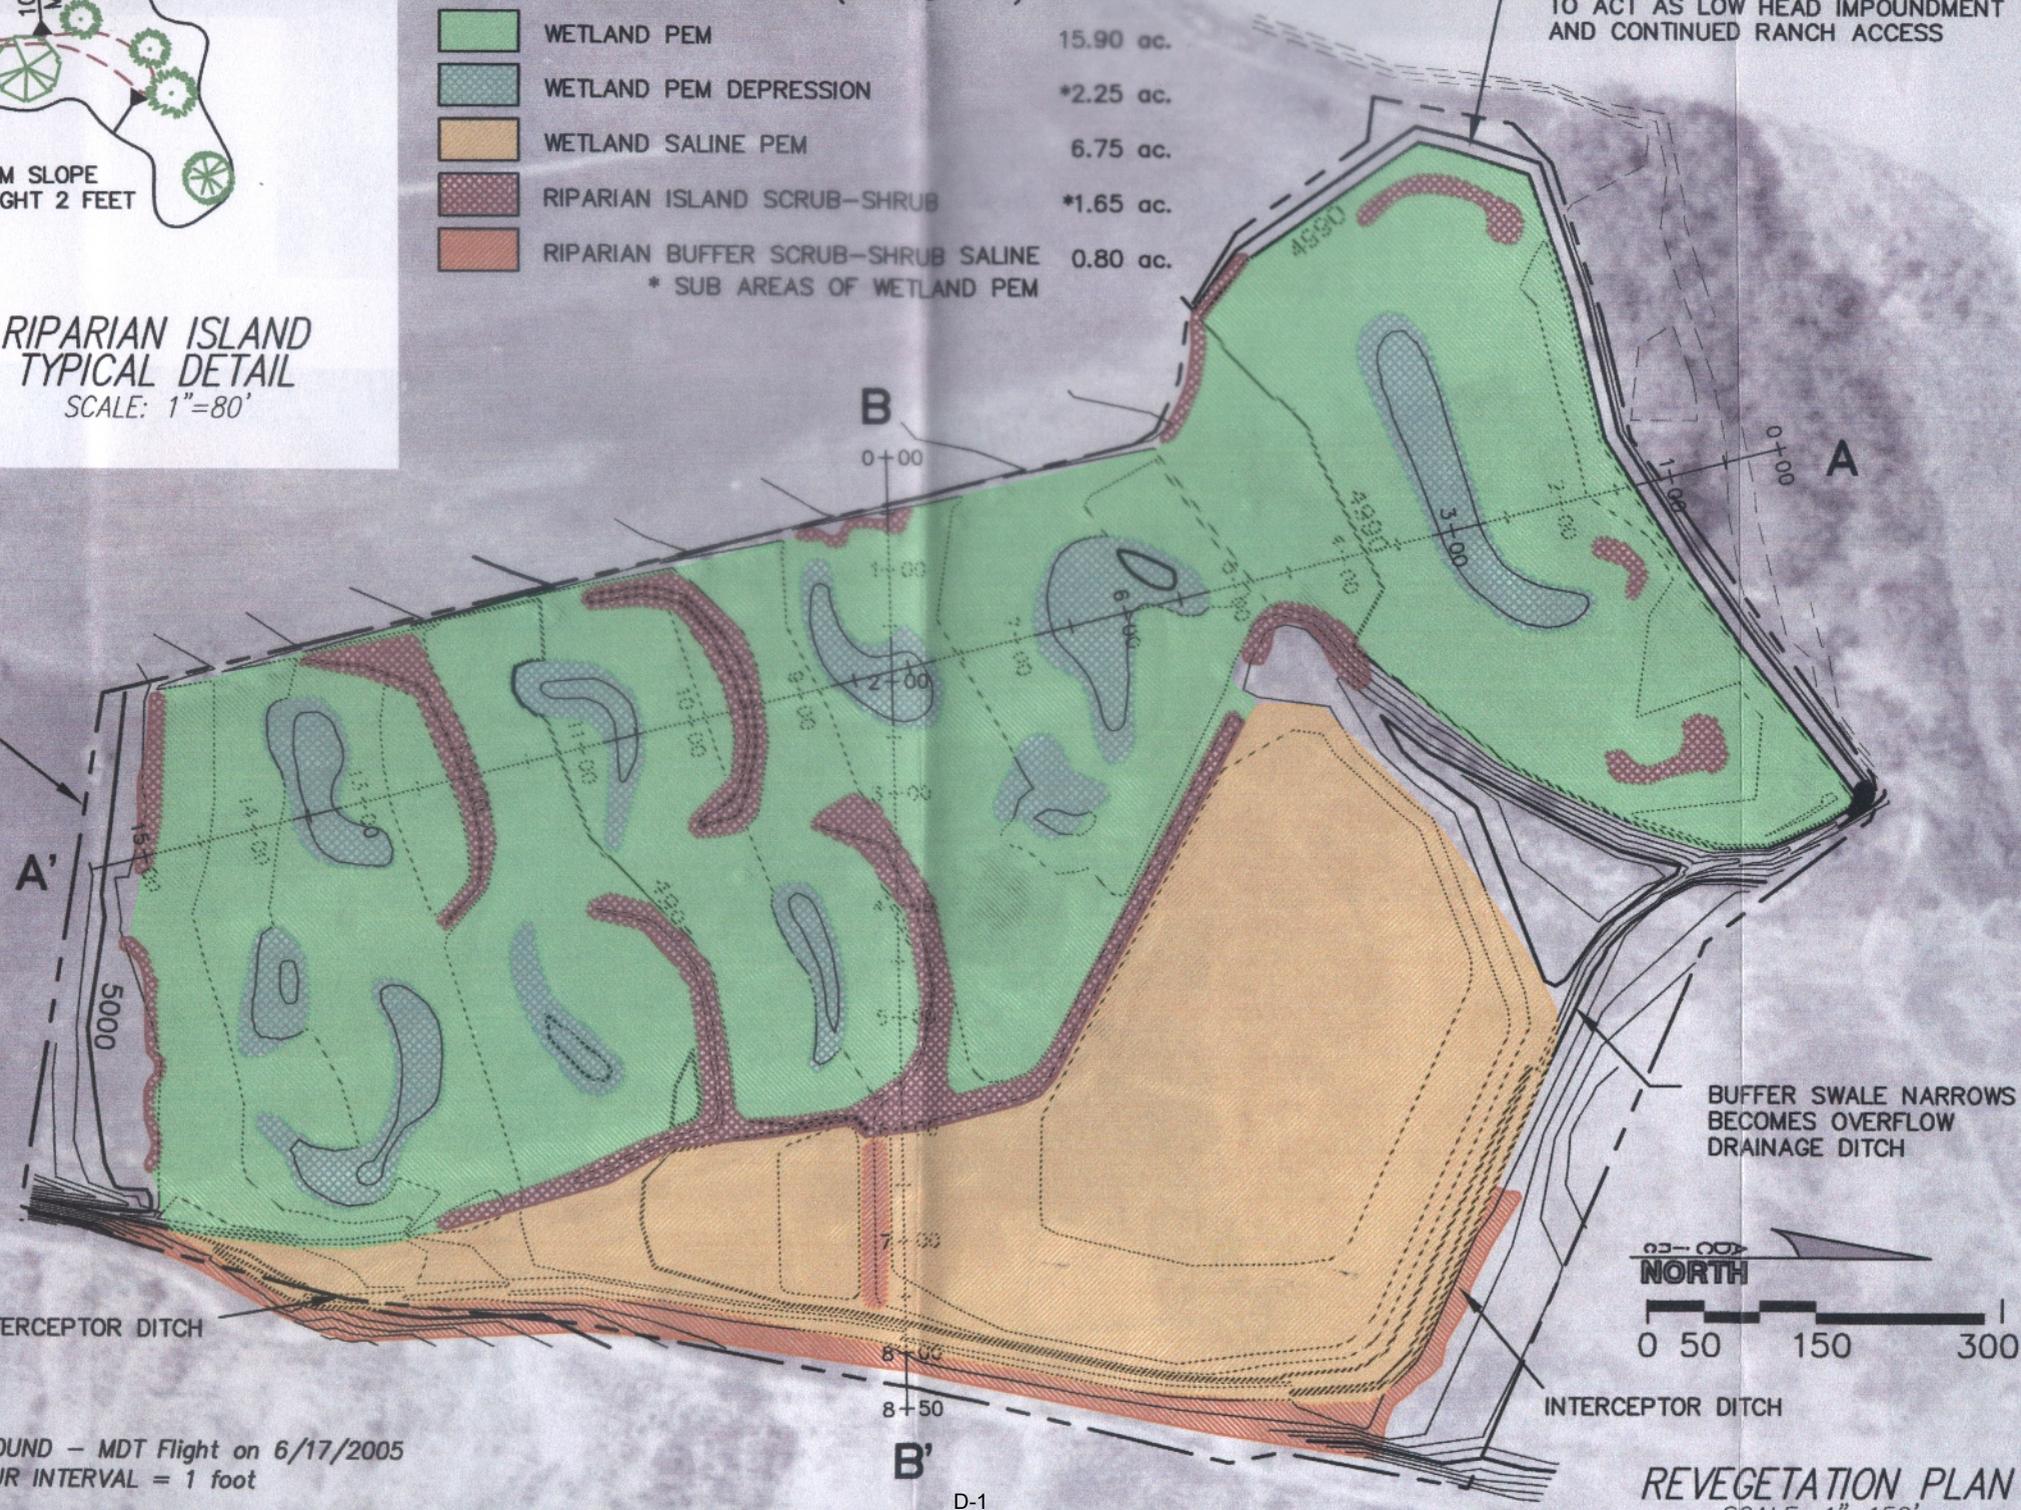
REVEGETATION PLAN
SCALE: 1"=150'

NOTES:
 1> AERIAL PHOTO BACKGROUND - MDT Flight on 6/17/2005
 2> FINISHED DESIGN CONTOUR INTERVAL = 1 foot
