**MONTANA DEPARTMENT OF TRANSPORTATION
WETLAND MITIGATION MONITORING REPORT: YEAR 2012**

*I-90 East Bozeman
Gallatin County, Montana*

December 2012

MDT Project Number STPX-0016(057)
Control Number 5710

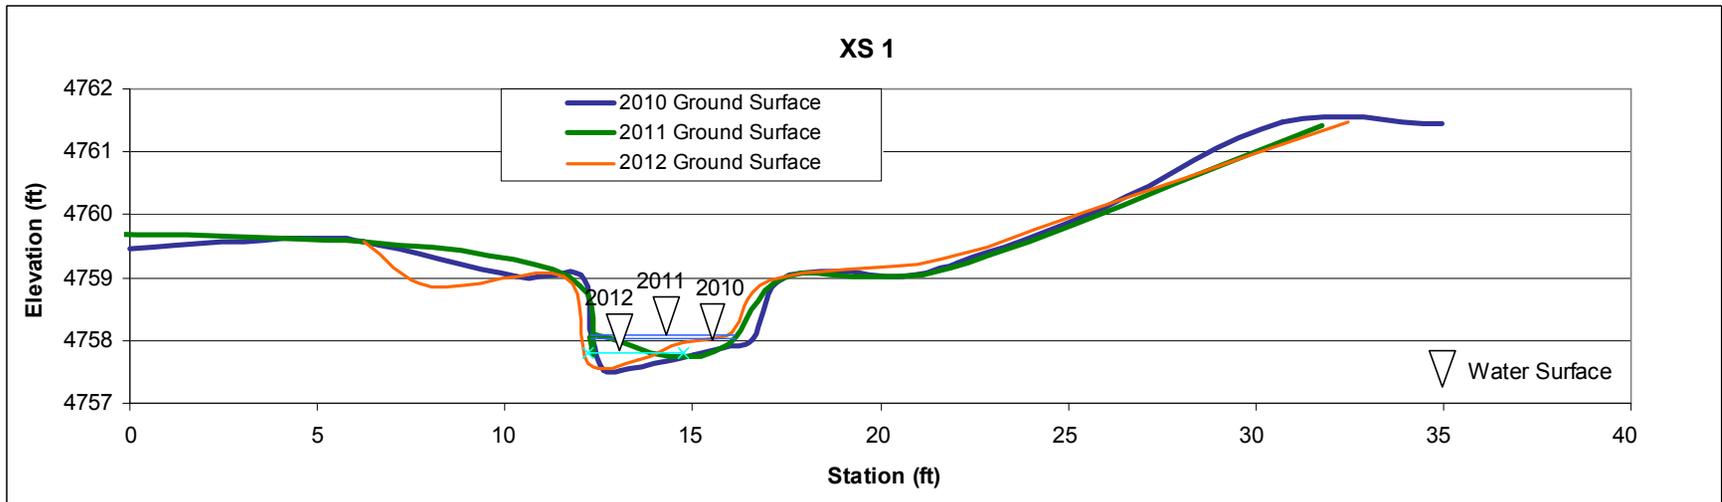
Chart 1. Survey data collected at cross-section 1 from 2010 to 2012.

Two baseline stream cross-sections were surveyed in 2010 at permanent locations to assess bank stability and lateral migration throughout the monitoring period. The cross-sections are surveyed annually. The cross-section survey data collected from 2010 to 2012 are presented on Charts 1 and 2. Photographs of the cross-sections are shown on pages C-6 through C-9 of Appendix C. Cross-section 1 showed approximately two inches of accumulation of streambed material on the right side of the channel bottom. The channel remained stable and did not move laterally from 2010 to 2012. Cross-section 2 exhibited a slight narrowing of the channel width with aggradation (accumulation of material) on the left and right edges of the channel bottom. The thalweg of the channel shifted from the left bank to near the center of the channel cross-section in 2012.

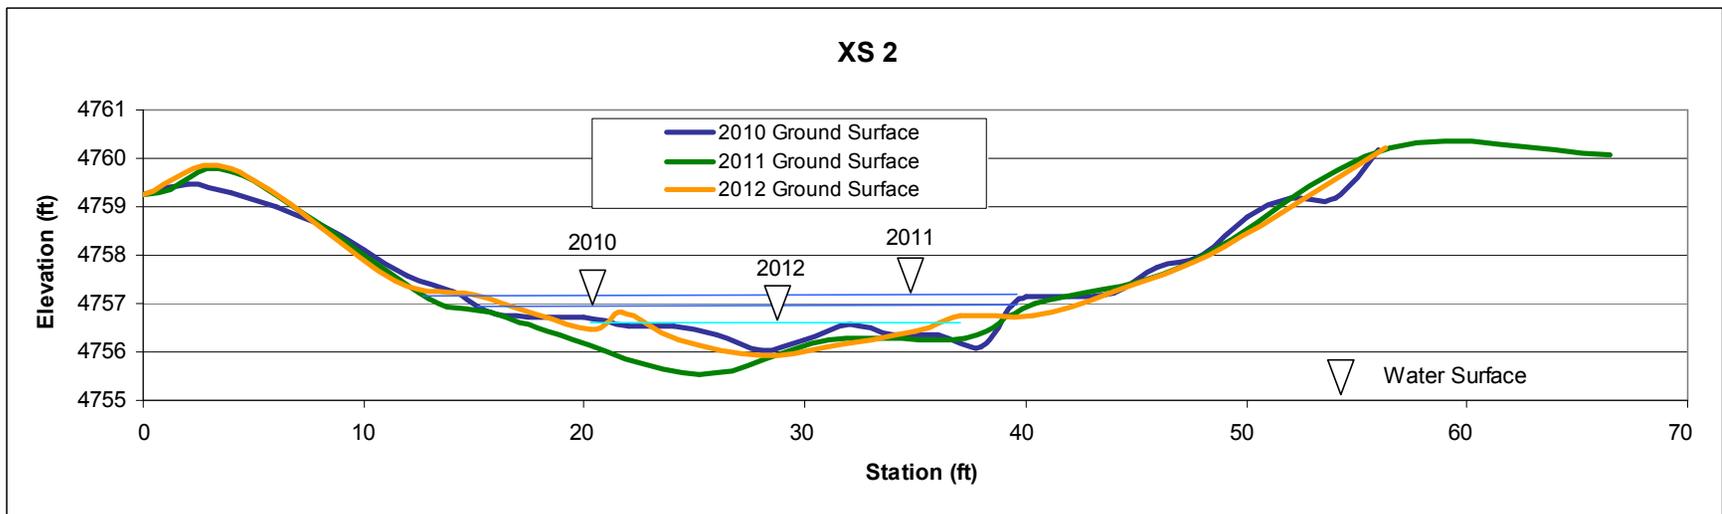
Chart 2. Survey data collected at cross-section 2 from 2010 to 2012.

The cover of plant species with high stability ratings such as sedge, rush, bulrush, and spikerush (Wetland community type 12) increased on the constructed channel streambanks in 2012. The percent cover on the banks increased from approximately 70 percent in 2011 to 90 percent in 2012. Surface water levels showed a decrease of approximately 0.2 foot at Cross-section 1 and 0.3 foot at Cross-Section 2 from 2011 to 2012. The average width of the constructed creek channel downgradient of the culvert outlet is greater than the 2 to 3 feet stipulated in the design. The width of the creek at cross-section 2 is approximately 25 feet.

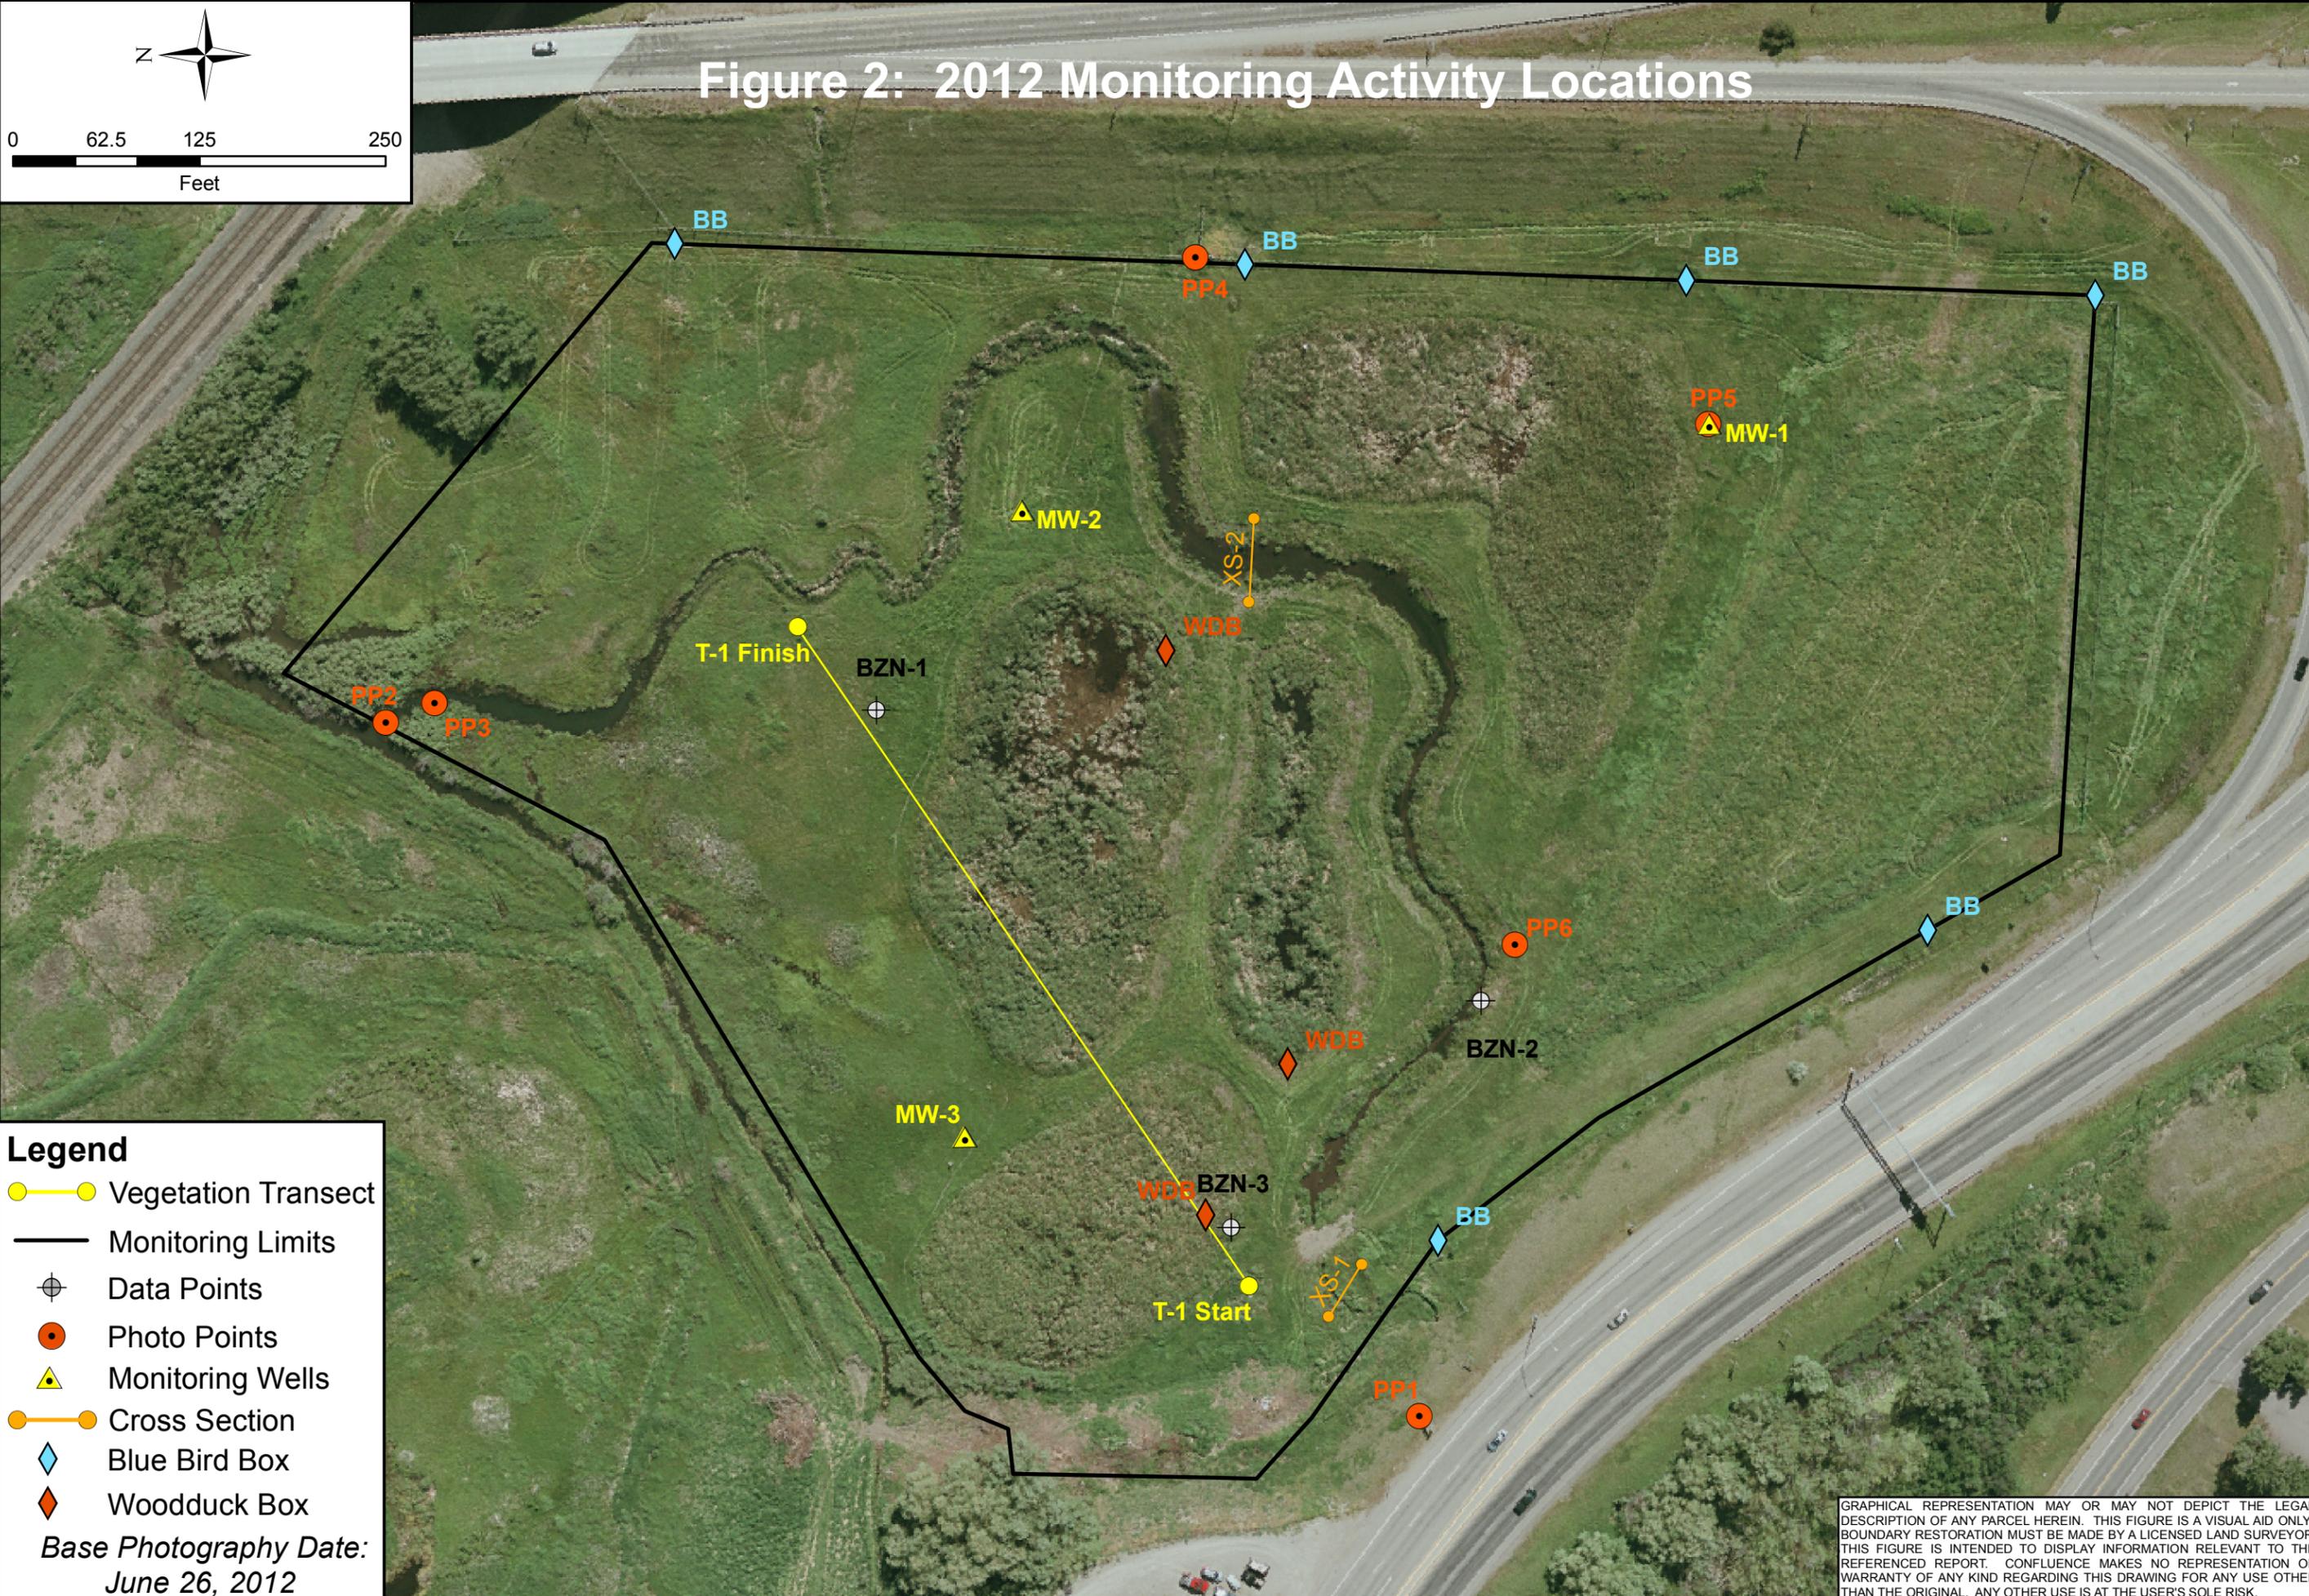
Figure 2: 2012 Monitoring Activity Locations

Figures 2 and 3 (Appendix A) show the Monitoring Activity Locations and Mapped Site Features at the mitigation site, respectively. Appendix B contains the MDT Wetland Mitigation Site Monitoring Forms, the USACE Wetland Determination Data Forms for the Western Mountains, Valleys, and Coast Region (USACE 2010), and the 2008 MDT Montana Wetland Assessment Forms (Berglund and McEldowney 2008). Appendix C contains photographs of the project area and Appendix D includes the project plan sheet.

Monitoring at photo points provided supplemental information documenting wetland conditions, trends, current land uses on the adjacent property, upland conditions, and vegetation transects. Photographs were taken at established photo points during the site visit (Appendix C). Photo point locations were recorded with a resource grade GPS unit (Figure 2, Appendix A).

Three data points, BZN-1 through BZN -3, were assessed to refine the upland and wetland boundaries in 2012 (Wetland Determination Data Forms, Appendix B). The data point locations are shown on Figure 2 (Appendix A). Photos of the data points are included on page C-10 of Appendix C. All three data points were located within areas that met the wetland hydrology criteria. Algal mats and surface soil cracks were positive indicators of wetland hydrology at Bzn-1, located within Wetland Community Type 8. Positive hydrology indicators present at Bzn-2, located on the edge of the constructed stream, were drift deposits and surface soil cracks. Surface soil cracks and a sparsely vegetated concave surface were observed at Bzn-3, located on the perimeter of a constructed cell.

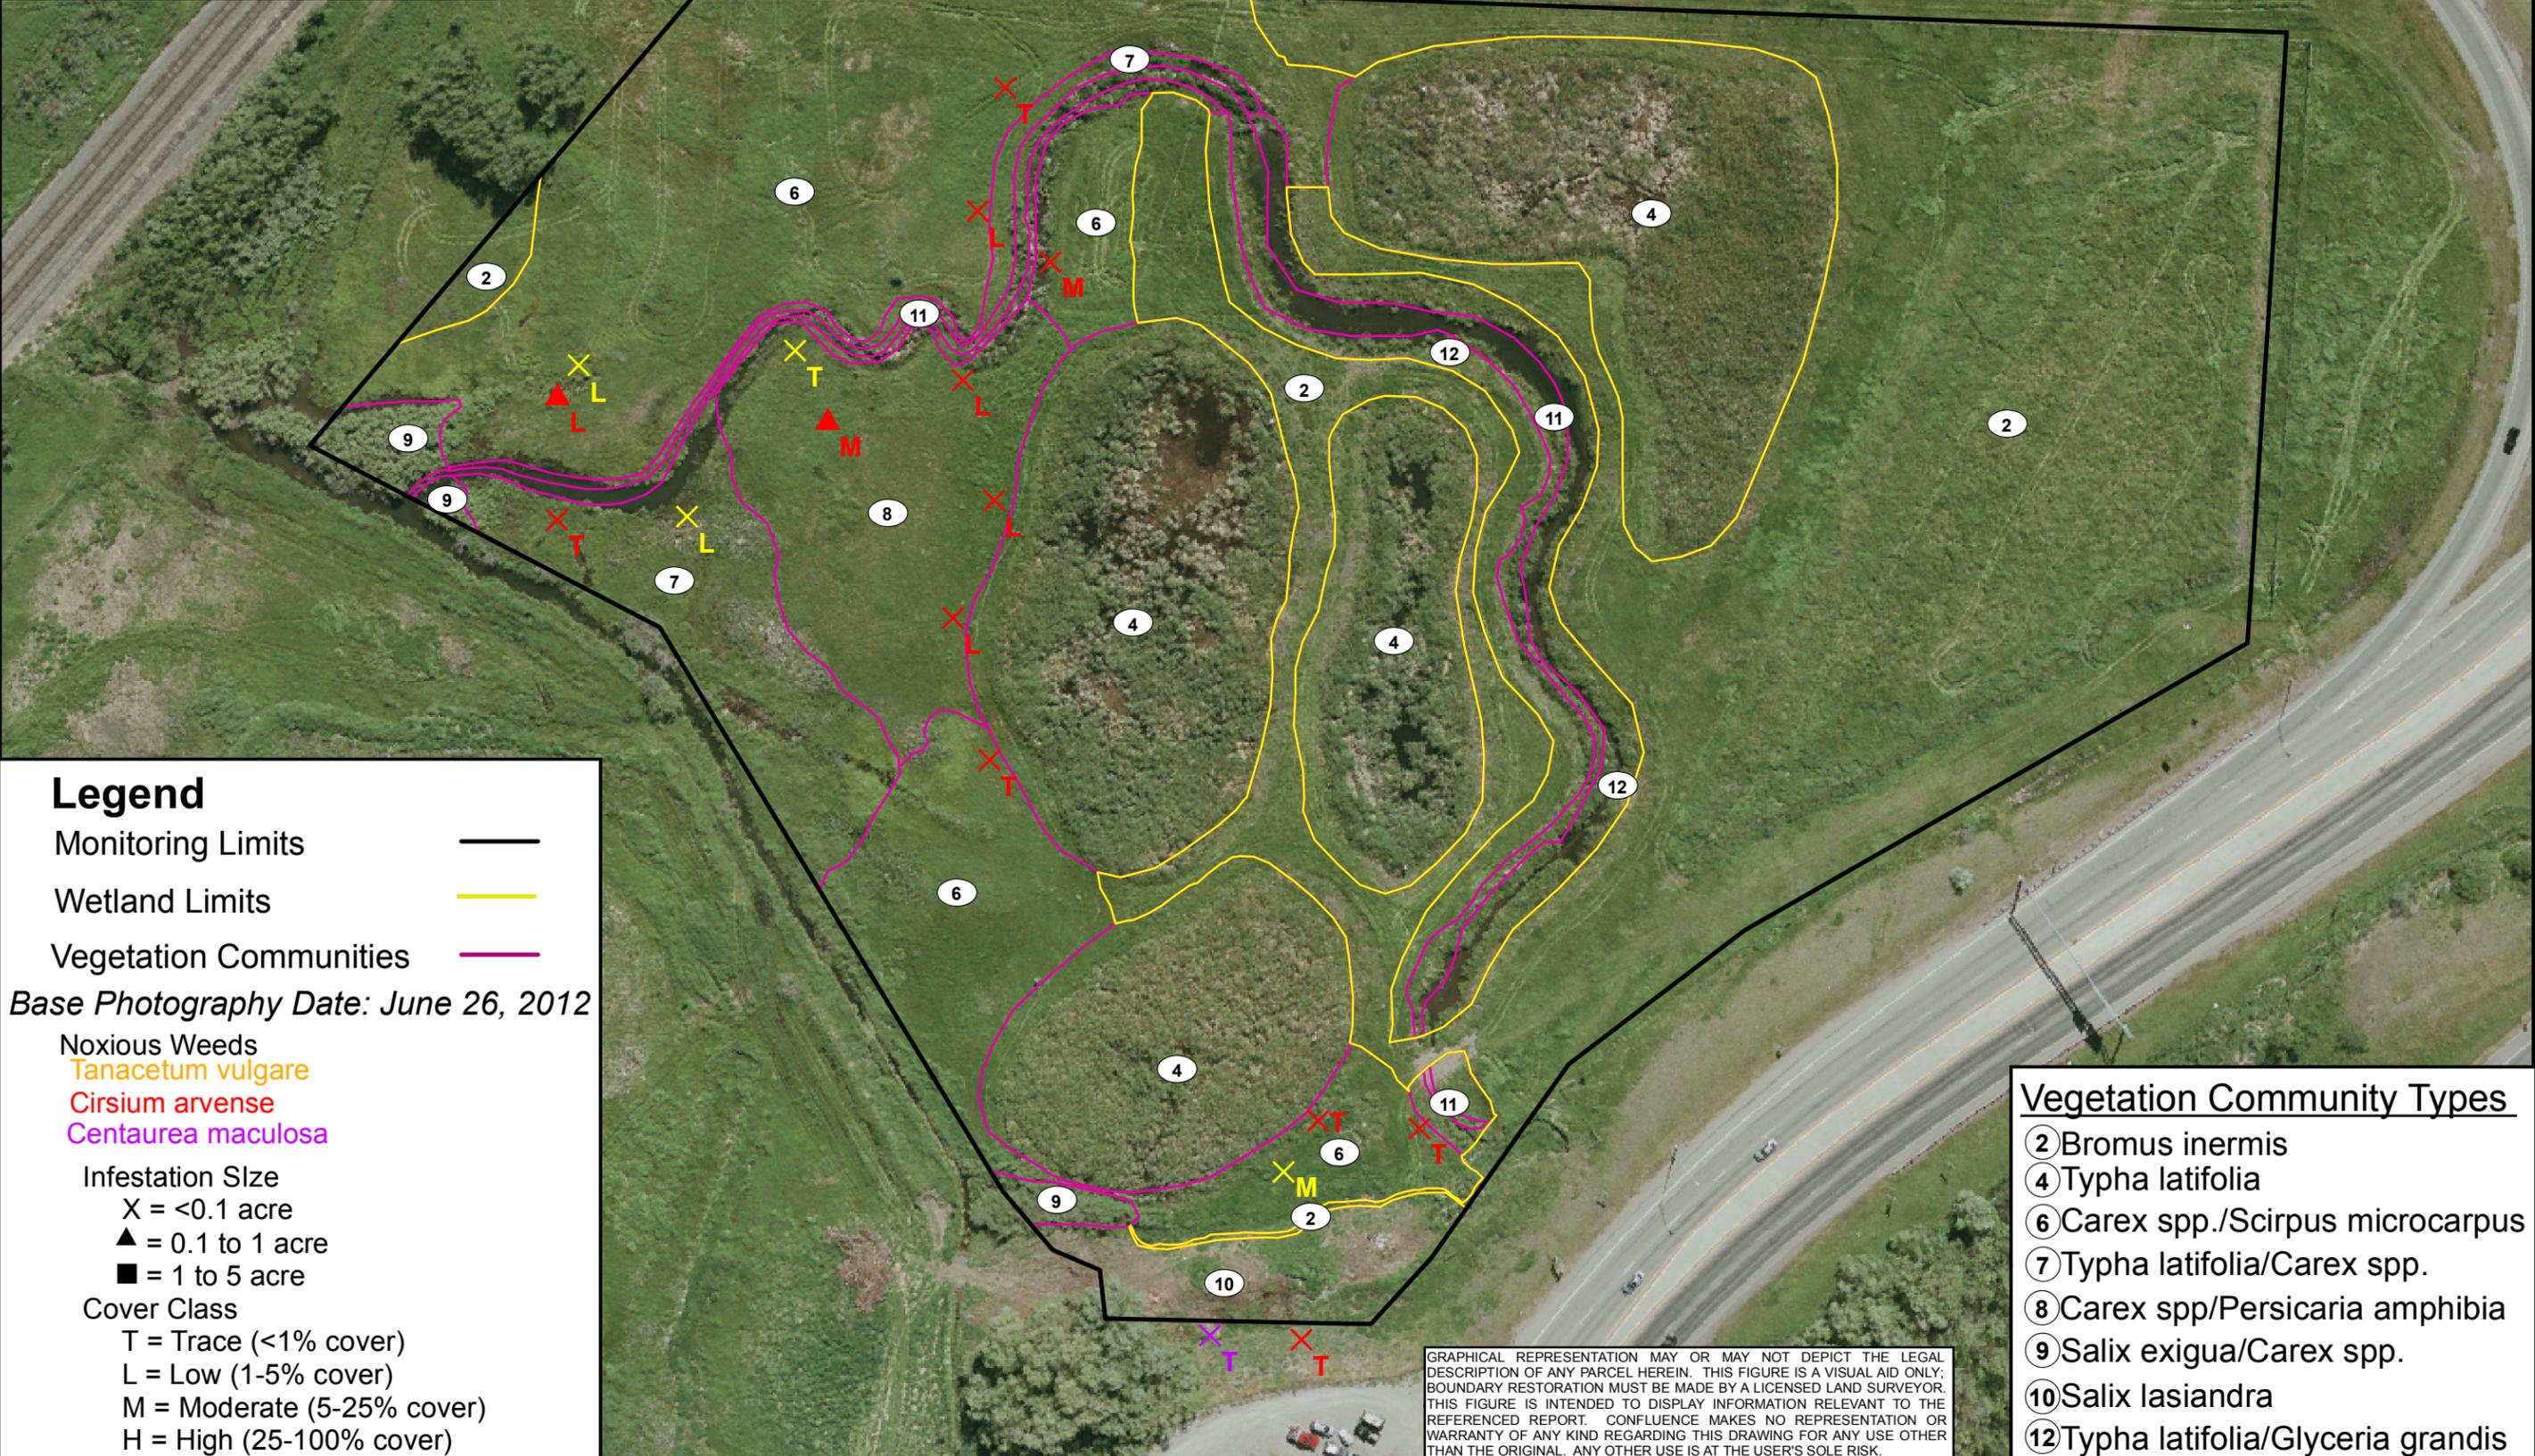
Figure 3: 2012 Mapped Site Features

The location of noxious weeds was noted in the field and mapped on the aerial photo (Figure 3, Appendix A). The noxious weed species identified are color-coded. The locations are denoted with the symbol “x”, “▲”, or “■” representing 0 to 0.1 acre, 0.1 to 1.0 acre, or greater than 1.0 acre in extent, respectively. Cover classes presented on Figure 3 are represented by T, L, M, or H, corresponding to less than 1 percent, 1 to 5 percent, 2 to 25 percent, and 25 to 100 percent, respectively.

The location of infestations of Canadian thistle, common tansy (*Tanacetum vulgare*), and spotted knapweed (*Centaurea maculosa*), all Priority 2B weeds, were mapped on Figure 3 (Appendix A). The prevalence of Canadian thistle decreased site wide from 2011 to 2012 as a result of herbicide spraying completed in August 2011. Isolated Canadian thistle plants were still present across Community Type 8 although the percent cover was less. The infestation size encompassed up to 1.0 acre with cover classes ranging from trace to moderate. The common tansy infestations were located primarily adjacent to the historic channel near the convergence with the Story Ditch. Another infestation of common tansy was located near the entry at the west boundary. The size was less than 0.1 acre with cover ranging from trace to moderate (less than 1 to 25 percent). One small spotted knapweed infestation was noted at the west boundary. The location was included on Figure 3 based on the aggressive nature of knapweed.

The location of infestations of common tansy and Canadian thistle were mapped on Figure 3 (Appendix A). There was a single infestation of spotted knapweed at the fence line on the southwest boundary. It was noted in this report owing to the aggressive nature of this weed. As mentioned in Section 3.2, the percent cover of Canadian thistle decreased site-wide in 2012 as a result of herbicide spraying completed in August, 2011. Isolated Canadian thistle plants were observed throughout Community 8, near the site entry at the southwest boundary, and adjacent to the stream near the Story Ditch confluence. Several isolated infestations of common tansy were observed at the entrance to the site and near the Story Ditch confluence.

Project Area	14.81 acres
WUS inc. Wetlands	9.67 acres
Existing Wetlands	3.51 acres
WUS (11)	0.34 acres
Created Wetlands	5.82 acres
Upland	5.14 acres

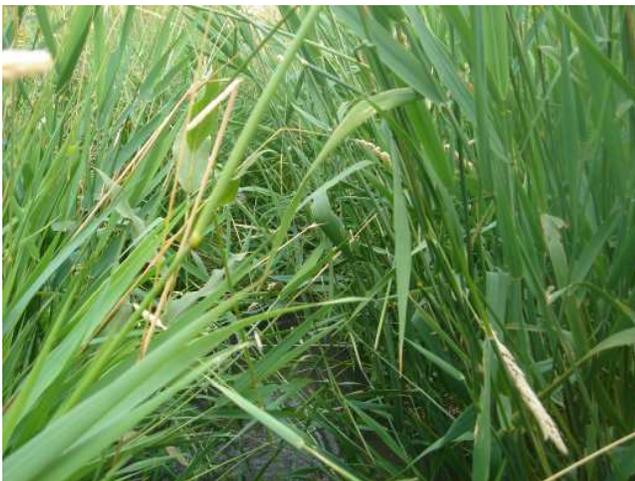
Cross Section 1 – Photo 1
Bearing: 350 Degrees

Location: XS-1 looking downstream
Taken in 2012

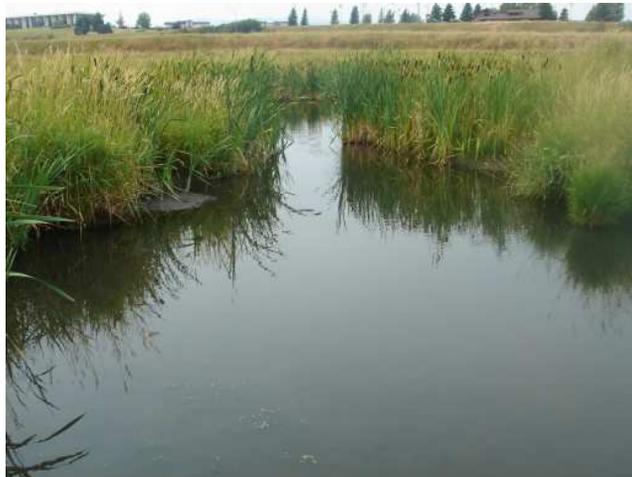
Cross Section 2 – Photo 1
Bearing: 310 Degrees

Location: XS-2 looking upstream
Taken in 2012
