Montana US 93 South Wildlife Crossings Research

MDT # HWY – 308445-RP

**Second Quarterly Report
November 1 2008 – February 1, 2009**

February 18, 2009

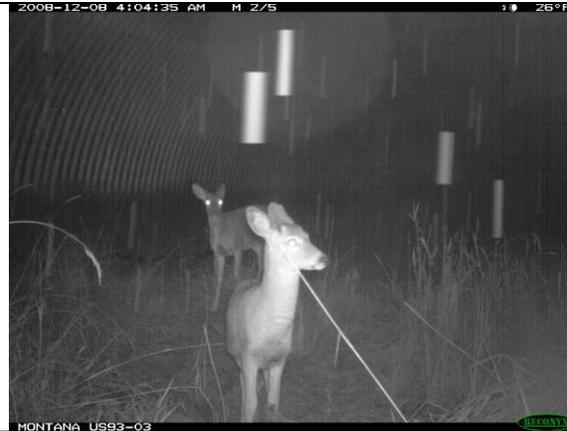
White-tailed deer taking refuge in culvert during snow storm.

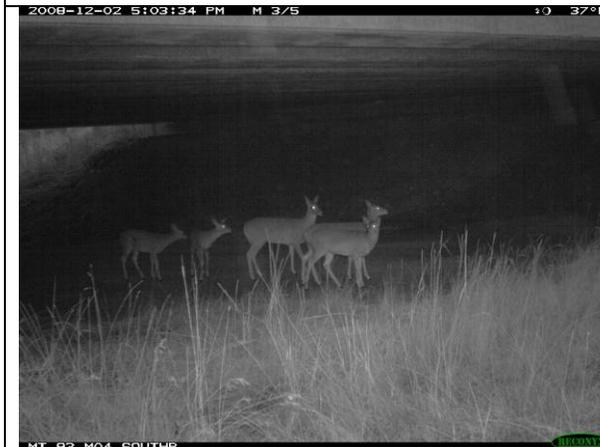
White-tailed deer using large bridge passage.

Overall, the open span bridge is the most successful crossing, with 76 animals passing through the crossing in 84 days ($76/84 = .90$ deer/day). This crossing is open and wide, with a natural soil floor, and almost no human visitation. The least successful crossing is one of the bridges (no wildlife fencing), with no deer recorded in 85 days. One of the bridges without fencing did have 10 deer visit in the time span from late October through late November, and only four deer used the passage. The culvert with fencing was more successful, with 36 successful passes by white-tailed deer, and only one repel (of a buck). The bridges without wildlife fencing also have visitation by humans, which may be of concern for the wildlife. Other species recorded at the crossings overall include raccoon, skunk, and red fox.
