Montana Rest Area Plan Update

APPENDIX B TECHNICAL MEMORANDUM

DOWL HKM

May 2014

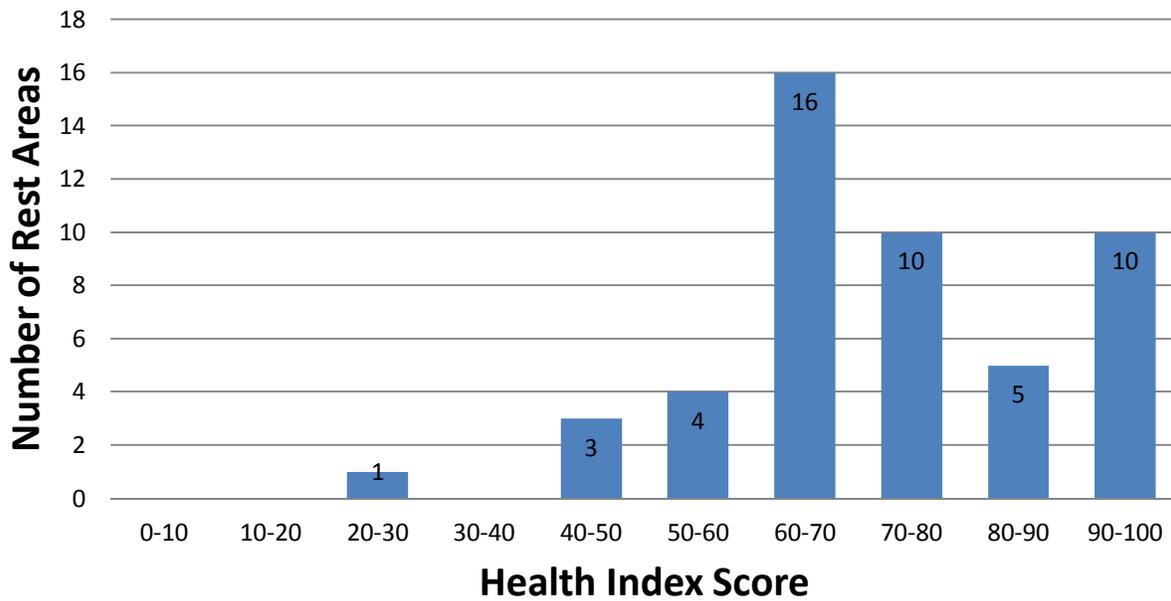
Figure 2-1 Health Index Score Distribution for State-maintained Rest Areas

Note: The single site within the scoring range from 20 to 30 is Vista Point, which does not have domestic water service. All relevant water and wastewater categories are assigned a “poor” value.

Health index scores are only intended for comparison purposes to assist the Statewide Rest Area Prioritization Plan Committee in identifying relative statewide needs. Demand estimates provided in this memorandum are not intended for use during design.

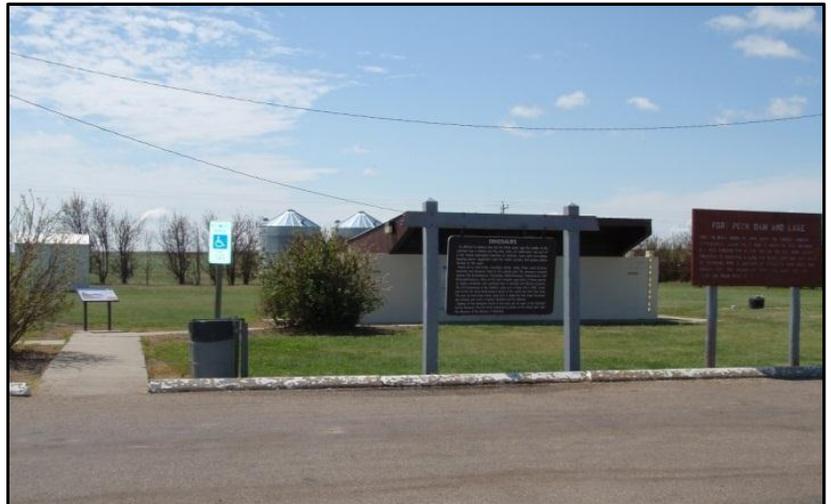
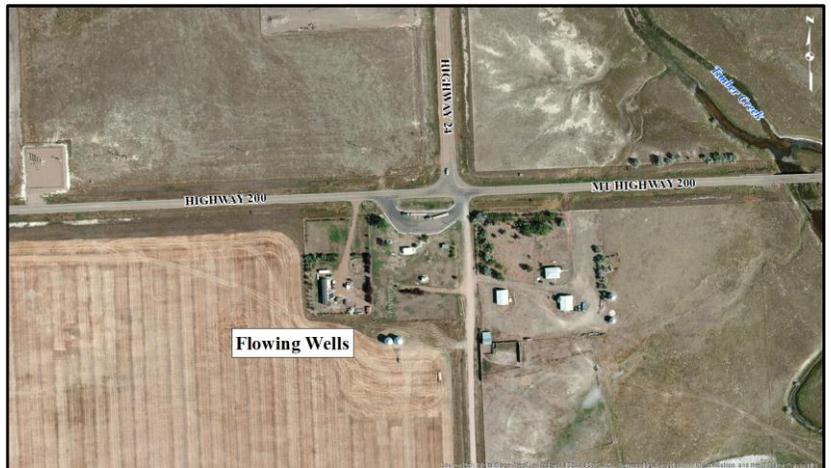
SRA-23 Date: February 28, 2014

Name: Flowing Wells Rest Area
Route: MT 200 (N-57)
Direction: East
Reference Post: 248+0.573
Year Built: 1964
Jurisdiction: District 4 - Glendive
Maintenance: State Site
AADT (2011): 330
Health Index: 65.00

Map Number:	SRA-23
Facility:	Flowing Wells
Year Constructed/Reconstructed:	1964
Facility Age (years):	50
Advance Signing:	Yes
Number of Passenger Vehicle Stalls:	10
Number of Oversized Vehicle Stalls:	0
Telephone:	No
Waste Receptacles:	Yes
Number of Restroom Stalls (Women):	2
Number of Restroom Stalls (Men):	2
Sep. ADA/Family Style Restroom:	No
Flush Toilet:	Yes
Vault Toilet:	No
Hand Dryers:	Yes
Advanced WW Treatment:	No
Municipal Water:	No
Municipal Wastewater:	No
Picnic Areas:	Yes
Landscaping/Irrigation:	No
Designated Pet Area:	No
Vending Machines:	No
Wi-Fi:	No

- Future Considerations:**
- Number of Oversized Vehicle Parking Stalls
 - Pavement Striping Quality
 - Remaining Service Life for the Parking Area
 - Site Signage
 - Remaining Service Life of the Structure

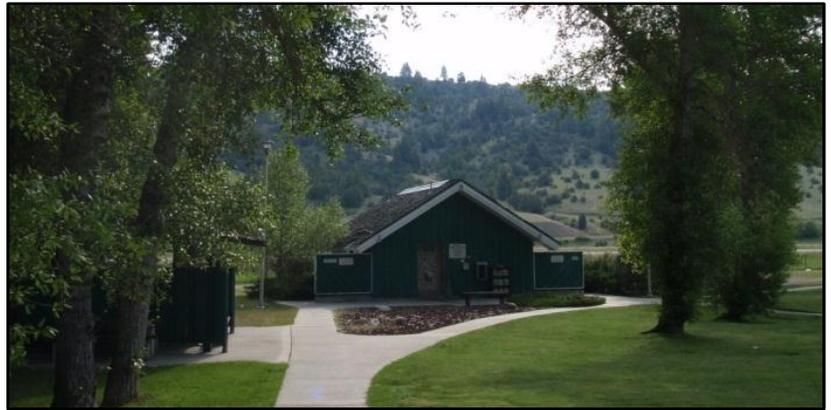
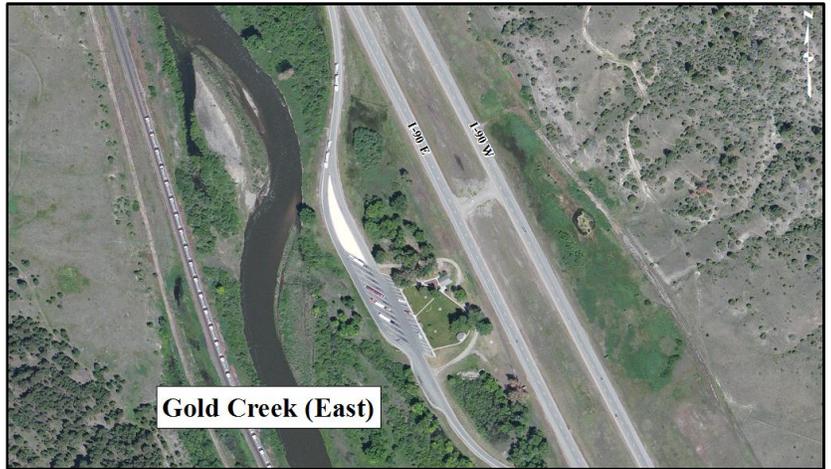
SRA-24 Date: February 28, 2014

Name: Gold Creek (East) Rest Area
Route: I-90
Direction: East
Reference Post: 169+0.402
Year Built: 1973
Jurisdiction: District 1 - Missoula
Maintenance: State Site
AADT (2011): 8050
Health Index: 52.33

Map Number:	SRA-24
Facility:	Gold Creek (East)
Year Constructed/Reconstructed:	1973
Facility Age (years):	41
Advance Signing:	Yes
Number of Passenger Vehicle Stalls:	19
Number of Oversized Vehicle Stalls:	11
Telephone:	No
Waste Receptacles:	Yes
Number of Restroom Stalls (Women):	3
Number of Restroom Stalls (Men):	3
Sep. ADA/Family Style Restroom:	No
Flush Toilet:	Yes
Vault Toilet:	Yes
Hand Dryers:	Yes
Advanced WW Treatment:	No
Municipal Water:	No
Municipal Wastewater:	No
Picnic Areas:	Yes
Landscaping/Irrigation:	Yes
Designated Pet Area:	Yes
Vending Machines:	No
Wi-Fi:	No

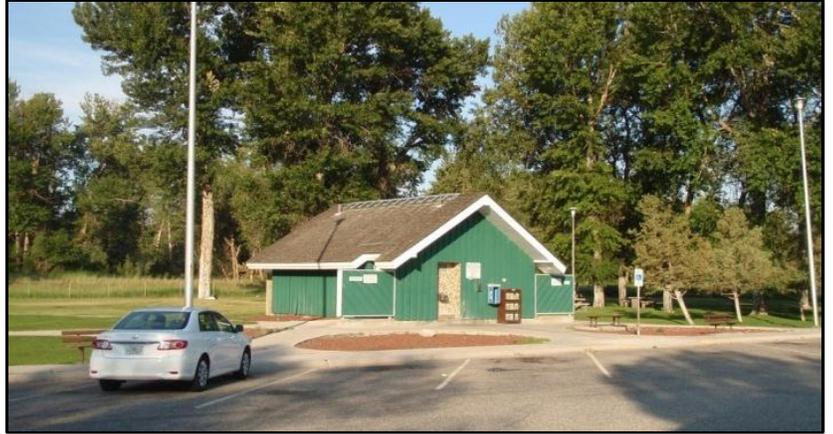
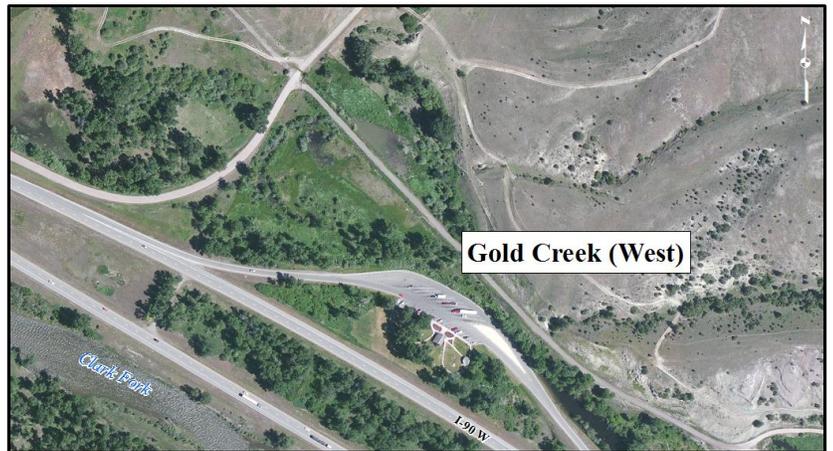
SRA-25 Date: February 28, 2014

Name: Gold Creek (West) Rest Area
Route: I-90
Direction: West
Reference Post: 167+0.411
Year Built: 1973
Jurisdiction: District 1 – Missoula
Maintenance: State Site
AADT (2011): 8050
Health Index: 48.67

Map Number:	SRA-25
Facility:	Gold Creek (West)
Year Constructed/Reconstructed:	1973
Facility Age (years):	41
Advance Signing:	Yes
Number of Passenger Vehicle Stalls:	17
Number of Oversized Vehicle Stalls:	10
Telephone:	No
Waste Receptacles:	Yes
Number of Restroom Stalls (Women):	3
Number of Restroom Stalls (Men):	3
Sep. ADA/Family Style Restroom:	No
Flush Toilet:	Yes
Vault Toilet:	Yes
Hand Dryers:	Yes
Advanced WW Treatment:	No
Municipal Water:	No
Municipal Wastewater:	No
Picnic Areas:	Yes
Landscaping/Irrigation:	Yes
Designated Pet Area:	Yes
Vending Machines:	No
Wi-Fi:	No

- Future Considerations:**
- Number of Oversized Vehicle Parking Stalls
 - Remaining Service Life for the Parking Area
 - Facility Ventilation
 - Remaining Service Life for the Structure
 - Source Capability to Meet Peak Daily Demand
 - Backflow Prevention
 - Remaining Service Life for the Water System
 - Remaining Service Life for the Wastewater System

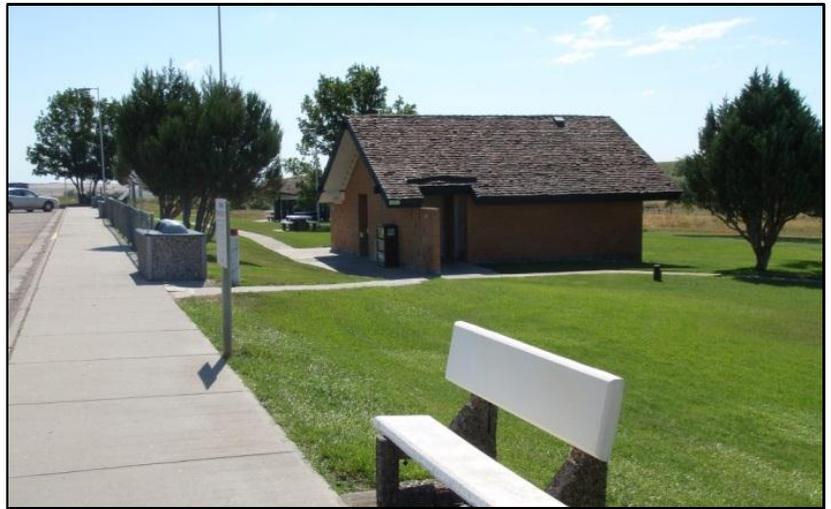
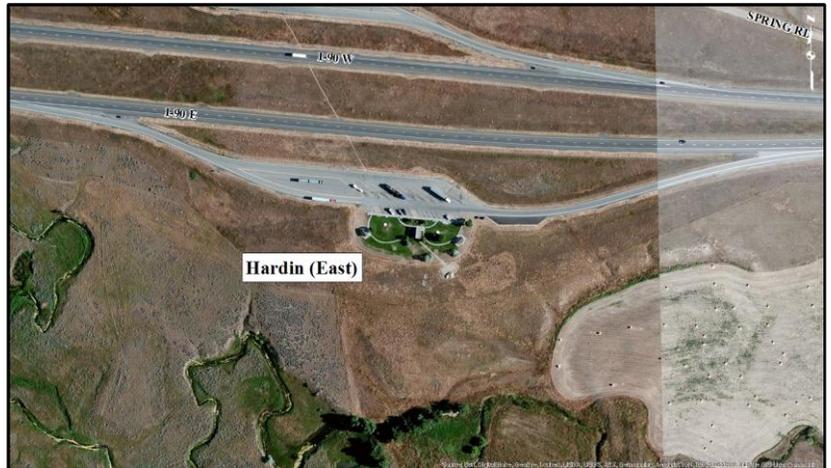
SRA-28 Date: February 28, 2014

Name: Hardin (East) Rest Area
Route: I-90
Direction: East
Reference Post: 476+0.594
Year Built: 1972
Jurisdiction: District 5 – Billings
Maintenance: State Site
AADT (2011): 5750
Health Index: 67.00

Map Number:	SRA-28
Facility:	Hardin (East)
Year Constructed/Reconstructed:	1972
Facility Age (years):	42
Advance Signing:	Yes
Number of Passenger Vehicle Stalls:	29
Number of Oversized Vehicle Stalls:	8
Telephone:	No
Waste Receptacles:	Yes
Number of Restroom Stalls (Women):	3
Number of Restroom Stalls (Men):	3
Sep. ADA/Family Style Restroom:	No
Flush Toilet:	Yes
Vault Toilet:	No
Hand Dryers:	Yes
Advanced WW Treatment:	No
Municipal Water:	No
Municipal Wastewater:	No
Picnic Areas:	Yes
Landscaping/Irrigation:	Yes
Designated Pet Area:	Yes
Vending Machines:	No
Wi-Fi:	No

- Future Considerations:**
- Number of Oversized Vehicle Parking Stalls
 - Remaining Service Life for the Parking Area
 - Remaining Service Life for the Structure
 - Source Capability to Meet Peak Daily Demand

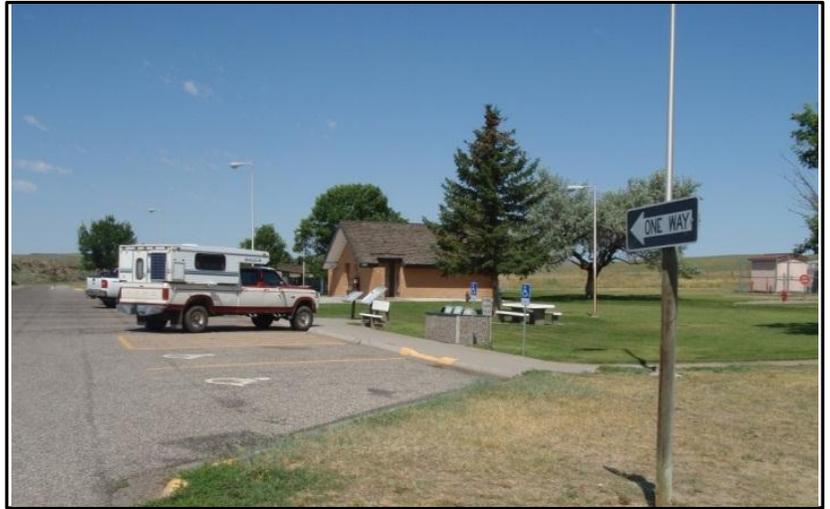
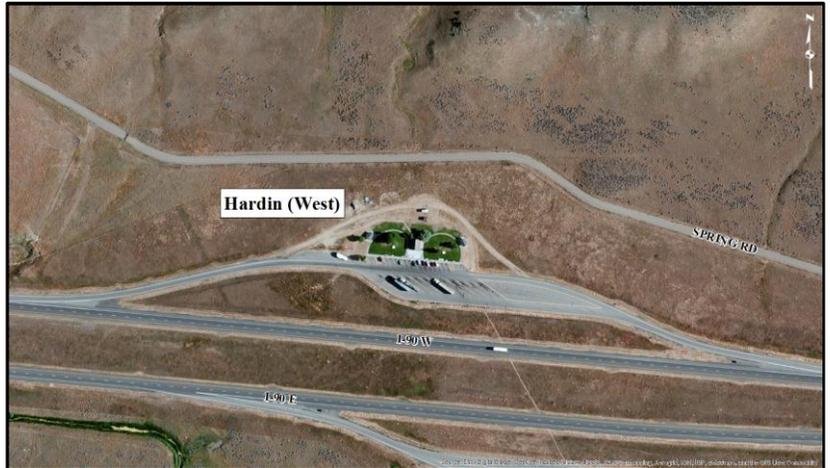
SRA-29 Date: February 28, 2014

Name: Hardin (West) Rest Area
Route: I-90
Direction: West
Reference Post: 476+0.463
Year Built: 1972
Jurisdiction: District 5 – Billings
Maintenance: State Site
AADT (2011): 5750
Health Index: 73.33

Map Number:	SRA-29
Facility:	Hardin (West)
Year Constructed/Reconstructed:	1972
Facility Age (years):	42
Advance Signing:	Yes
Number of Passenger Vehicle Stalls:	14
Number of Oversized Vehicle Stalls:	13
Telephone:	No
Waste Receptacles:	Yes
Number of Restroom Stalls (Women):	3
Number of Restroom Stalls (Men):	3
Sep. ADA/Family Style Restroom:	No
Flush Toilet:	Yes
Vault Toilet:	No
Hand Dryers:	Yes
Advanced WW Treatment:	No
Municipal Water:	No
Municipal Wastewater:	No
Picnic Areas:	Yes
Landscaping/Irrigation:	Yes
Designated Pet Area:	Yes
Vending Machines:	No
Wi-Fi:	No

- Future Considerations:**
- Remaining Service Life for the Parking Area
 - Remaining Service Life for the Structure
 - Source Capability to Meet peak Daily Demand

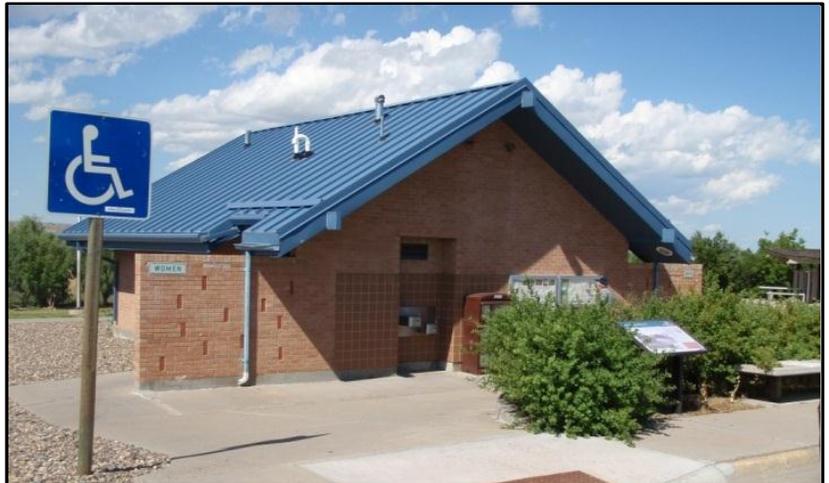
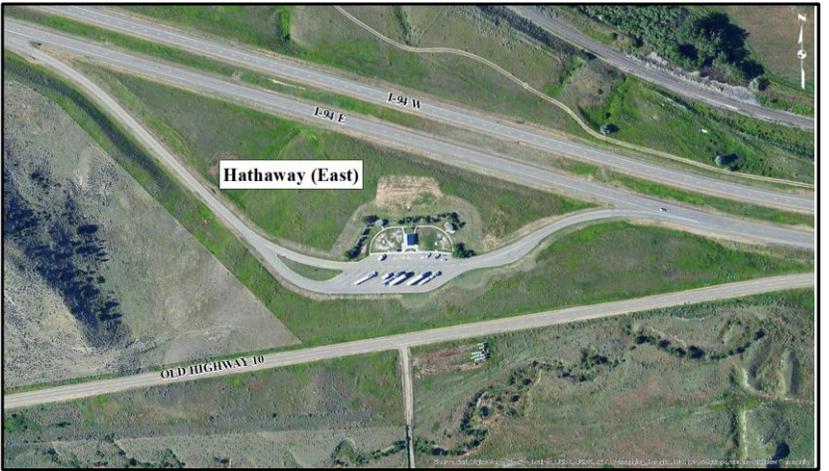
SRA-31 Date: February 28, 2014

Name: Hathaway (East) Rest Area
Route: I-94
Direction: East
Reference Post: 113+0.787
Year Built: 1963
Jurisdiction: District 4 - Glendive
Maintenance: State Site
AADT (2011): 4690
Health Index: 63.67

Map Number:	SRA-31
Facility:	Hathaway (East)
Year Constructed/Reconstructed:	1963
Facility Age (years):	51
Advance Signing:	Yes
Number of Passenger Vehicle Stalls:	11
Number of Oversized Vehicle Stalls:	11
Telephone:	No
Waste Receptacles:	Yes
Number of Restroom Stalls (Women):	3
Number of Restroom Stalls (Men):	3
Sep. ADA/Family Style Restroom:	No
Flush Toilet:	Yes
Vault Toilet:	No
Hand Dryers:	Yes
Advanced WW Treatment:	No
Municipal Water:	No
Municipal Wastewater:	No
Picnic Areas:	Yes
Landscaping/Irrigation:	Yes
Designated Pet Area:	Yes
Vending Machines:	No
Wi-Fi:	No

- Future Considerations:**
- Pavement Striping Quality
 - Remaining Service Life for the Parking Area
 - Remaining Service Life for the Structure
 - Remaining Service Life for the Water System
 - Remaining Service Life for the Wastewater System

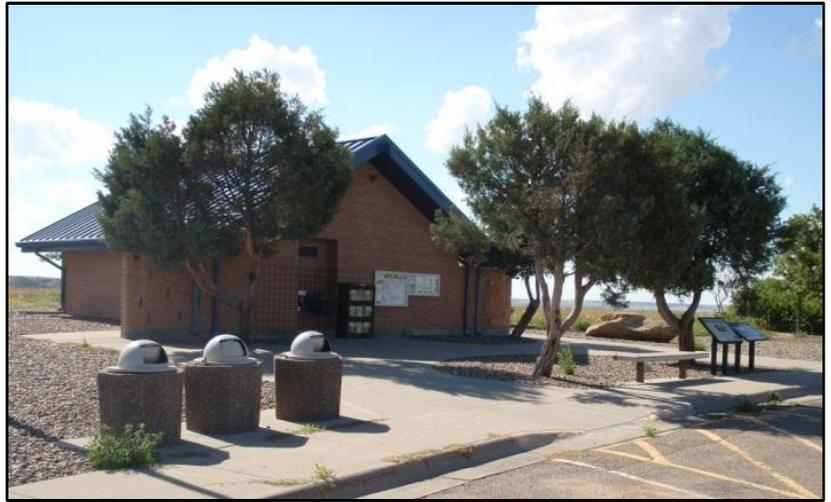
Name: Hathaway (West) Rest Area
Route: I-94
Direction: West
Reference Post: 112+0.400
Year Built: 1963
Jurisdiction: District 4 – Glendive
Maintenance: State Site
AADT (2011): 4690
Health Index: 68.67

Map Number:	SRA-32
Facility:	Hathaway (West)
Year Constructed/Reconstructed:	1963
Facility Age (years):	51
Advance Signing:	Yes
Number of Passenger Vehicle Stalls:	8
Number of Oversized Vehicle Stalls:	12
Telephone:	No
Waste Receptacles:	Yes
Number of Restroom Stalls (Women):	3
Number of Restroom Stalls (Men):	3
Sep. ADA/Family Style Restroom:	No
Flush Toilet:	Yes
Vault Toilet:	Yes
Hand Dryers:	Yes
Advanced WW Treatment:	No
Municipal Water:	No
Municipal Wastewater:	No
Picnic Areas:	Yes
Landscaping/Irrigation:	Yes
Designated Pet Area:	Yes
Vending Machines:	No
Wi-Fi:	No

- Future Considerations:**
- Remaining Service Life for the Parking Area
 - Remaining Service Life for the Structure
 - Remaining Service Life for the Wastewater System

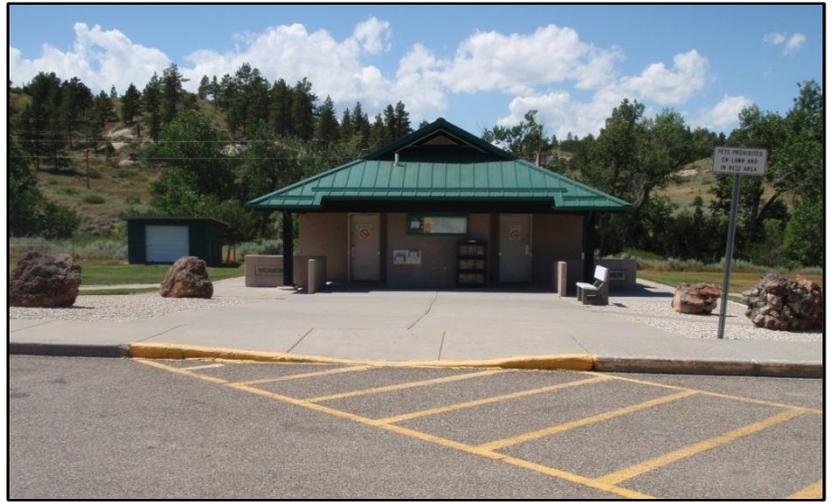
SRA-34 Date: February 28, 2014

Name: Hysham (West) Rest Area
Route: I-94
Direction: West
Reference Post: 064+0.847
Year Built: 1967
Jurisdiction: District 4 – Glendive
Maintenance: State Site
AADT (2011): 4670
Health Index: 61.67

Map Number:	SRA-34
Facility:	Hysham (West)
Year Constructed/Reconstructed:	1967
Facility Age (years):	47
Advance Signing:	Yes
Number of Passenger Vehicle Stalls:	16
Number of Oversized Vehicle Stalls:	4
Telephone:	No
Waste Receptacles:	Yes
Number of Restroom Stalls (Women):	4
Number of Restroom Stalls (Men):	4
Sep. ADA/Family Style Restroom:	No
Flush Toilet:	Yes
Vault Toilet:	No
Hand Dryers:	Yes
Advanced WW Treatment:	No
Municipal Water:	No
Municipal Wastewater:	No
Picnic Areas:	Yes
Landscaping/Irrigation:	Yes
Designated Pet Area:	Yes
Vending Machines:	No
Wi-Fi:	No

- Future Considerations:**
- Number of Oversized Vehicle Parking Stalls
 - Remaining Service Life for the Parking Area
 - Remaining Service Life for the Structure
 - Source Capability to Meet Peak Daily Demand
 - Remaining Service Life for the Water System

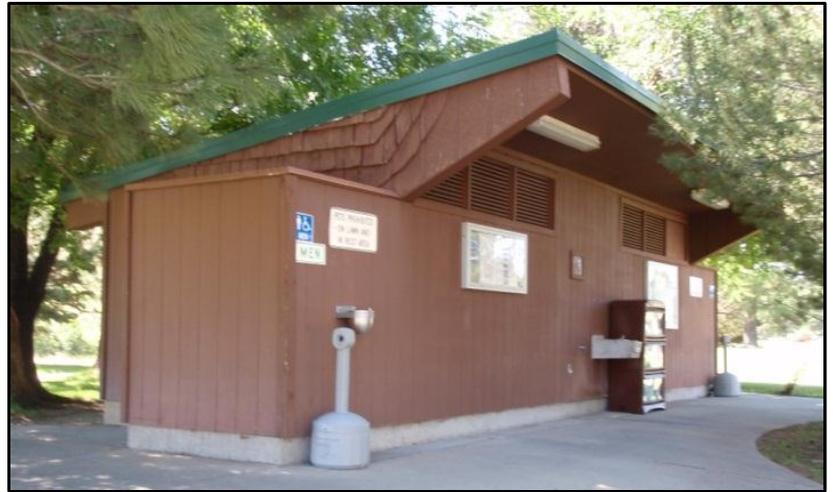
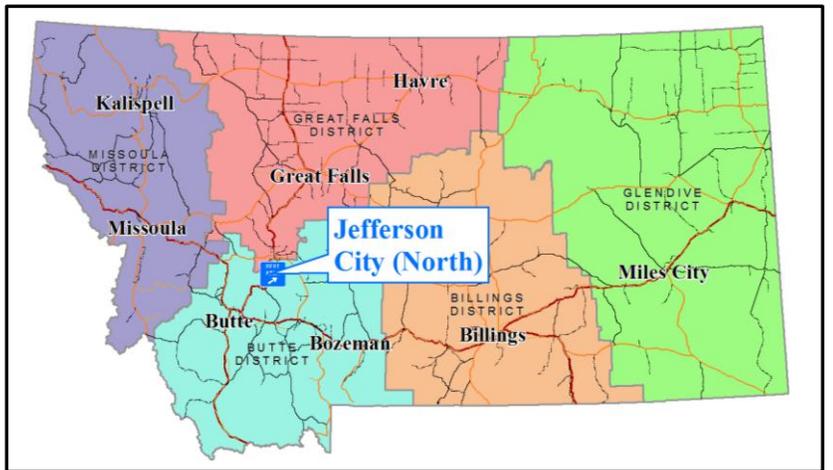
Name: Jefferson City (North) Rest Area
Route: I-15
Direction: North
Reference Post: 177+0.506
Year Built: 1972
Jurisdiction: District 2 – Butte
Maintenance: State Site
AADT (2011): 4060
Health Index: 63.33

Map Number:	SRA-35
Facility:	Jefferson City (N)
Year Constructed/Reconstructed:	1972
Facility Age (years):	42
Advance Signing:	Yes
Number of Passenger Vehicle Stalls:	10
Number of Oversized Vehicle Stalls:	6
Telephone:	No
Waste Receptacles:	Yes
Number of Restroom Stalls (Women):	2
Number of Restroom Stalls (Men):	2
Sep. ADA/Family Style Restroom:	No
Flush Toilet:	Yes
Vault Toilet:	No
Hand Dryers:	Yes
Advanced WW Treatment:	No
Municipal Water:	No
Municipal Wastewater:	No
Picnic Areas:	Yes
Landscaping/Irrigation:	Yes
Designated Pet Area:	Yes
Vending Machines:	No
Wi-Fi:	No

- Future Considerations:**
- Number of Oversized Vehicle Parking Stalls
 - Remaining Service Life for the Parking Area
 - Remaining Service Life for the Structure
 - Remaining Service Life for the Water System
 - Remaining Service Life for the Wastewater System

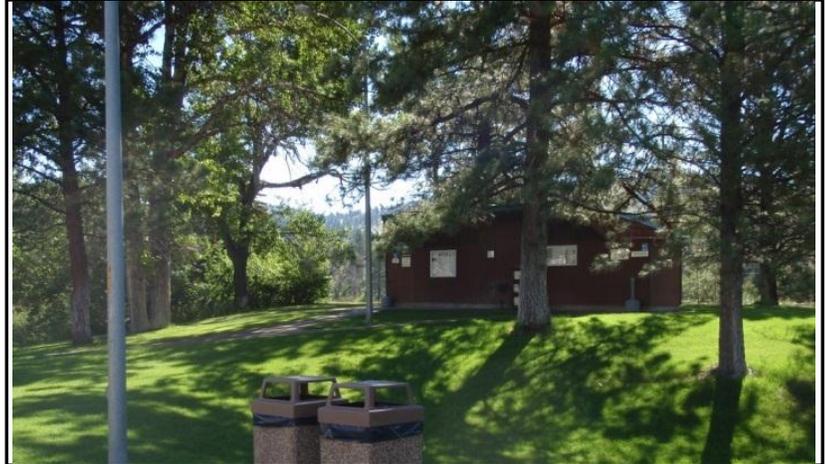
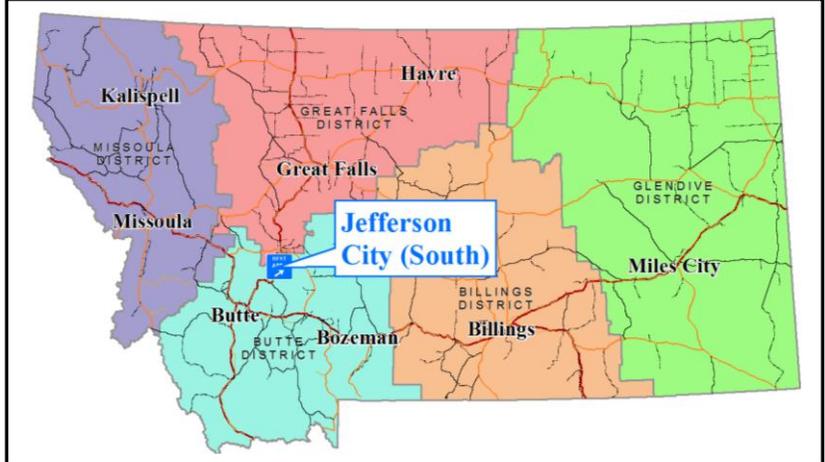
SRA-36 Date: February 28, 2014

Name: Jefferson City (South) Rest Area
Route: I-15
Direction: South
Reference Post: 178+0.233
Year Built: 1972
Jurisdiction: District 2 – Butte
Maintenance: State Site
AADT (2011): 4060
Health Index: 65.00

Map Number:	SRA-36
Facility:	Jefferson City (S)
Year Constructed/Reconstructed:	1972
Facility Age (years):	42
Advance Signing:	Yes
Number of Passenger Vehicle Stalls:	10
Number of Oversized Vehicle Stalls:	4
Telephone:	No
Waste Receptacles:	Yes
Number of Restroom Stalls (Women):	2
Number of Restroom Stalls (Men):	2
Sep. ADA/Family Style Restroom:	No
Flush Toilet:	Yes
Vault Toilet:	No
Hand Dryers:	Yes
Advanced WW Treatment:	No
Municipal Water:	No
Municipal Wastewater:	No
Picnic Areas:	Yes
Landscaping/Irrigation:	Yes
Designated Pet Area:	Yes
Vending Machines:	No
Wi-Fi:	No

- Future Considerations:**
- Number of Oversized Vehicle Parking Stalls
 - Remaining Service Life for the Parking Area
 - Remaining Service Life for the Structure
 - Remaining Service Life for the Water System
 - Remaining Service Life for the Wastewater System

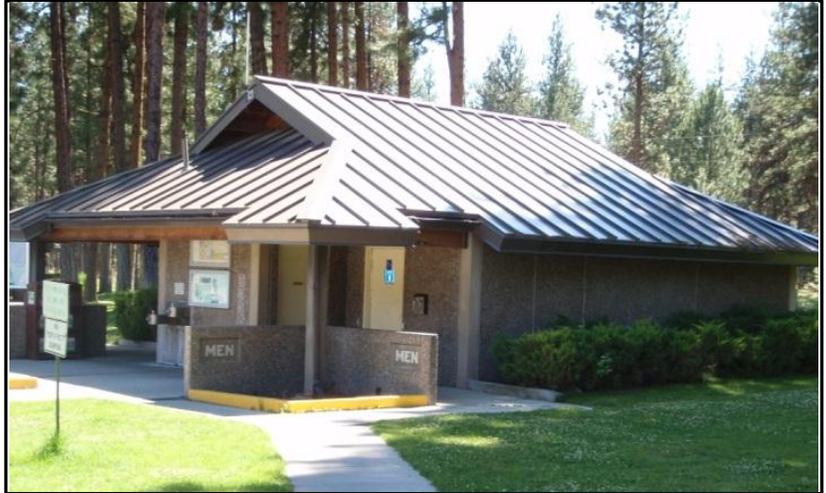
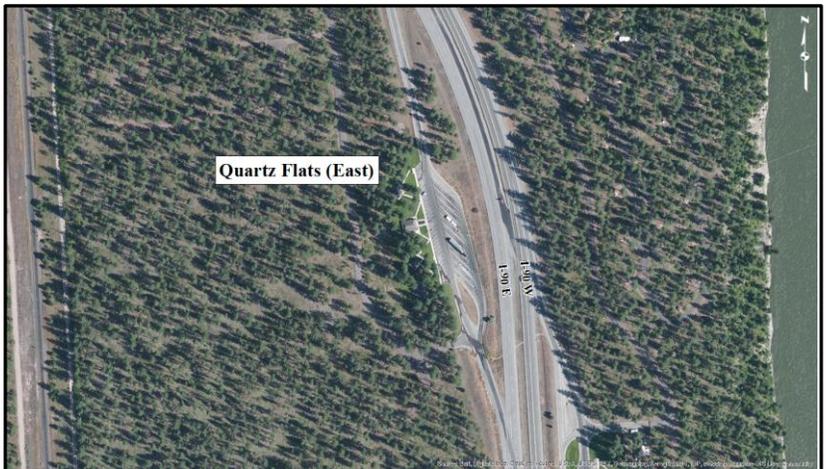
Name: Quartz Flats (East) Rest Area
Route: I-90
Direction: East
Reference Post: 058+0.027
Year Built: 1967
Jurisdiction: District 1 – Missoula
Maintenance: State Site
AADT (2011): 6280
Health Index: 52.33

Map Number:	SRA-40
Facility:	Quarts Flats (East)
Year Constructed/Reconstructed:	1967
Facility Age (years):	47
Advance Signing:	Yes
Number of Passenger Vehicle Stalls:	26
Number of Oversized Vehicle Stalls:	11
Telephone:	No
Waste Receptacles:	Yes
Number of Restroom Stalls (Women):	4
Number of Restroom Stalls (Men):	4
Sep. ADA/Family Style Restroom:	No
Flush Toilet:	Yes
Vault Toilet:	Yes
Hand Dryers:	Yes
Advanced WW Treatment:	No
Municipal Water:	No
Municipal Wastewater:	No
Picnic Areas:	Yes
Landscaping/Irrigation:	Yes
Designated Pet Area:	Yes
Vending Machines:	No
Wi-Fi:	No

- Future Considerations:**
- Number of Oversized Vehicle Parking Stalls
 - Remaining Service Life for the Parking Area
 - Remaining Service Life for the Structure
 - Wastewater Design Flow
 - Drain Field Site Constraints
 - Remaining Service Life for the Wastewater System

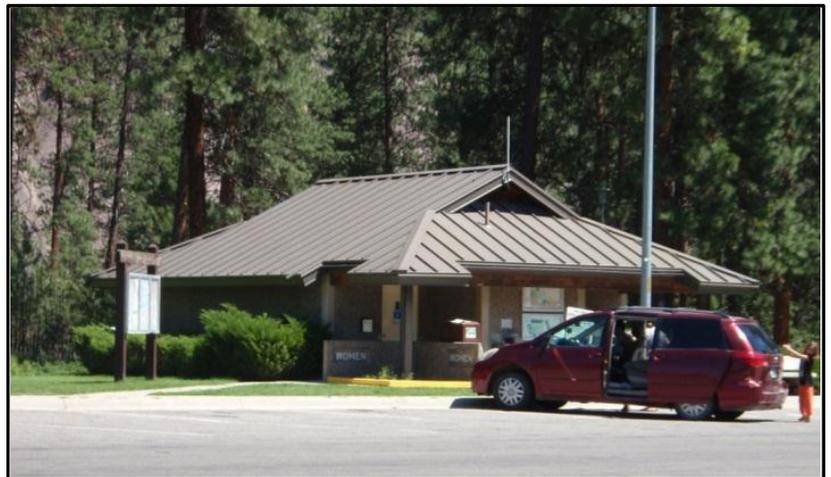
SRA-41 Date: February 28, 2014

Name: Quartz Flats (West) Rest Area
Route: I-90
Direction: West
Reference Post: 058+0.219
Year Built: 1967
Jurisdiction: District 1 – Missoula
Maintenance: State Site
AADT (2011): 6280
Health Index: 48.33

Map Number:	SRA-41
Facility:	Quartz Flats (W)
Year Constructed/Reconstructed:	1967
Facility Age (years):	47
Advance Signing:	Yes
Number of Passenger Vehicle Stalls:	25
Number of Oversized Vehicle Stalls:	10
Telephone:	No
Waste Receptacles:	Yes
Number of Restroom Stalls (Women):	4
Number of Restroom Stalls (Men):	4
Sep. ADA/Family Style Restroom:	No
Flush Toilet:	Yes
Vault Toilet:	Yes
Hand Dryers:	Yes
Advanced WW Treatment:	No
Municipal Water:	No
Municipal Wastewater:	No
Picnic Areas:	Yes
Landscaping/Irrigation:	Yes
Designated Pet Area:	Yes
Vending Machines:	No
Wi-Fi:	No

- Future Considerations:**
- Number of Oversized Vehicle Parking Stalls
 - Remaining Service Life for the Parking Area
 - Remaining Service Life for the Structure
 - Remaining Service Life for the Water System
 - Wastewater Design Flow
 - Drain Field Site Constraints
 - Remaining Service Life for the Wastewater System

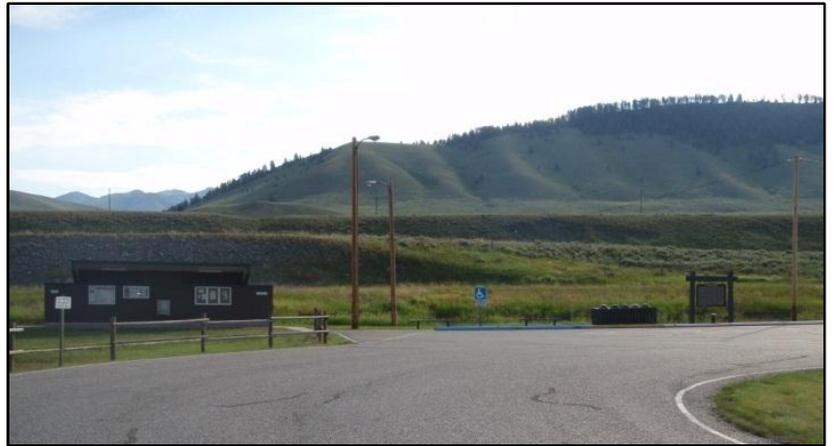
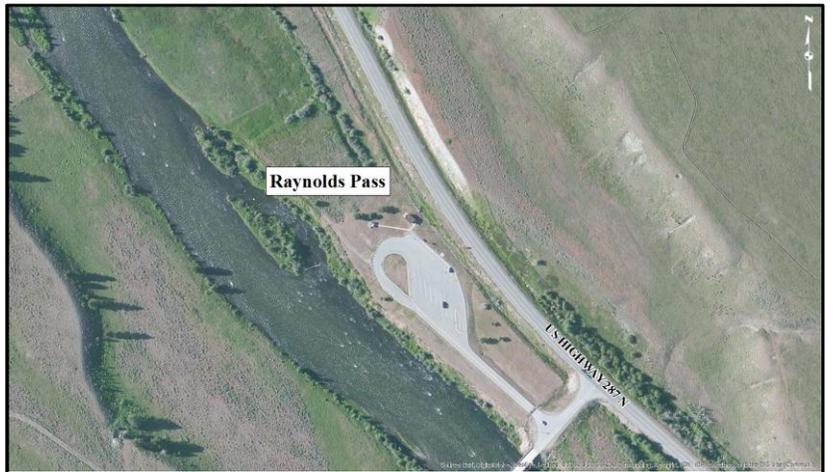
SRA-42 Date: February 28, 2014

Map Number:	SRA-42
Facility:	Reynolds Pass
Year Constructed/Reconstructed:	1969
Facility Age (years):	45
Advance Signing:	Yes
Number of Passenger Vehicle Stalls:	11
Number of Oversized Vehicle Stalls:	9
Telephone:	No
Waste Receptacles:	Yes
Number of Restroom Stalls (Women):	2
Number of Restroom Stalls (Men):	2
Sep. ADA/Family Style Restroom:	No
Flush Toilet:	Yes
Vault Toilet:	No
Hand Dryers:	Yes
Advanced W Treatment:	No
Municipal Water:	No
Municipal Wastewater:	No
Picnic Areas:	Yes
Landscaping/Irrigation:	Yes
Designated Pet Area:	Yes
Vending Machines:	No
Wi-Fi:	No

- Future Considerations:**
- Remaining Service Life for the Parking Area
 - Remaining Service Life for the Structure
 - Source Capability to Meet peak Daily Demand
 - Backflow Prevention
 - Remaining Service Life for the Water System
 - Wastewater Treatment System
 - Remaining Service Life for the Wastewater System

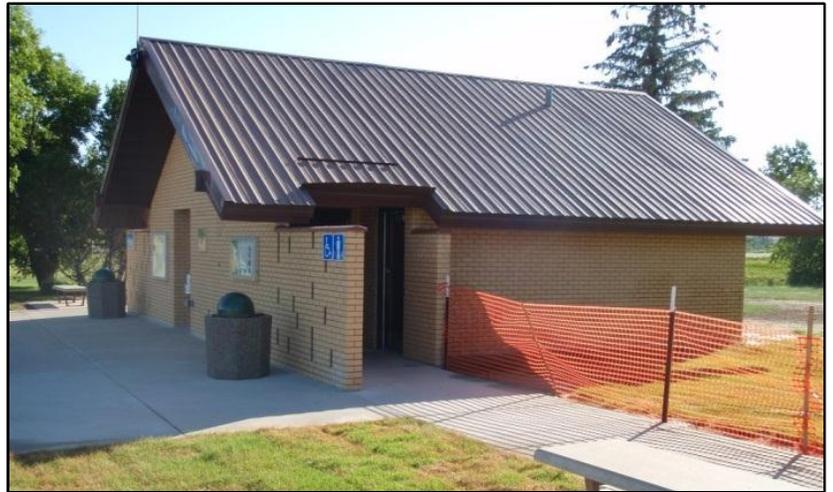
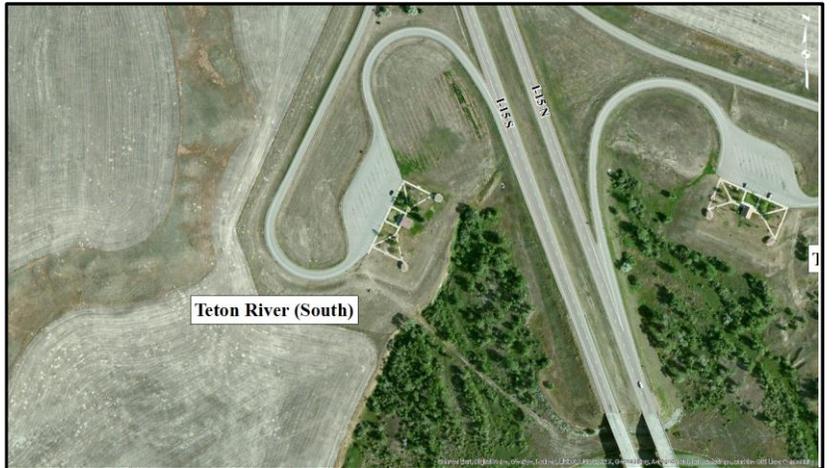
SRA-46 Date: February 28, 2014

Map Number:	SRA-46
Facility:	Teton River (South)
Year Constructed/Reconstructed:	1978
Facility Age (years):	36
Advance Signing:	Yes
Number of Passenger Vehicle Stalls:	21
Number of Oversized Vehicle Stalls:	10
Telephone:	No
Waste Receptacles:	Yes
Number of Restroom Stalls (Women):	3
Number of Restroom Stalls (Men):	3
Sep. ADA/Family Style Restroom:	Yes
Flush Toilet:	Yes
Vault Toilet:	No
Hand Dryers:	Yes
Advanced WW Treatment:	No
Municipal Water:	Yes
Municipal Wastewater:	No
Picnic Areas:	Yes
Landscaping/Irrigation:	Yes
Designated Pet Area:	Yes
Vending Machines:	No
Wi-Fi:	No

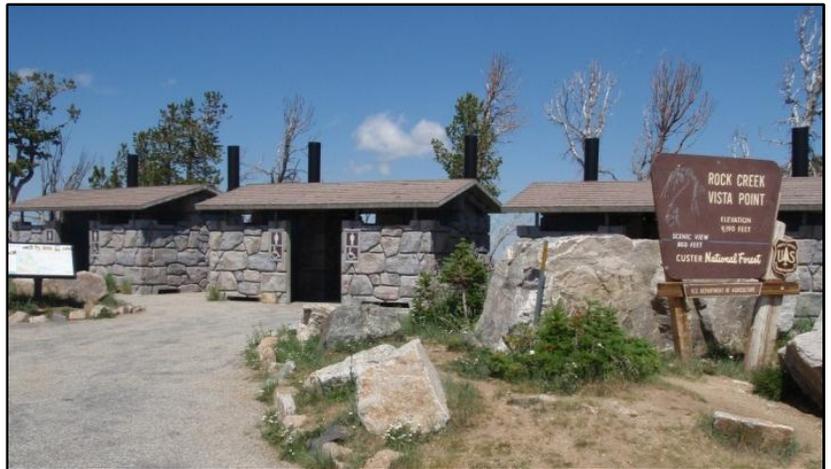
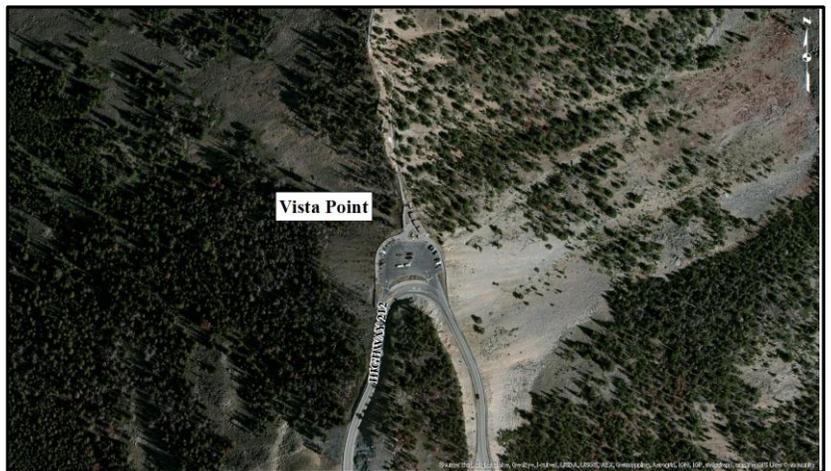
SRA-49 Date: February 28, 2014

Map Number:	SRA-49
Facility:	Vista Point
Year Constructed/Reconstructed:	1995
Facility Age (years):	19
Advance Signing:	Yes
Number of Passenger Vehicle Stalls:	20
Number of Oversized Vehicle Stalls:	5
Telephone:	Yes
Waste Receptacles:	Yes
Number of Restroom Stalls (Women):	0
Number of Restroom Stalls (Men):	0
Sep. ADA/Family Style Restroom:	No
Flush Toilet:	No
Vault Toilet:	Yes
Hand Dryers:	No
Advanced WW Treatment:	No
Municipal Water:	No
Municipal Wastewater:	No
Picnic Areas:	No
Landscaping/Irrigation:	No
Designated Pet Area:	No
Vending Machines:	No
Wi-Fi:	No

- Future Considerations:**
- Remaining Service Life for the Parking Area
 - Exterior Lighting
 - Picnic Areas
 - Facility Ventilation
 - Interior Lighting
 - Restroom Plumbing Fixtures

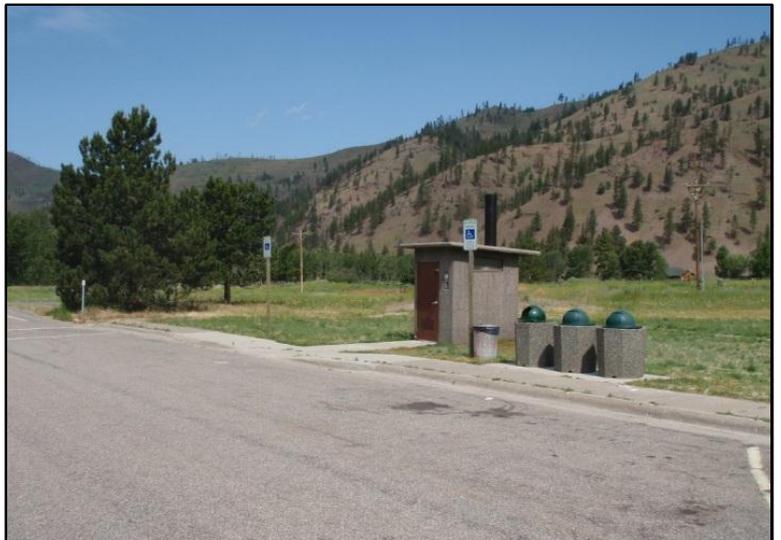
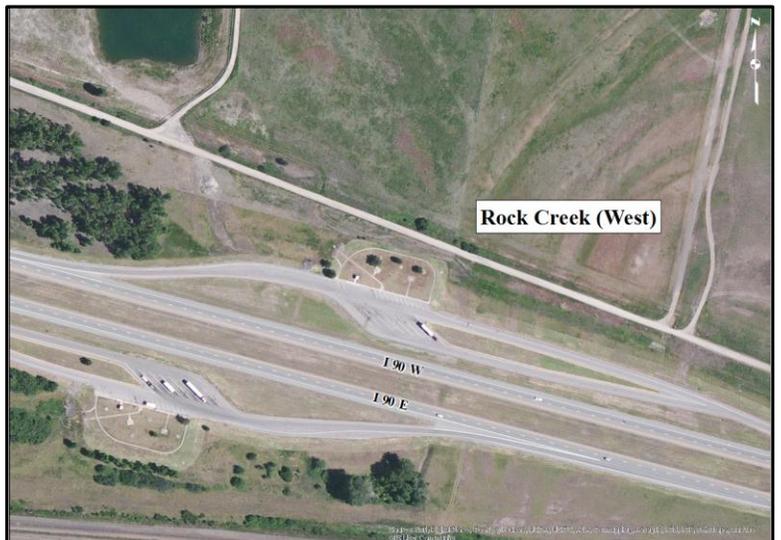
Name: Rock Creek (West) Parking Area
Route: I-90
Direction: West
Reference Post: 127+0.561
Year Built: Unknown
Jurisdiction: District 1 – Missoula
Maintenance: State Site
AADT (2011): 8630

Map Number:	SPA-14
Facility:	Rock Creek (West)
Year Constructed/Reconstructed:	Unknown
Facility Age (years):	Unknown
Advance Signing:	Yes
Number of Passenger Vehicle Stalls:	12
Number of Oversized Vehicle Stalls:	7
Telephone:	No
Waste Receptacles:	Yes
Number of Restroom Stalls (Women):	0
Number of Restroom Stalls (Men):	0
Sep. ADA/Family Style Restroom:	No
Flush Toilet:	No
Vault Toilet:	Yes
Hand Dryers:	No
Advanced WW Treatment:	No
Municipal Water:	No
Municipal Wastewater:	No
Picnic Area:	No
Landscaping/Irrigation:	No
Designated Pet Area:	No
Vending Machines:	No
Wi-Fi:	No

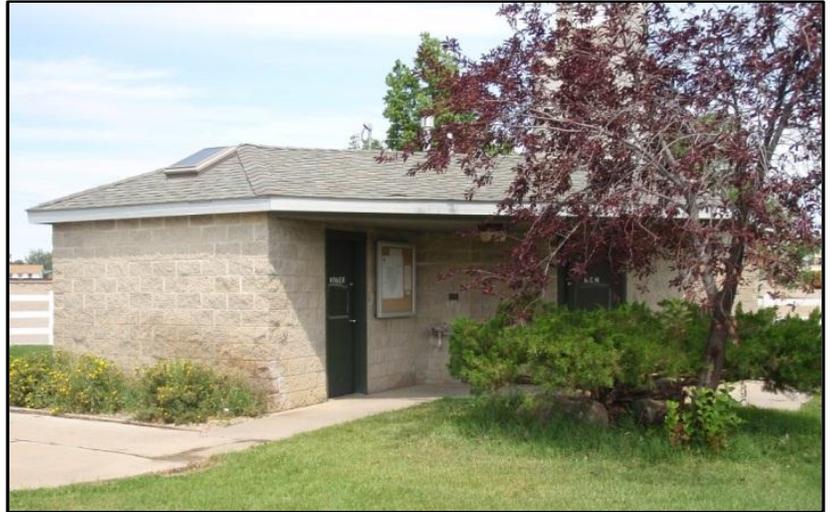
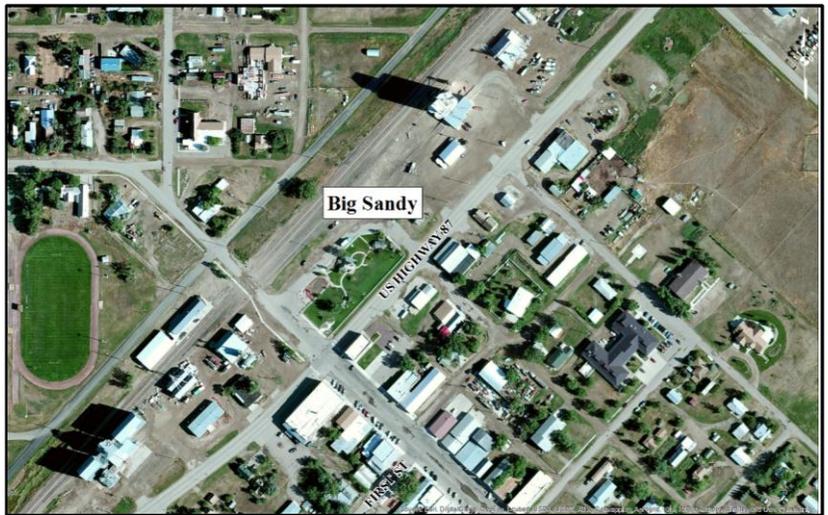
CPRA-1 Date: February 28, 2014

Name: Big Sandy City Park Rest Area
Route: US 87 (N-10)
Direction: North
Reference Post: 079+0.290
Year Built: 1991
Jurisdiction: District 3 – Great Falls
Maintenance: City Site
AADT (2011): 1980

Map Number:	CPRA-1
Facility:	Big Sandy
Year Constructed/Reconstructed:	1991
Facility Age (years):	23
Advance Signing:	Yes
Number of Passenger Vehicle Stalls:	14
Number of Oversized Vehicle Stalls:	4
Telephone:	No
Waste Receptacles:	Yes
Number of Restroom Stalls (Women):	1
Number of Restroom Stalls (Men):	1
Sep. ADA/Family Style Restroom:	No
Flush Toilet:	Yes
Vault Toilet:	No
Hand Dryers:	Yes
Advanced WW Treatment:	No
Municipal Water:	Yes
Municipal Wastewater:	Yes
Picnic Areas:	Yes
Landscaping/Irrigation:	Yes
Designated Pet Area:	No
Vending Machines:	Yes
Wi-Fi:	No

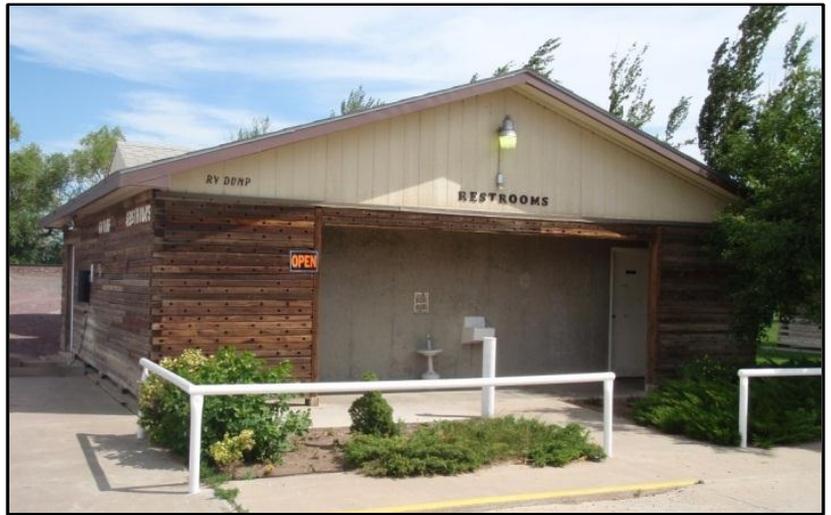
CPRA-2 Date: February 28, 2014

Name: Chester City Park Rest Area
Route: US 2 (N-1)
Direction: East
Reference Post: 322+0.302
Year Built: 1986
Jurisdiction: District 3 – Great Falls
Maintenance: City Site
AADT (2011): 2080

Map Number:	CPRA-2
Facility:	Chester
Year Constructed/Reconstructed:	1986
Facility Age (years):	28
Advance Signing:	Yes
Number of Passenger Vehicle Stalls:	30
Number of Oversized Vehicle Stalls:	0
Telephone:	No
Waste Receptacles:	Yes
Number of Restroom Stalls (Women):	2
Number of Restroom Stalls (Men):	2
Sep. ADA/Family Style Restroom:	No
Flush Toilet:	Yes
Vault Toilet:	Yes
Hand Dryers:	Yes
Advanced WW Treatment:	No
Municipal Water:	Yes
Municipal Wastewater:	Yes
Picnic Areas:	Yes
Landscaping/Irrigation:	No
Designated Pet Area:	Yes
Vending Machines:	No
Wi-Fi:	No

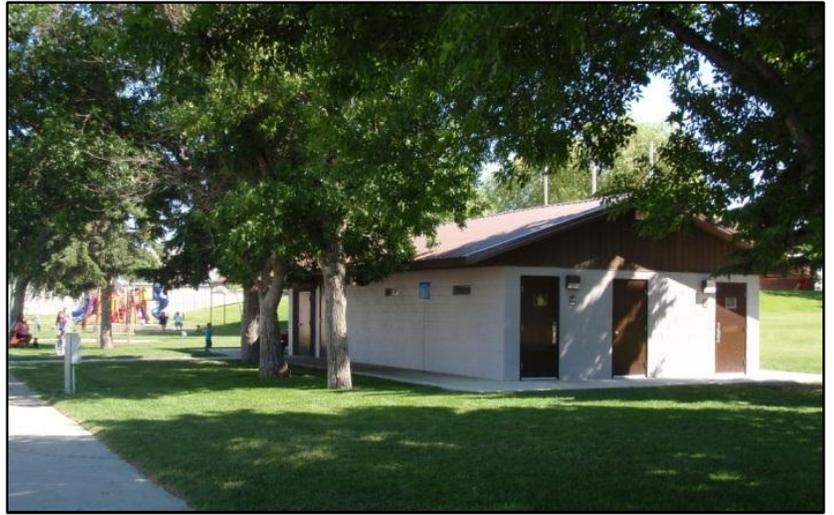
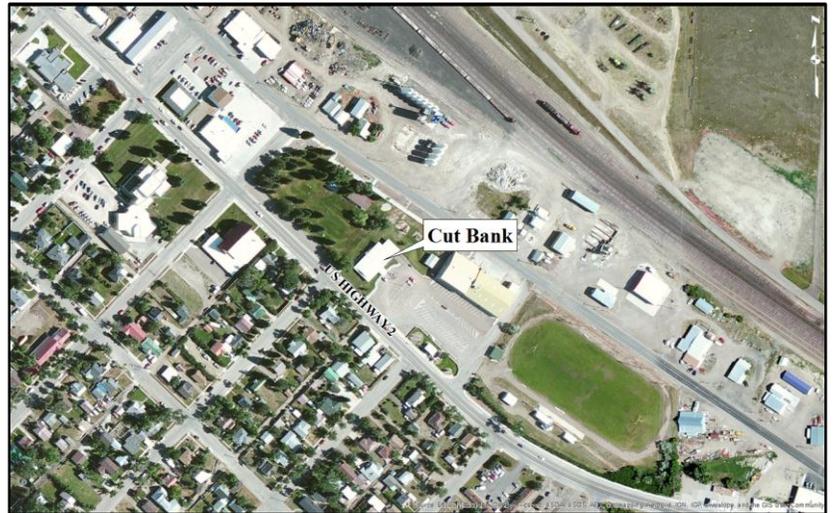
CPRA-3 Date: February 28, 2014

Name: Cut Bank City Park Rest Area
Route: US 2 (N-1)
Direction: West
Reference Post: 255+0.649
Year Built: 1988
Jurisdiction: District 3 – Great Falls
Maintenance: City Site
AADT (2011): 2760

Map Number:	CPRA-3
Facility:	Cut Bank
Year Constructed/Reconstructed:	1988
Facility Age (years):	26
Advance Signing:	Yes
Number of Passenger Vehicle Stalls:	28
Number of Oversized Vehicle Stalls:	0
Telephone:	No
Waste Receptacles:	No
Number of Restroom Stalls (Women):	4
Number of Restroom Stalls (Men):	4
Sep. ADA/Family Style Restroom:	No
Flush Toilet:	Yes
Vault Toilet:	No
Hand Dryers:	Yes
Advanced WW Treatment:	No
Municipal Water:	Yes
Municipal Wastewater:	Yes
Picnic Areas:	Yes
Landscaping/Irrigation:	Yes
Designated Pet Area:	No
Vending Machines:	No
Wi-Fi:	No

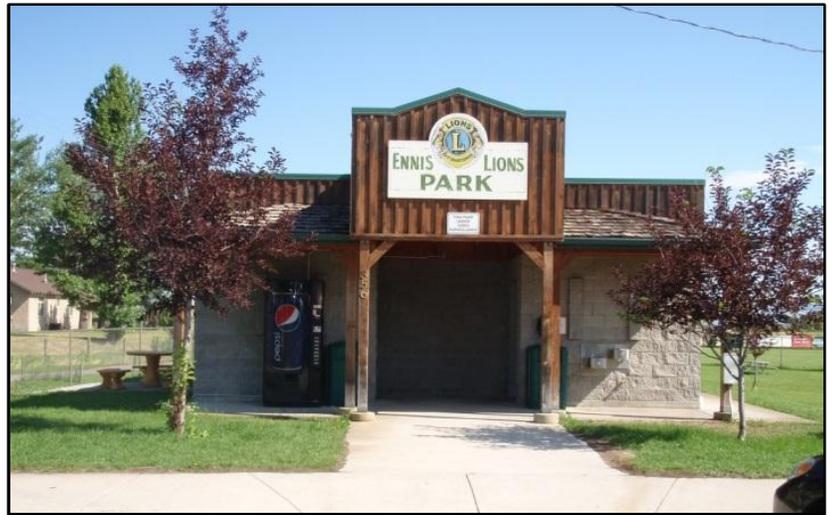
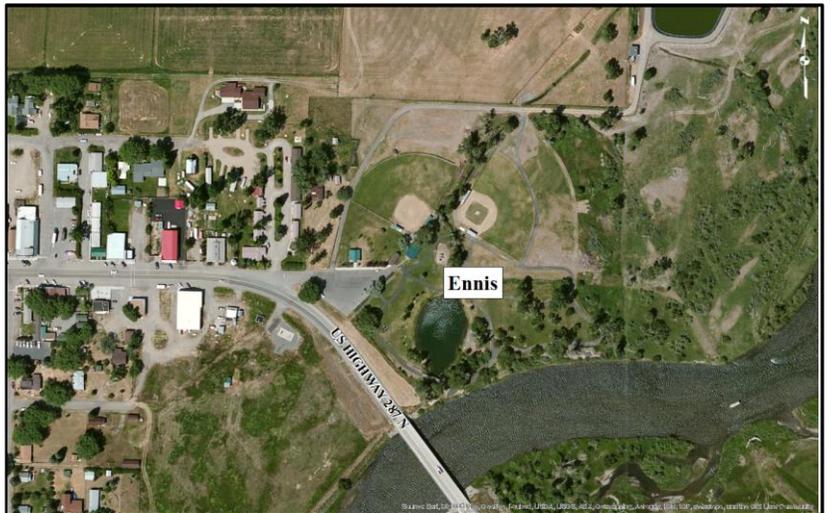
CPRA-4 Date: February 28, 2014

Name: Ennis City Park Rest Area
Route: US 287 (P-13)
Direction: North
Reference Post: 048+0.649
Year Built: 1999
Jurisdiction: District 2 – Butte
Maintenance: City Site
AADT (2011): 2510

Map Number:	CPRA-4
Facility:	Ennis
Year Constructed/Reconstructed:	1999
Facility Age (years):	15
Advance Signing:	No
Number of Passenger Vehicle Stalls:	30
Number of Oversized Vehicle Stalls:	0
Telephone:	No
Waste Receptacles:	Yes
Number of Restroom Stalls (Women):	2
Number of Restroom Stalls (Men):	2
Sep. ADA/Family Style Restroom:	No
Flush Toilet:	Yes
Vault Toilet:	No
Hand Dryers:	Yes
Advanced WW Treatment:	No
Municipal Water:	Yes
Municipal Wastewater:	Yes
Picnic Areas:	Yes
Landscaping/Irrigation:	Yes
Designated Pet Area:	No
Vending Machines:	Yes
Wi-Fi:	No

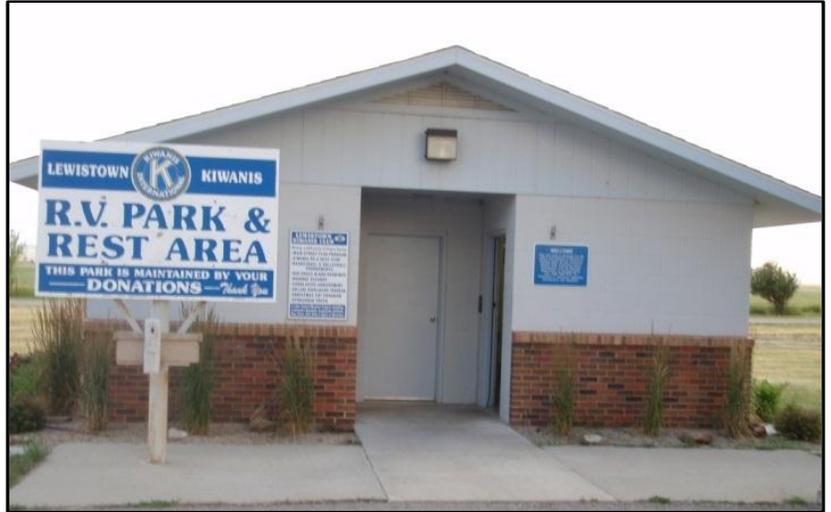
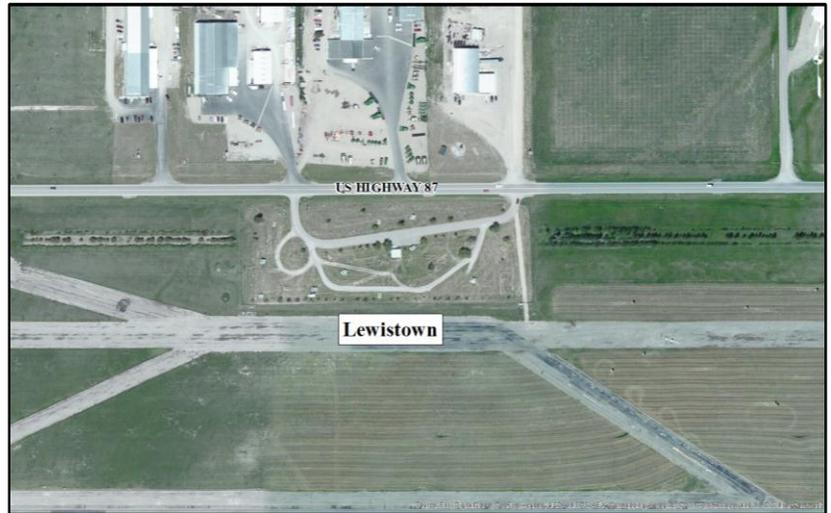
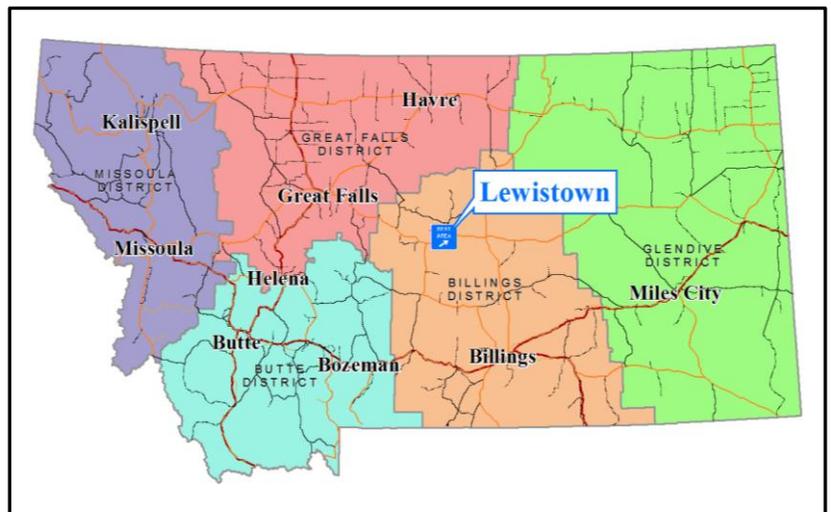
CPRA-5 Date: February 28, 2014

Name: Lewistown City Park Rest Area
Route: US 87 (N-57)
Direction: East
Reference Post: 080+0.399
Year Built: 1998
Jurisdiction: District 5 - Billings
Maintenance: City Site
AADT (2011): 2510

Map Number:	CPRA-5
Facility:	Lewistown
Year Constructed/Reconstructed:	1998
Facility Age (years):	16
Advance Signing:	No
Number of Passenger Vehicle Stalls:	8
Number of Oversized Vehicle Stalls:	0
Telephone:	No
Waste Receptacles:	Yes
Number of Restroom Stalls (Women):	2
Number of Restroom Stalls (Men):	2
Sep. ADA/Family Style Restroom:	No
Flush Toilet:	Yes
Vault Toilet:	No
Hand Dryers:	Yes
Advanced WW Treatment:	No
Municipal Water:	Yes
Municipal Wastewater:	Yes
Picnic Areas:	Yes
Landscaping/Irrigation:	No
Designated Pet Area:	No
Vending Machines:	No
Wi-Fi:	No
