Montana Rest Area Plan Update

APPENDIX B TECHNICAL MEMORANDUM

DOWL HKM

May 2014

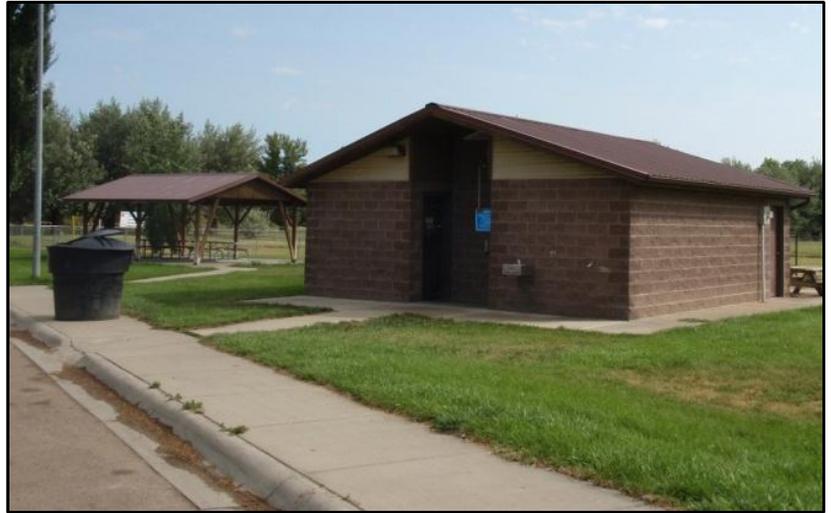
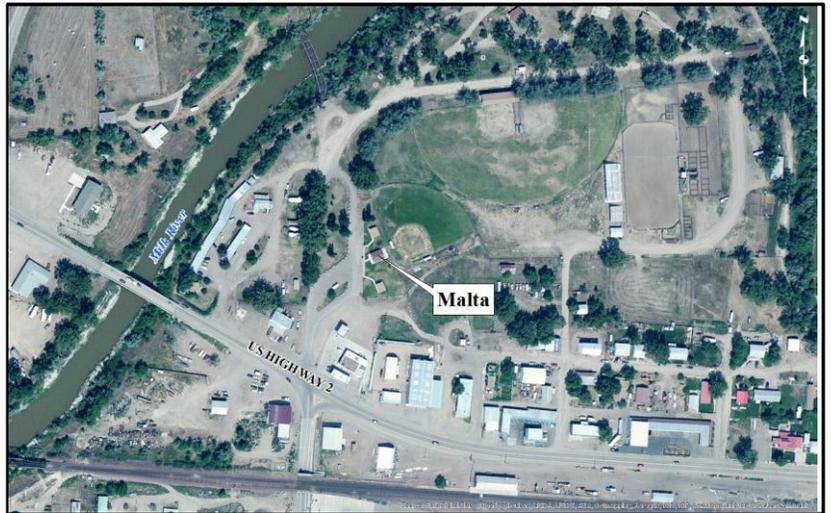
CPRA-6 Date: February 28, 2014

Name: Malta City Park Rest Area
Route: US 2 (N-1)
Direction: West
Reference Post: 471+0.811
Year Built: 1992
Jurisdiction: District 4 - Glendive
Maintenance: City Site
AADT (2011): 3000

Map Number:	CPRA-6
Facility:	Malta
Year Constructed/Reconstructed:	1992
Facility Age (years):	22
Advance Signing:	Yes
Number of Passenger Vehicle Stalls:	8
Number of Oversized Vehicle Stalls:	0
Telephone:	No
Waste Receptacles:	Yes
Number of Restroom Stalls (Women):	2
Number of Restroom Stalls (Men):	2
Sep. ADA/Family Style Restroom:	No
Flush Toilet:	Yes
Vault Toilet:	No
Hand Dryers:	Yes
Advanced WW Treatment:	No
Municipal Water:	Yes
Municipal Wastewater:	Yes
Picnic Areas:	Yes
Landscaping/Irrigation:	Yes
Designated Pet Area:	Yes
Vending Machines:	No
Wi-Fi:	No

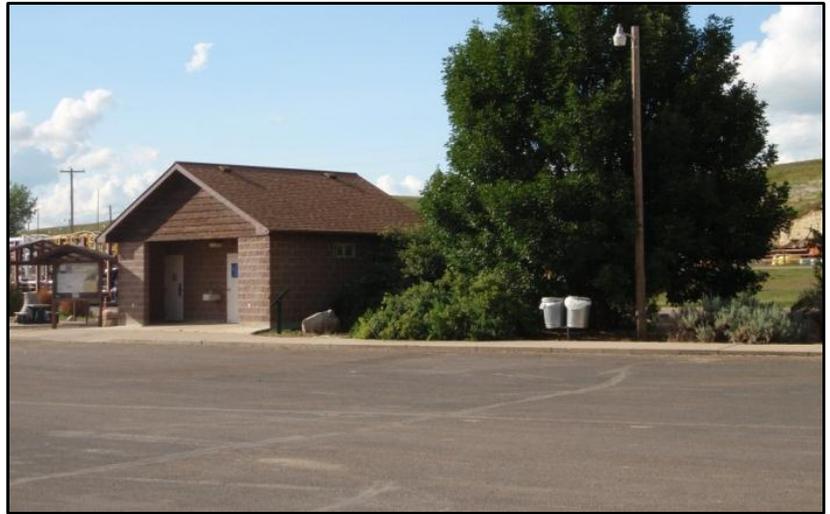
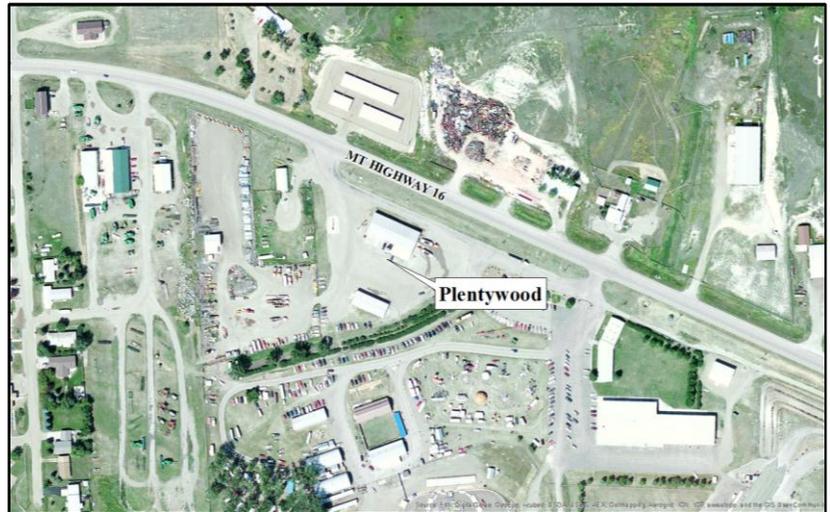
CPRA-7 Date: February 28, 2014

Name: Plentywood City Park Rest Area
Route: MT 5 & MT 16 (N-22)
Direction: South
Reference Post: 042+0.581
Year Built: 1992
Jurisdiction: District 4 – Glendive
Maintenance: City Site
AADT (2011): 2180

Map Number:	CPRA-7
Facility:	Plentywood
Year Constructed/Reconstructed:	1992
Facility Age (years):	22
Advance Signing:	Yes
Number of Passenger Vehicle Stalls:	24
Number of Oversized Vehicle Stalls:	0
Telephone:	No
Waste Receptacles:	Yes
Number of Restroom Stalls (Women):	2
Number of Restroom Stalls (Men):	2
Sep. ADA/Family Style Restroom:	No
Flush Toilet:	Yes
Vault Toilet:	No
Hand Dryers:	Yes
Advanced WW Treatment:	No
Municipal Water:	Yes
Municipal Wastewater:	Yes
Picnic Areas:	Yes
Landscaping/Irrigation:	N/A
Designated Pet Area:	No
Vending Machines:	No
Wi-Fi:	No

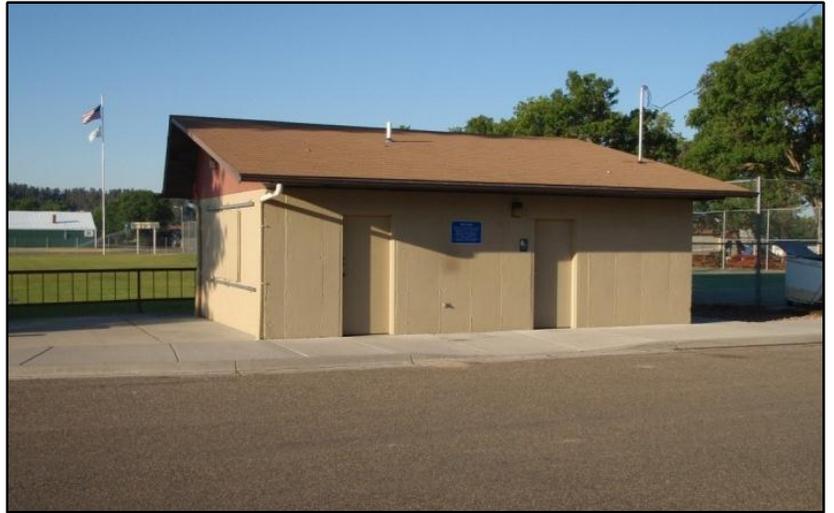
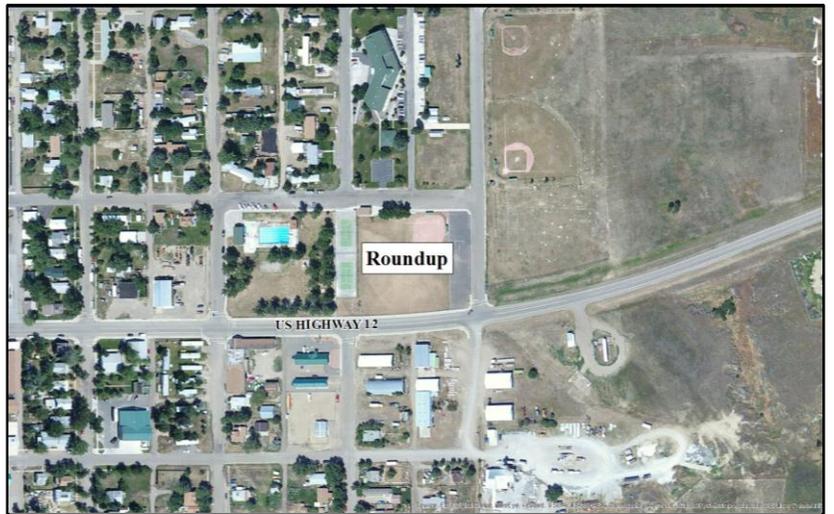
CPRA-8 Date: February 28, 2014

Name: Roundup City Park Rest Area
Route: US 12 (N-14)
Direction: West
Reference Post: 169+0.705
Year Built: 1996
Jurisdiction: District 5 – Billings
Maintenance: City Site
AADT (2011): 1490

Map Number:	CPRA-8
Facility:	Roundup
Year Constructed/Reconstructed:	1996
Facility Age (years):	18
Advance Signing:	Yes
Number of Passenger Vehicle Stalls:	24
Number of Oversized Vehicle Stalls:	0
Telephone:	No
Waste Receptacles:	Yes
Number of Restroom Stalls (Women):	1
Number of Restroom Stalls (Men):	1
Sep. ADA/Family Style Restroom:	No
Flush Toilet:	Yes
Vault Toilet:	No
Hand Dryers:	Yes
Advanced WW Treatment:	No
Municipal Water:	Yes
Municipal Wastewater:	Yes
Picnic Areas:	Yes
Landscaping/Irrigation:	Yes
Designated Pet Area:	No
Vending Machines:	No
Wi-Fi:	No

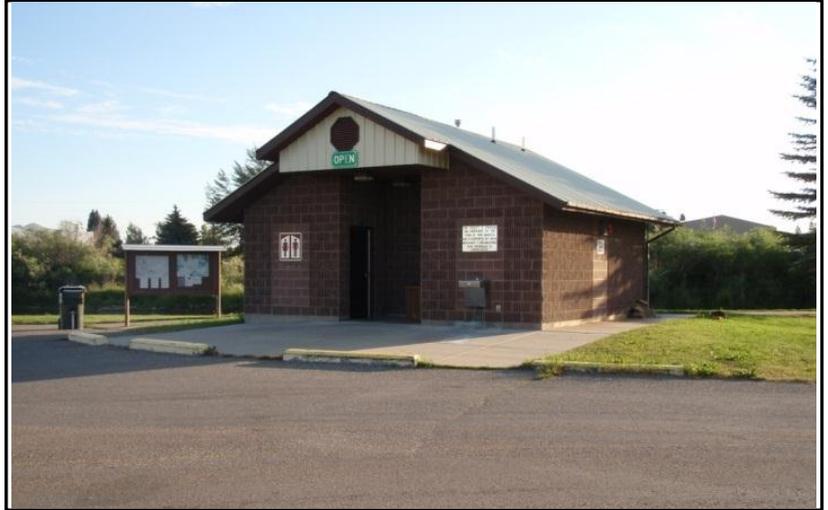
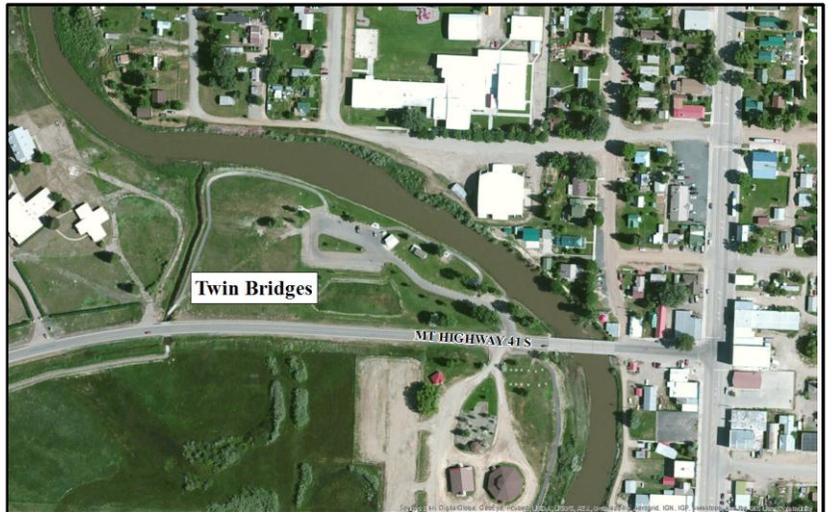
CPRA-9 Date: February 28, 2014

Name: Twin Bridges City Park Rest Area
Route: MT 41 (P-49)
Direction: South
Reference Post: 027+0.393
Year Built: 1993
Jurisdiction: District 2 – Butte
Maintenance: City Site
AADT (2011): 2320

Map Number:	CPRA-9
Facility:	Twin Bridges
Year Constructed/Reconstructed:	1993
Facility Age (years):	21
Advance Signing:	Yes
Number of Passenger Vehicle Stalls:	17
Number of Oversized Vehicle Stalls:	4
Telephone:	No
Waste Receptacles:	Yes
Number of Restroom Stalls (Women):	2
Number of Restroom Stalls (Men):	2
Sep. ADA/Family Style Restroom:	Yes
Flush Toilet:	Yes
Vault Toilet:	No
Hand Dryers:	Yes
Advanced WW Treatment:	No
Municipal Water:	Yes
Municipal Wastewater:	Yes
Picnic Areas:	Yes
Landscaping/Irrigation:	Yes
Designated Pet Area:	Yes
Vending Machines:	No
Wi-Fi:	No

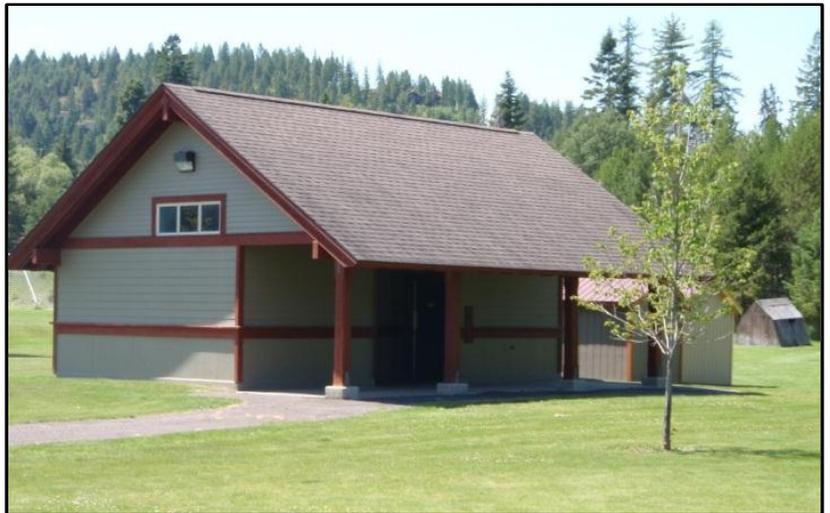
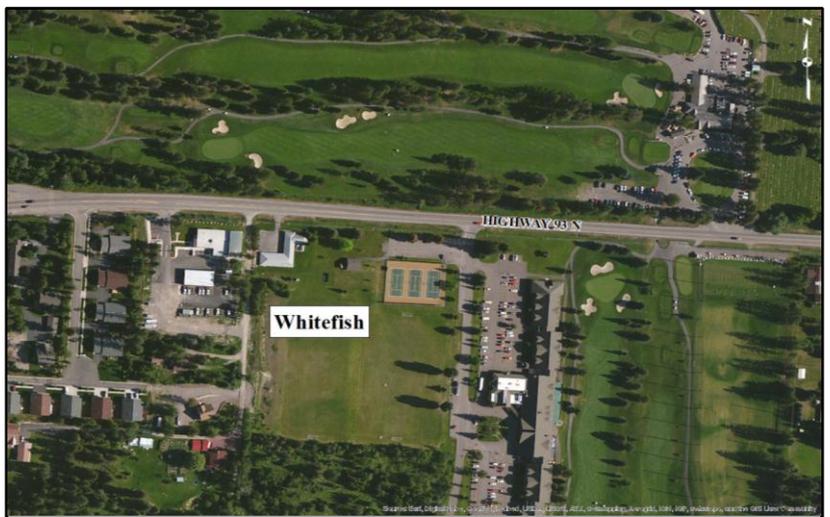
CPRA-10 Date: February 28, 2014

Name: Whitefish City Park Rest Area
Route: US 93 (N-5)
Direction: South
Reference Post: 128+0.965
Year Built: 1996
Jurisdiction: District 1 – Missoula
Maintenance: City Site
AADT (2011): 6510

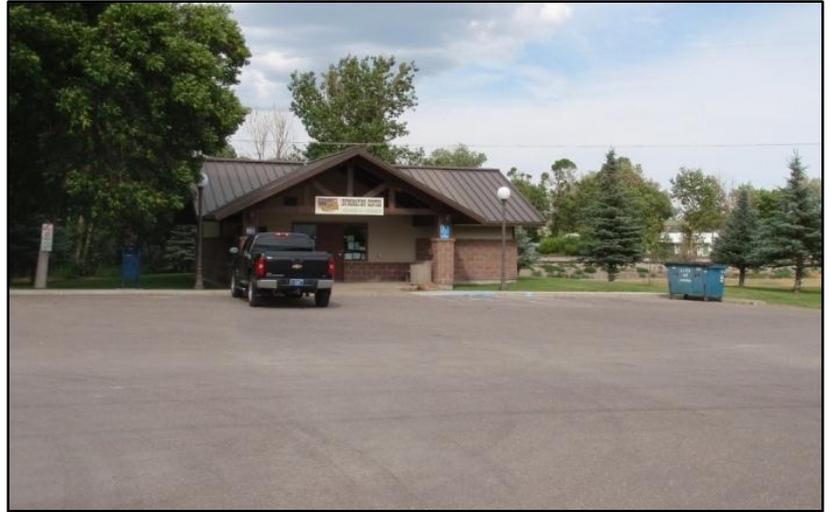
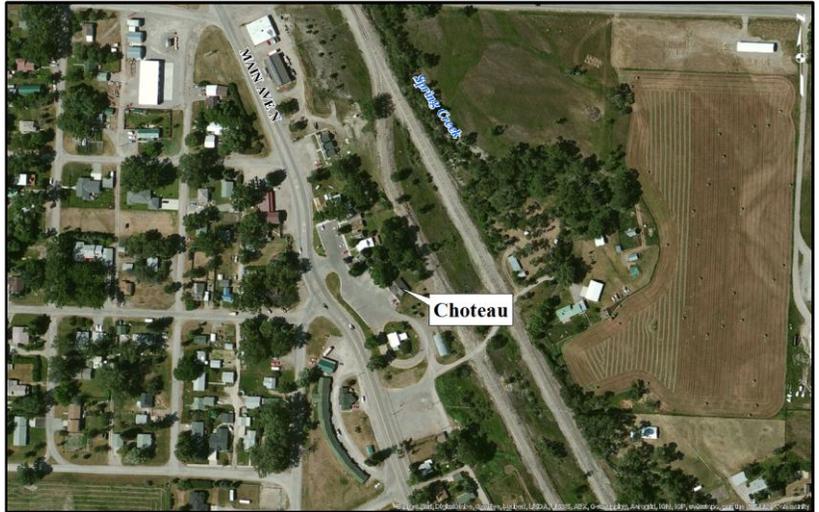
Name: Choteau Rest Area
Route: (US 89) P-3
Direction: North
Reference Post: 0+41.790
Year Built: 1998
Jurisdiction: District 3 – Great Falls
Maintenance: City Site
AADT (2011): 2140

Map Number:	OS-1
Facility:	Choteau
Year Constructed/Reconstructed:	1998
Facility Age (years):	16
Advance Signing:	Yes
Number of Passenger Vehicle Stalls:	8
Number of Oversized Vehicle Stalls:	0
Telephone:	No
Waste Receptacles:	Yes
Number of Restroom Stalls (Women):	2
Number of Restroom Stalls (Men):	2
Sep. ADA/Family Style Restroom:	No
Flush Toilet:	Yes
Vault Toilet:	No
Hand Dryers:	Yes
Advanced WW Treatment:	Unknown
Municipal Water:	Unknown
Municipal Wastewater:	Unknown
Picnic Areas:	Yes
Landscaping/Irrigation:	Yes
Designated Pet Area:	Yes
Vending Machines:	Yes
Wi-Fi:	No

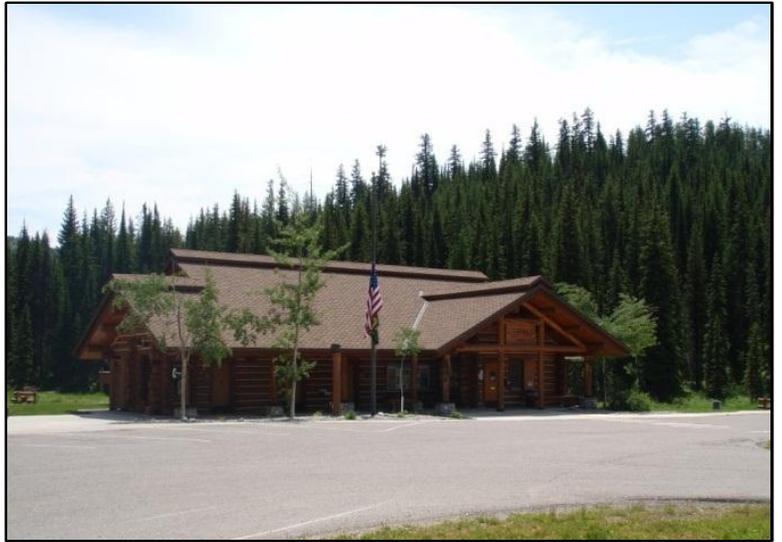
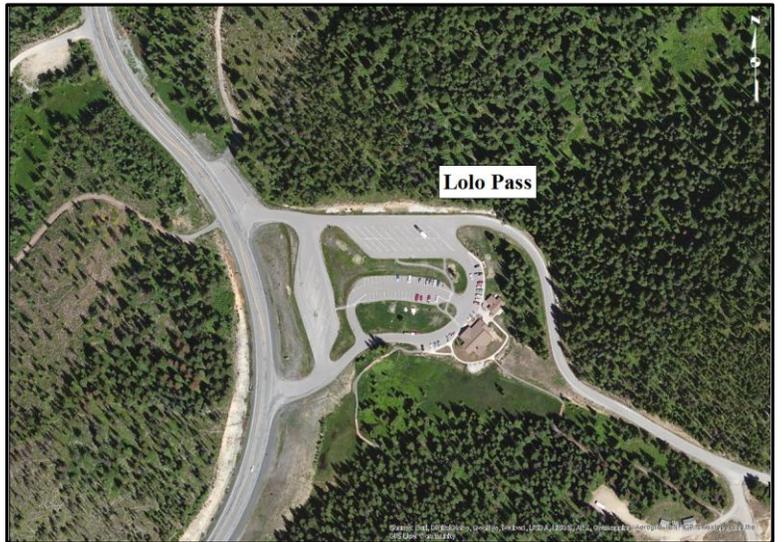
Name: Lolo Pass Parking Area
Route: US 12 (N-93)
Direction: North
Reference Post: 000+0.000
Year Built: Unknown
Jurisdiction: District 1 – Missoula
Maintenance: Other Site
AADT (2011): 790

Map Number:	OS-2
Facility:	Lolo Pass
Year Constructed/Reconstructed:	Unknown
Facility Age (years):	Unknown
Advance Signing:	Yes
Number of Passenger Vehicle Stalls:	56
Number of Oversized Vehicle Stalls:	15
Telephone:	Yes
Waste Receptacles:	Yes
Number of Restroom Stalls (Women):	3
Number of Restroom Stalls (Men):	3
Sep. ADA/Family Style Restroom:	Yes
Flush Toilet:	Yes
Vault Toilet:	No
Hand Dryers:	Yes
Advanced WW Treatment:	Unknown
Municipal Water:	Unknown
Municipal Wastewater:	Unknown
Picnic Area:	Yes
Landscaping/Irrigation:	Yes
Designated Pet Area:	Yes
Vending Machines:	No
Wi-Fi:	Yes

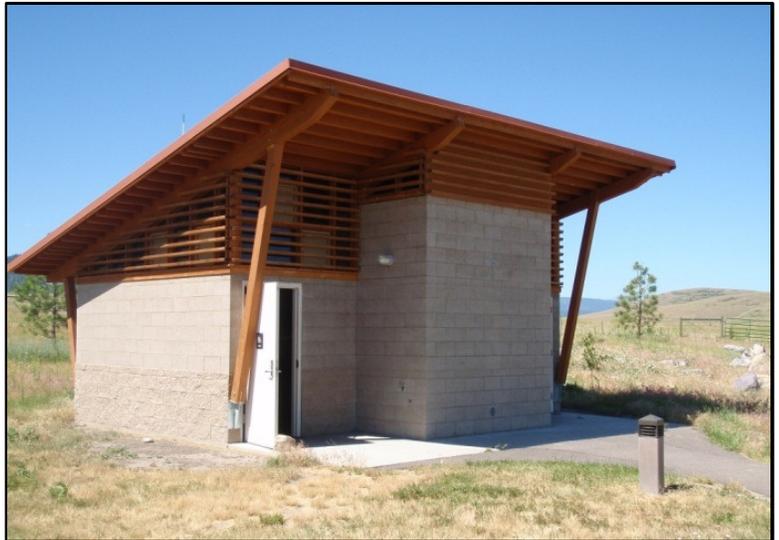
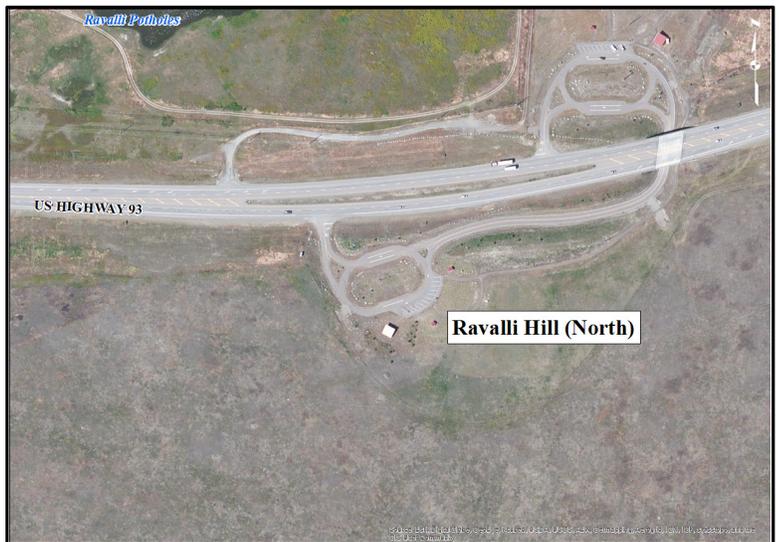
Name: Ravalli Hill (North) Rest Area
Route: US 93 (N-5)
Direction: North
Reference Post: 029+0.145
Year Built: Unknown
Jurisdiction: District 1 - Missoula
Maintenance: Other Site
AADT (2011): 5740

Map Number:	OS-3
Facility:	Ravalli Hill (North)
Year Constructed/Reconstructed:	Unknown
Facility Age (years):	Unknown
Advance Signing:	Yes
Number of Passenger Vehicle Stalls:	11
Number of Oversized Vehicle Stalls:	3
Telephone:	No
Waste Receptacles:	Yes
Number of Restroom Stalls (Women):	2
Number of Restroom Stalls (Men):	2
Sep. ADA/Family Style Restroom:	No
Flush Toilet:	Yes
Vault Toilet:	No
Hand Dryers:	Yes
Advanced WW Treatment:	Unknown
Municipal Water:	Unknown
Municipal Wastewater:	Unknown
Picnic Area:	Yes
Landscaping/Irrigation:	No
Designated Pet Area:	No
Vending Machines:	No
Wi-Fi:	No

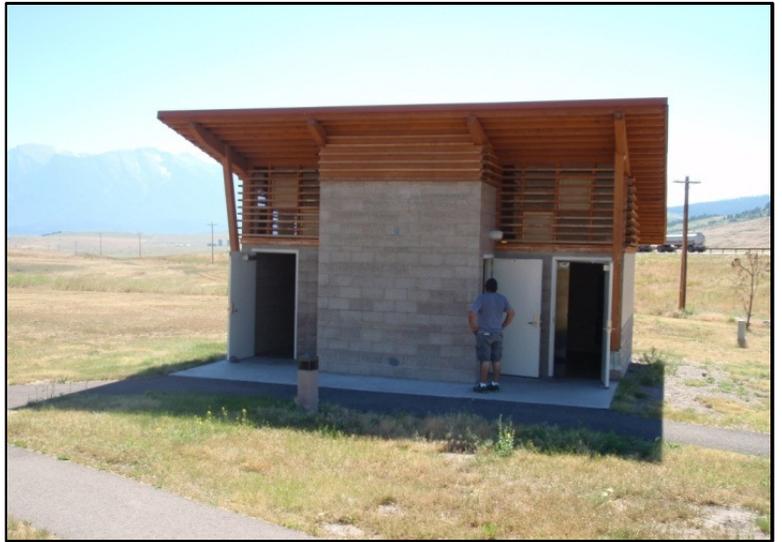
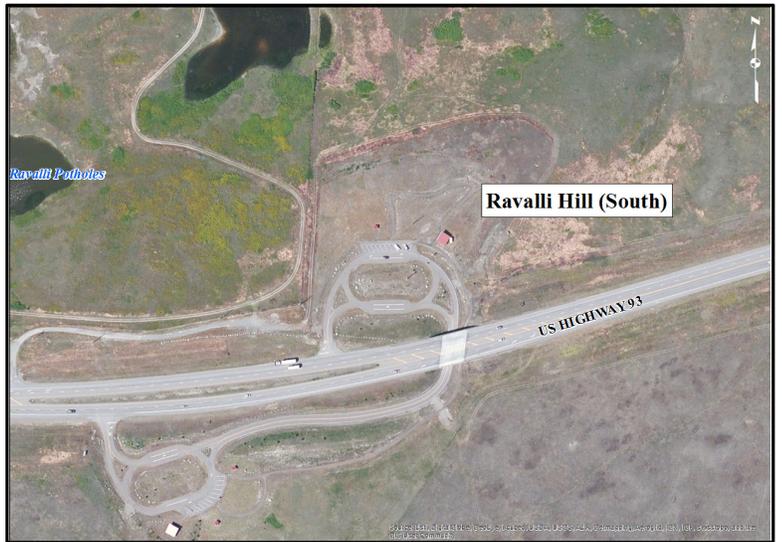
Name: Ravalli Hill (South) Rest Area
Route: US 93 (N-5)
Direction: South
Reference Post: 029+0.268
Year Built: Unknown
Jurisdiction: District 1 – Missoula
Maintenance: Other Site
AADT (2011): 5740

Map Number:	OS-4
Facility:	Ravalli Hill (South)
Year Constructed/Reconstructed:	Unknown
Facility Age (years):	Unknown
Advance Signing:	Yes
Number of Passenger Vehicle Stalls:	10
Number of Oversized Vehicle Stalls:	3
Telephone:	No
Waste Receptacles:	Yes
Number of Restroom Stalls (Women):	2
Number of Restroom Stalls (Men):	2
Sep. ADA/Family Style Restroom:	No
Flush Toilet:	Yes
Vault Toilet:	No
Hand Dryers:	Yes
Advanced WW Treatment:	Unknown
Municipal Water:	Unknown
Municipal Wastewater:	Unknown
Picnic Area:	Yes
Landscaping/Irrigation:	No
Designated Pet Area:	No
Vending Machines:	No
Wi-Fi:	No

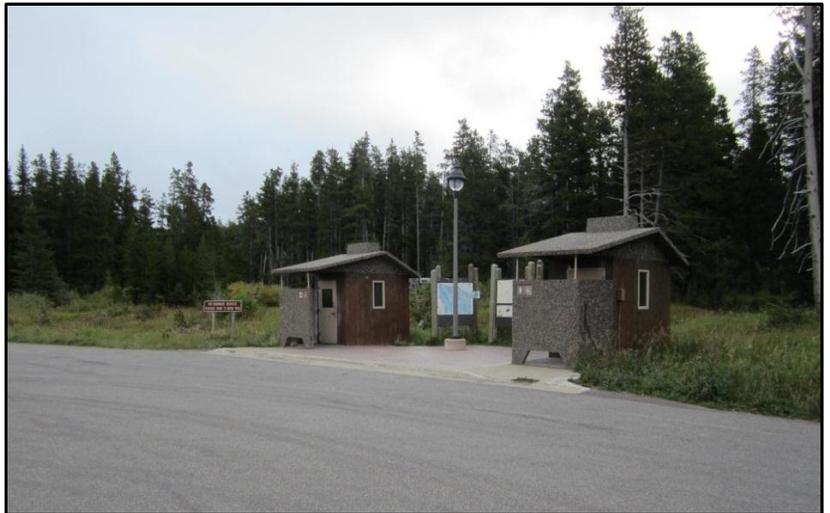
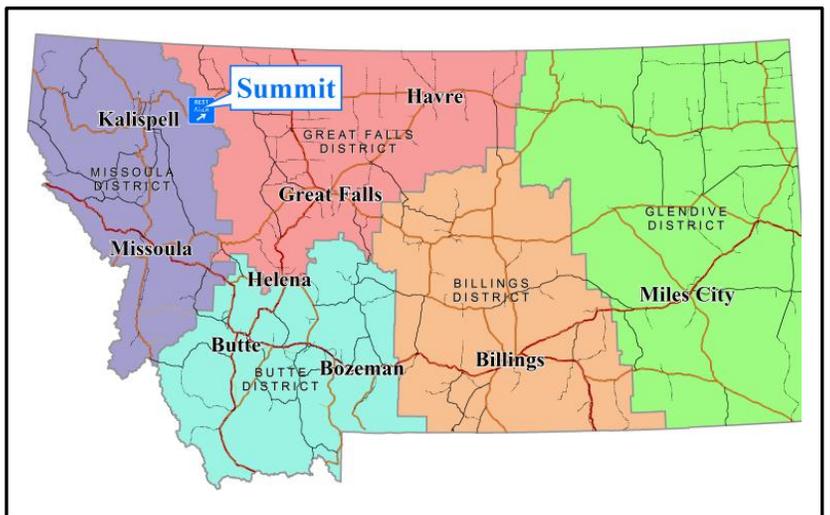
Name: Summit Rest Area
Route: US 2 (N-1)
Direction: East
Reference Post: 197+00.67
Year Built: Unknown
Jurisdiction: District 1 – Missoula
Maintenance: Other Site
AADT (2011): 1500

Map Number:	OS-5
Facility:	Summit
Year Constructed/Reconstructed:	Unknown
Facility Age (years):	Unknown
Advance Signing:	No
Number of Passenger Vehicle Stalls:	24
Number of Oversized Vehicle Stalls:	9
Telephone:	No
Waste Receptacles:	Yes
Number of Restroom Stalls (Women):	0
Number of Restroom Stalls (Men):	0
Sep. ADA/Family Style Restroom:	Yes
Flush Toilet:	No
Vault Toilet:	Yes
Hand Dryers:	No
Advanced WW Treatment:	No
Municipal Water:	No
Municipal Wastewater:	No
Picnic Areas:	No
Landscaping/Irrigation:	No
Designated Pet Area:	No
Vending Machines:	No
Wi-Fi:	No

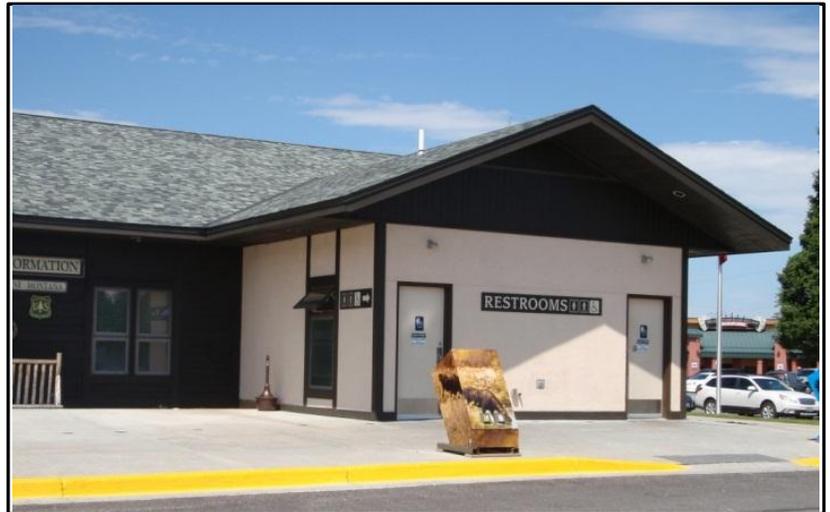
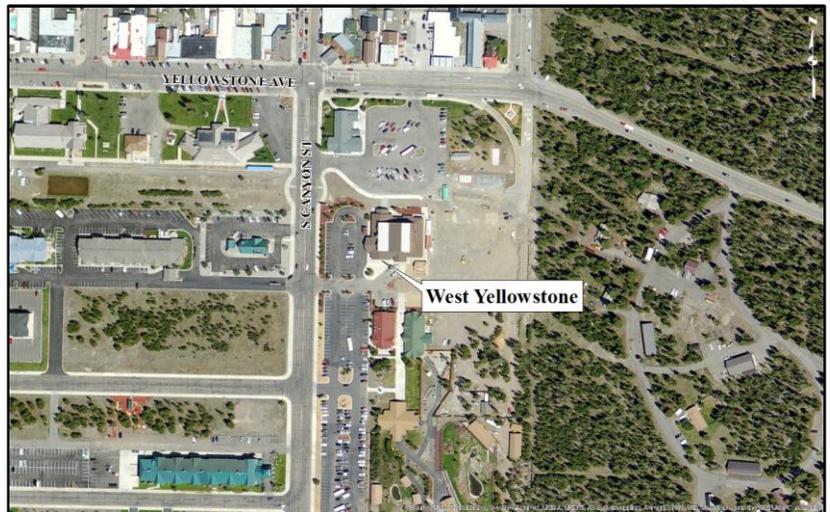
Name: West Yellowstone Rest Area
Route: US 287 (N-50)
Direction: South
Reference Post: 000+0.080
Year Built: 1997
Jurisdiction: District 2 – Butte
Maintenance: Other Site
AADT (2011): 4720

Map Number:	OS-6
Facility:	West Yellowstone
Year Constructed/Reconstructed:	1997
Facility Age (years):	17
Advance Signing:	No
Number of Passenger Vehicle Stalls:	52
Number of Oversized Vehicle Stalls:	0
Telephone:	No
Waste Receptacles:	Yes
Number of Restroom Stalls (Women):	4
Number of Restroom Stalls (Men):	4
Sep. ADA/Family Style Restroom:	Yes
Flush Toilet:	Yes
Vault Toilet:	No
Hand Dryers:	Yes
Advanced WW Treatment:	Unknown
Municipal Water:	Unknown
Municipal Wastewater:	Unknown
Picnic Areas:	Yes
Landscaping/Irrigation:	N/A
Designated Pet Area:	No
Vending Machines:	No
Wi-Fi:	No

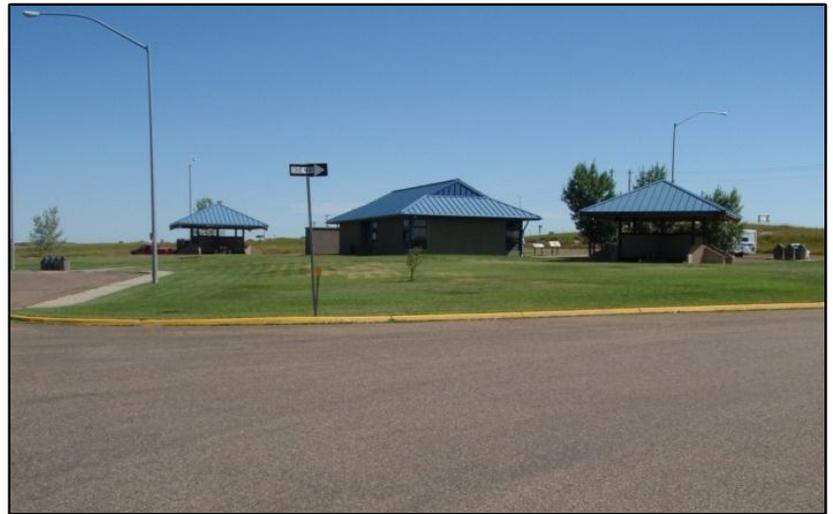
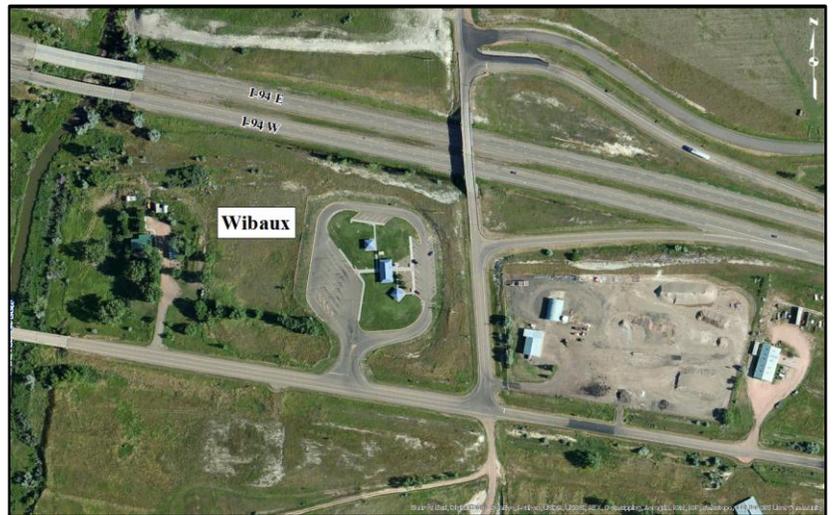
Name: Wibaux Rest Area
Route: I-94
Direction: East
Reference Post: 242+0.408
Year Built: 2001
Jurisdiction: District 4 – Glendive
Maintenance: Other Site
AADT (2011): 2860

Map Number:	OS-7
Facility:	Wibaux
Year Constructed/Reconstructed:	2001
Facility Age (years):	13
Advance Signing:	Yes
Number of Passenger Vehicle Stalls:	27
Number of Oversized Vehicle Stalls:	8
Telephone:	No
Waste Receptacles:	Yes
Number of Restroom Stalls (Women):	2
Number of Restroom Stalls (Men):	2
Sep. ADA/Family Style Restroom:	No
Flush Toilet:	Yes
Vault Toilet:	No
Hand Dryers:	Yes
Advanced WW Treatment:	Unknown
Municipal Water:	Unknown
Municipal Wastewater:	Unknown
Picnic Areas:	Yes
Landscaping/Irrigation:	Yes
Designated Pet Area:	Yes
Vending Machines:	No
Wi-Fi:	No

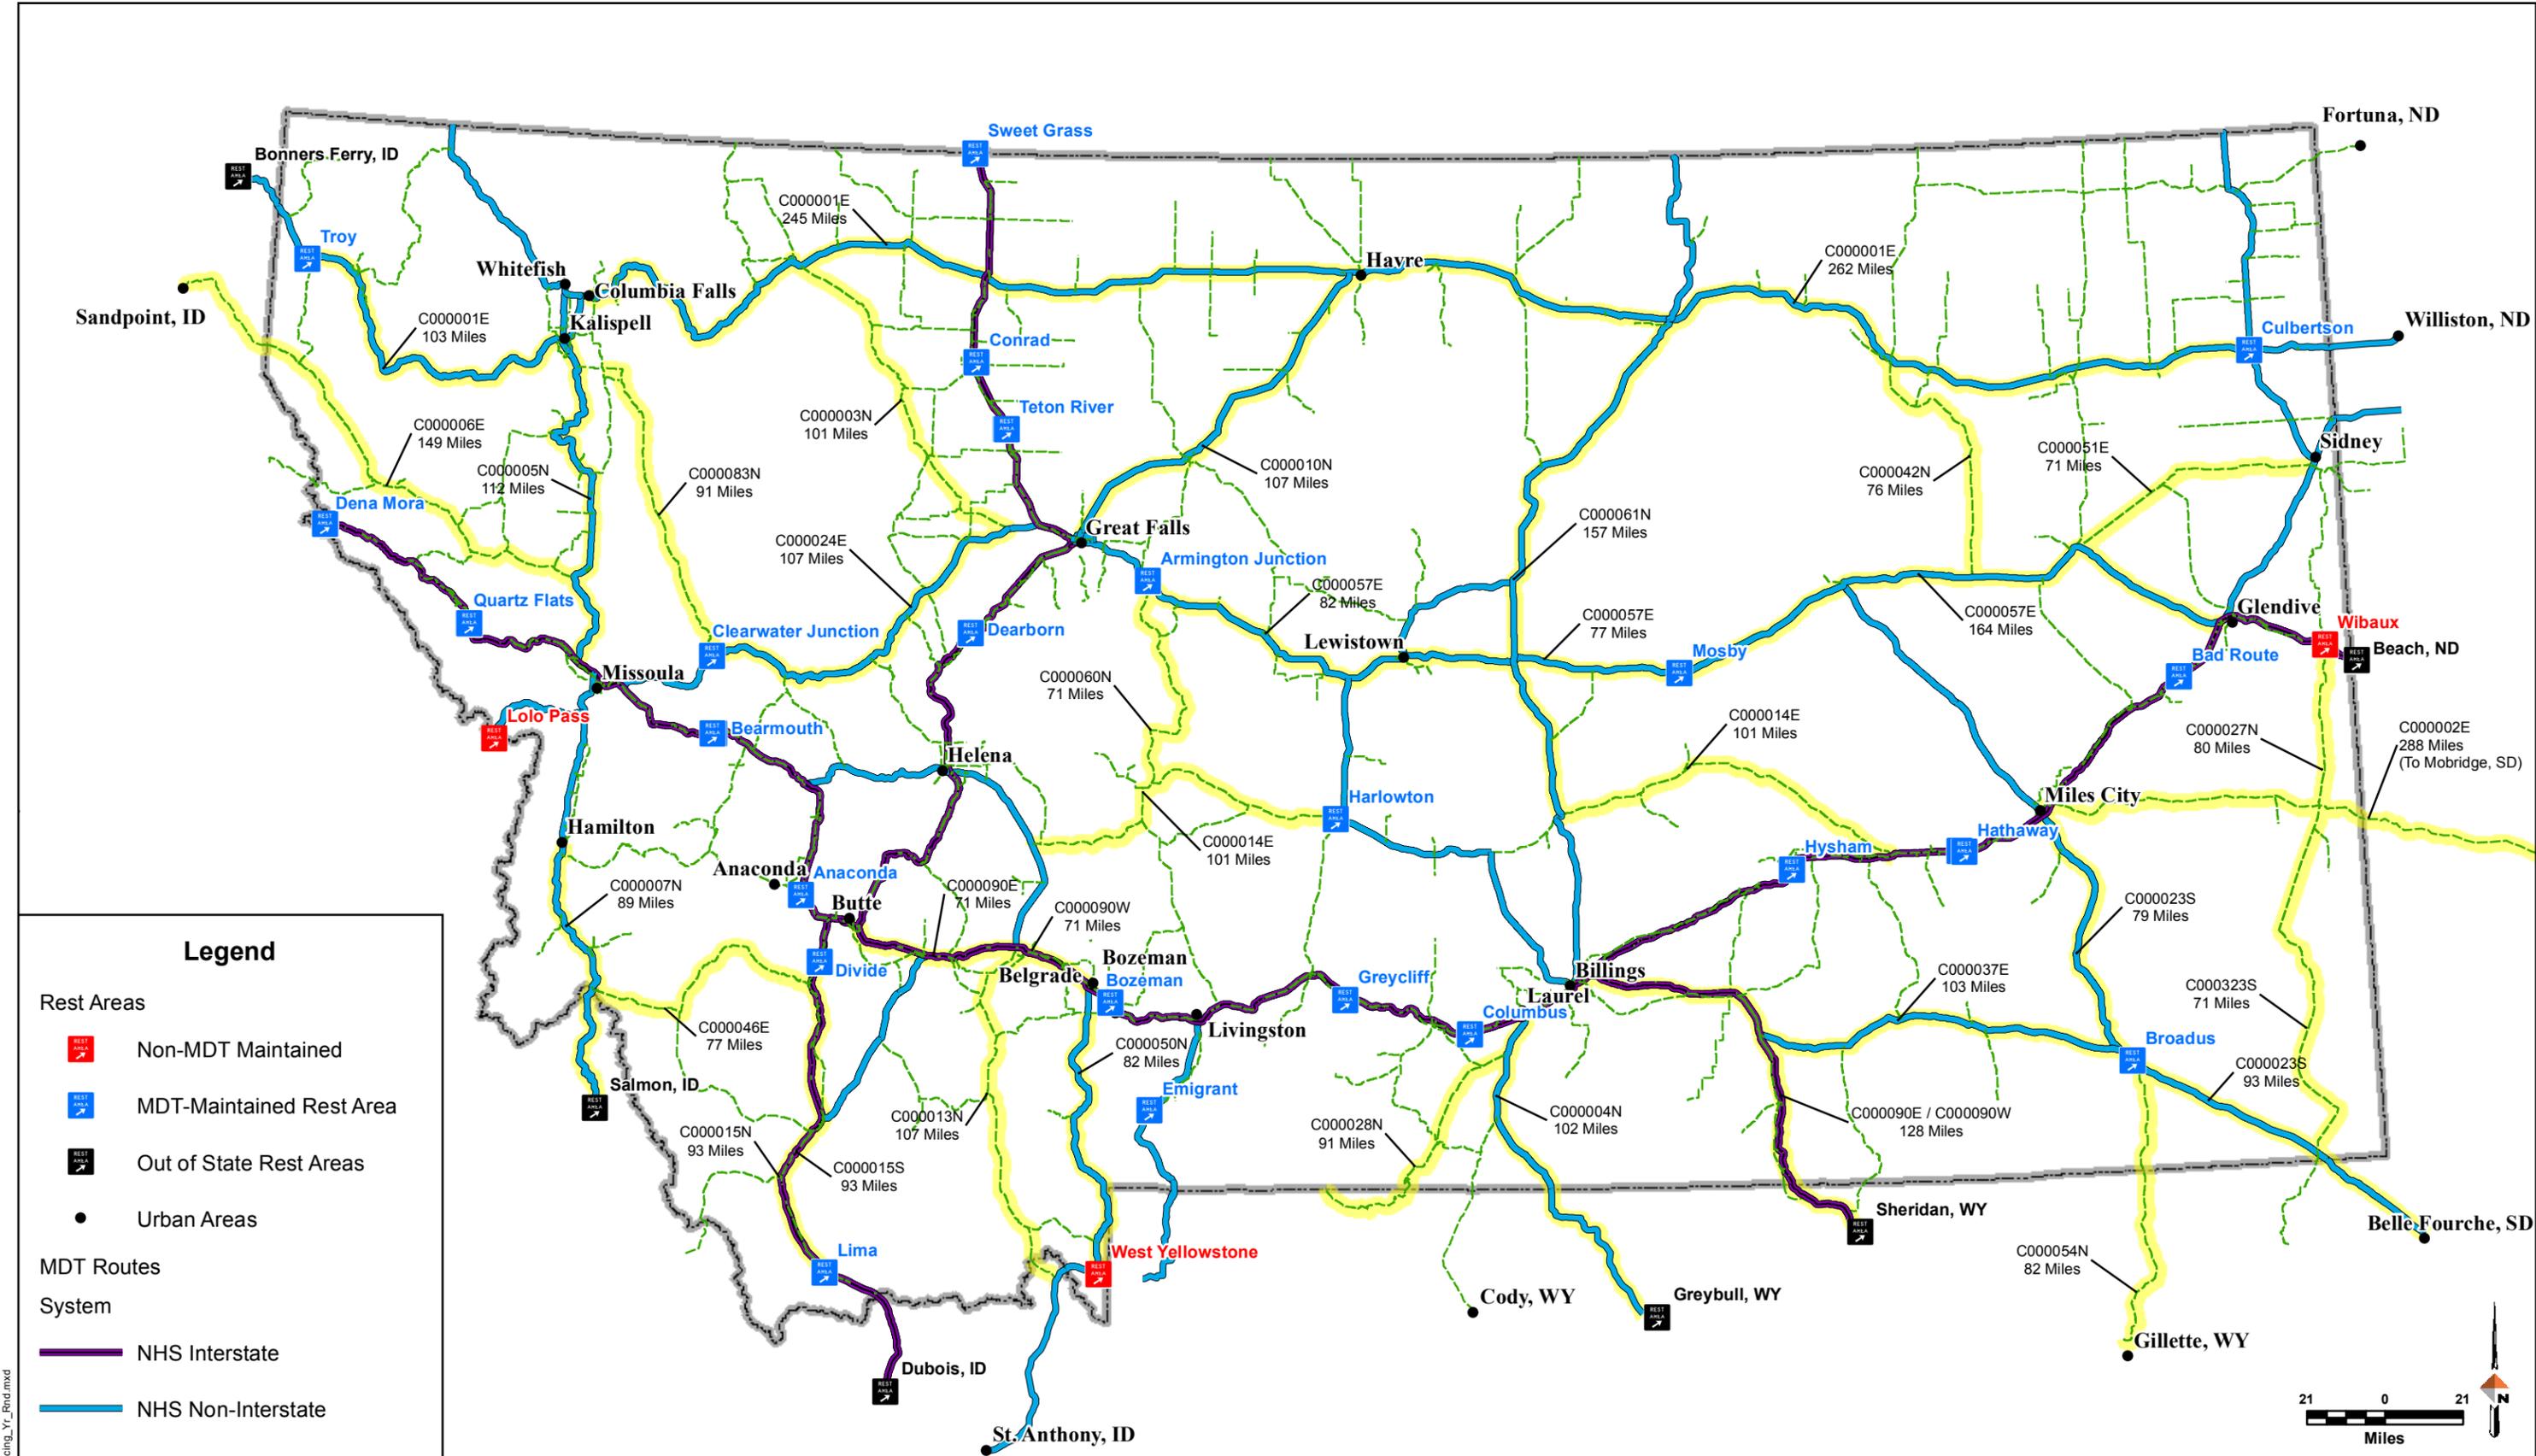
SPACING ANALYSIS

MONTANA REST AREA PLAN UPDATE
REST AREA SPACING
 (Excluding Truck Parking Areas and Seasonal Rest Areas)
