# MONTANA DEPARTMENT OF TRANSPORTATION STREAM MITIGATION MONITORING REPORT

*Ashley Creek  
Flathead County, Montana*

*Project Completed: 2010  
Monitoring Report #3: December, 2015*

MDT Project Number: NH-MT 5-3(59) FST  
Control Number: 2038

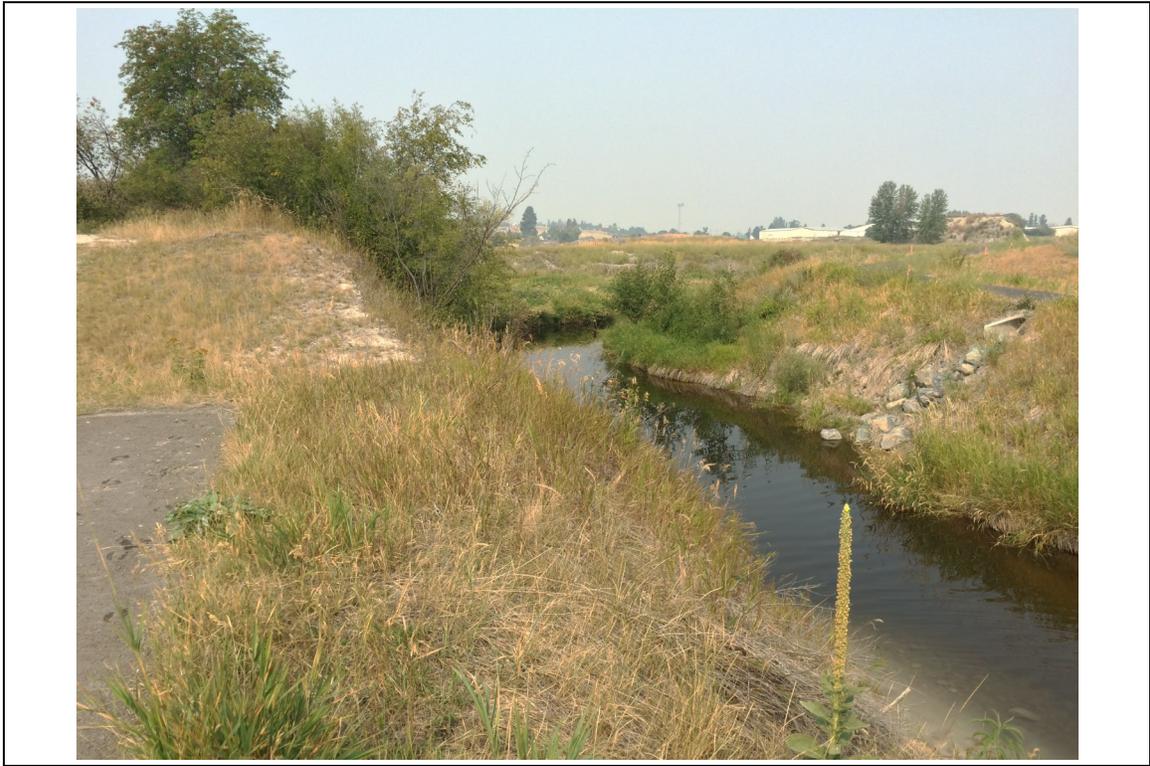
Transect #3 runs through a 50-foot riffle that extends from Station 2+30 to 2+80. Erosion has also been noted along the right bank of Transect #3, with lateral movement of approximately 1 foot over the past two years. Bankfull width at Transect #3 is 27 feet, while the maximum depth is 2.8 feet.

T3 Right: Looking West Upstream

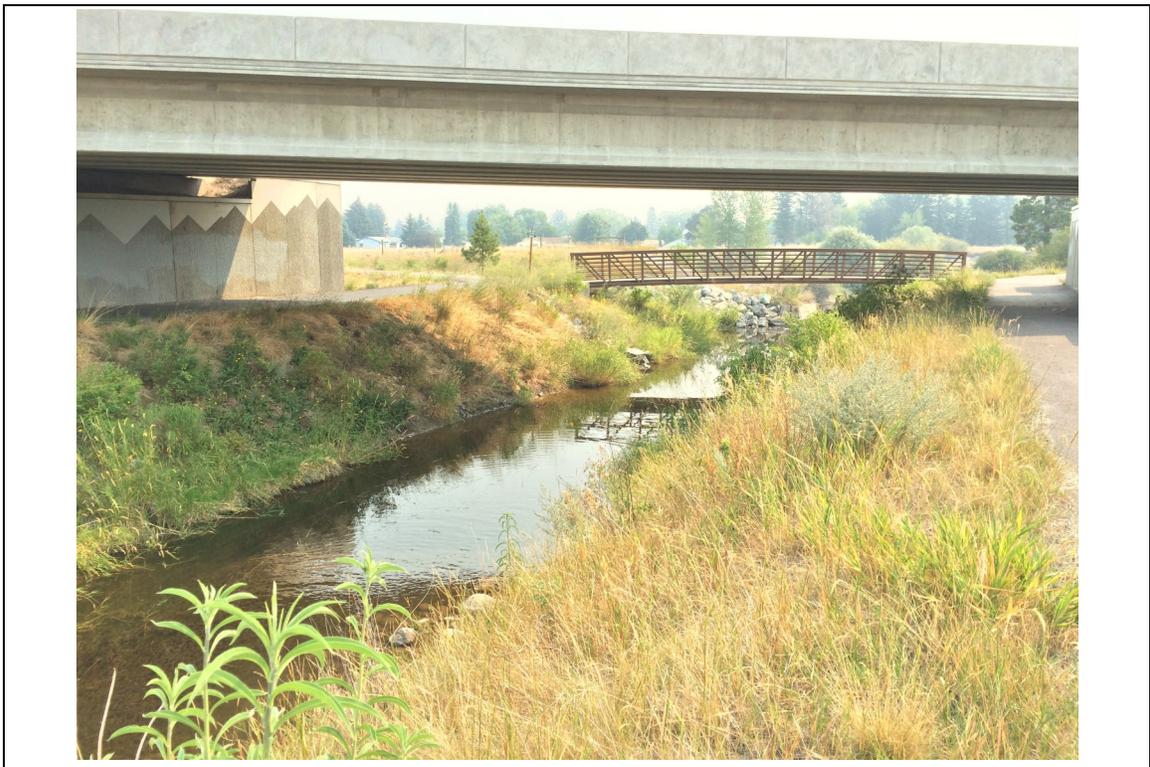
T3 Right: Looking East down stream
