# MONTANA DEPARTMENT OF TRANSPORTATION STREAM MITIGATION MONITORING REPORT

*Mill Creek  
Ravalli County, Montana*

*Project Constructed: 2011  
Monitoring Report #3: December, 2015*

## **STREAM MITIGATION MONITORING REPORT #3**

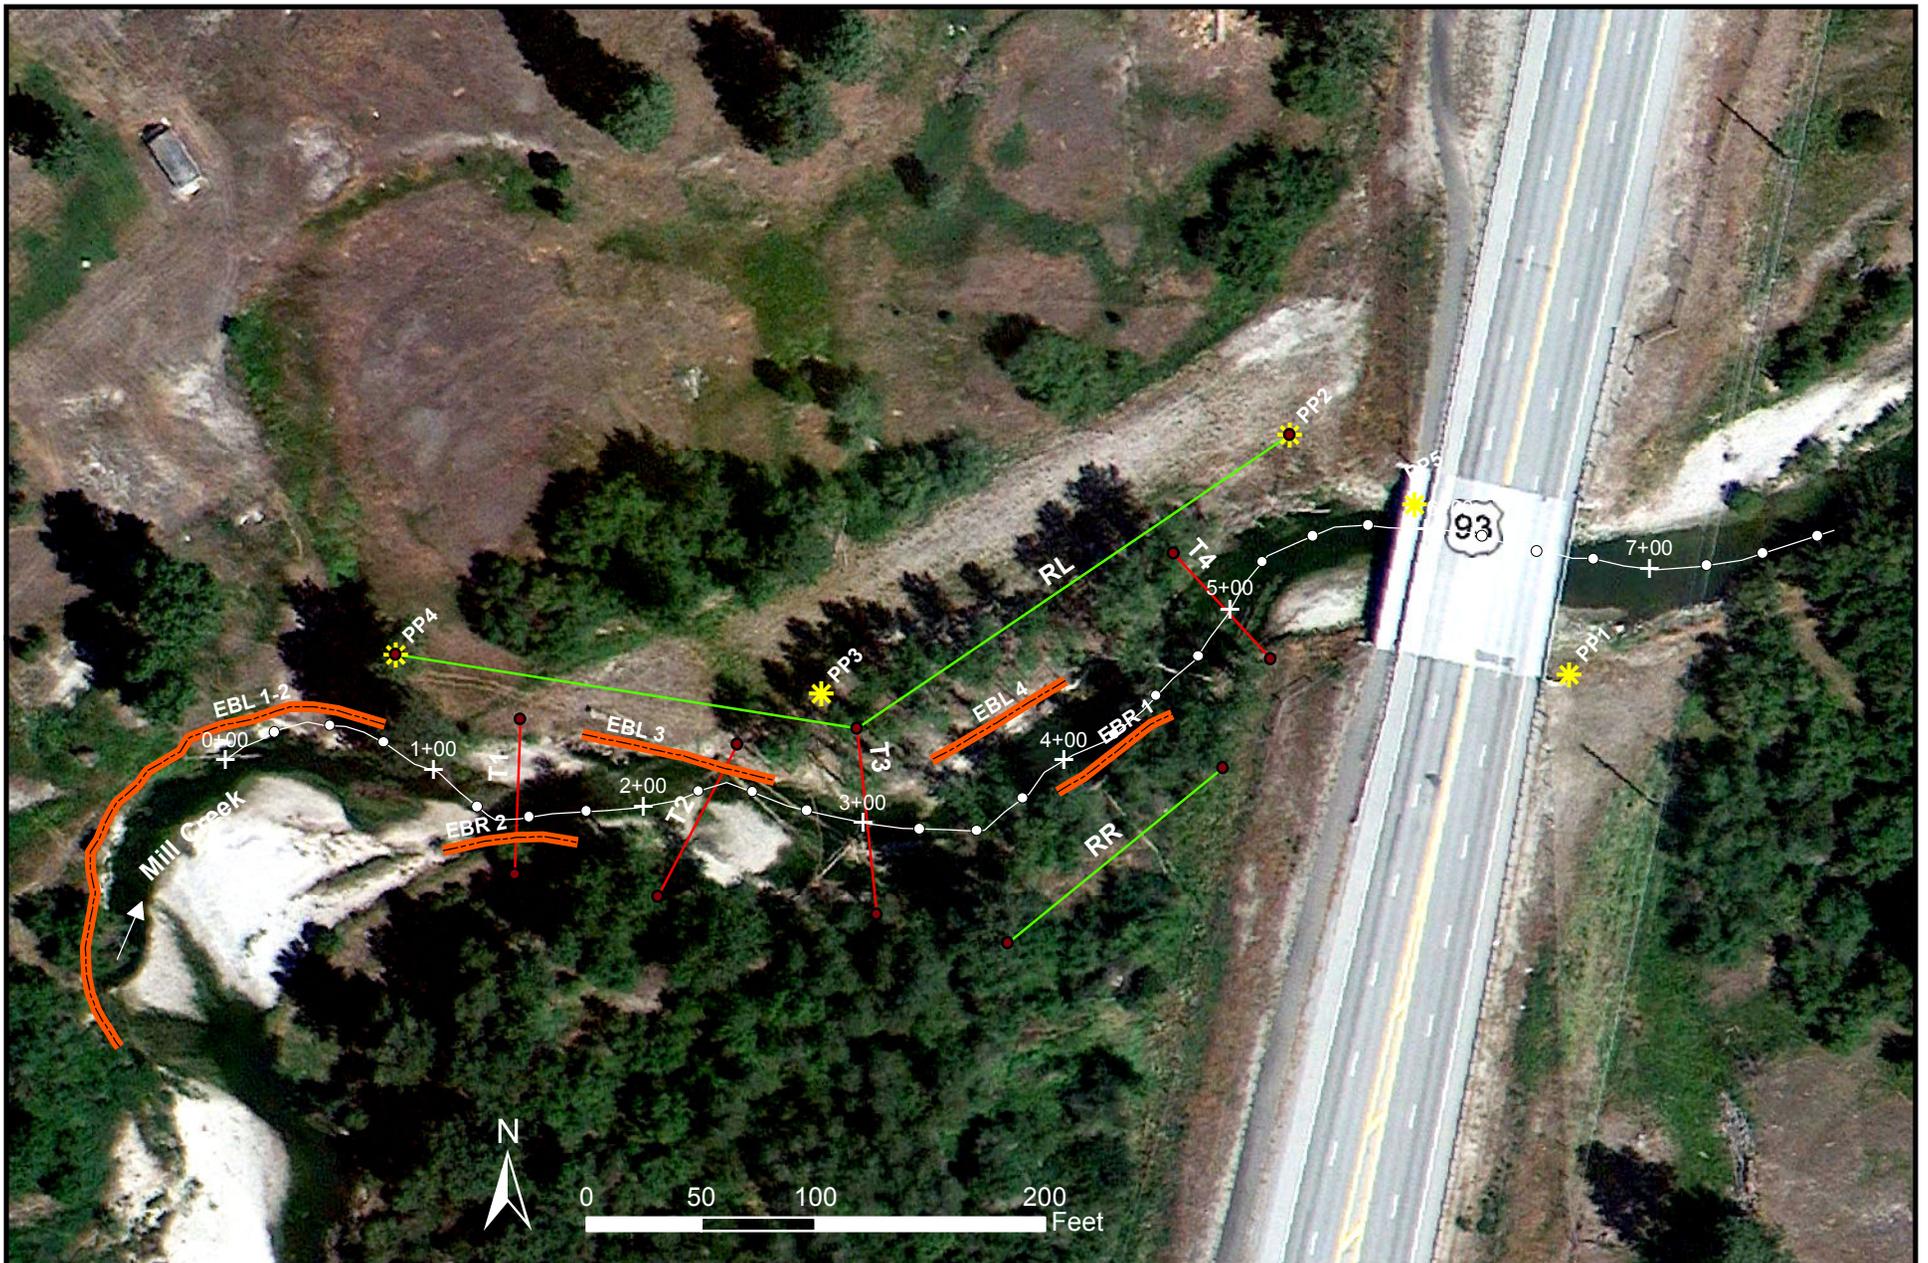
Four eroding banks were observed within the project reach (EBL3, EBL4, EBR1, EBR2). No new bank erosion was noted in 2015. Two eroding banks (EBL1 and EBL2) that were identified in 2013 occur just upstream of the project reach, and combined into one long eroding bank segment in 2014 (herein referred to as EBL1-2). Locations of all eroding banks are illustrated on Figure 2 in Appendix A. A qualitative erosion severity rating was generated by observing substrate composition of the bank, vegetation composition, and whether depositional features such as point bars were developing near the erosional area. Descriptions of erosion at each bank are included in the following section.

Bank erosion at EBL1-2 is due to adjacent point bar formation forcing the channel against a relatively high, herbaceous vegetated stream bank along a relatively sharp meander. Root wads and large rocks placed, but not keyed into the toe of the banks are causing increased scour and block failure. The vegetation community along these banks include speckled alder, Kentucky bluegrass, smooth brome, sedges, common yarrow, western-wheat grass, Canadian goldenrod, and ox-eye daisy. The bank retreated between 3 and 7 feet from 2013 to 2014 and an additional 2-5 feet from 2014

Erosion at EBL3 is occurring at the head of the former channel alignment (now backfilled with gravel, cobble, and soil), and extends downstream approximately 90 feet beyond the root ball of a fallen tree. In 2014, erosion was noted along the toe of the bank, causing it to retreat. The vegetation community consists of short-awn meadow foxtail, white and red clover, Kentucky bluegrass, common tansy, and ox-eye daisy. Erosion along this bank did not appear to advance in length or retreat further in 2015. The bank has retreated approximately 1 to 2 feet since 2013. Based on the combination of erosion factors, severity of erosion along EBL3 is considered low.

At eroding bank EBL4, bank sloughing has continued to occur upstream and downstream of several root balls that fell into the channel. The 64-foot long eroding bank has several root balls from cut trees along the toe, which may have been used to construct the log and root wad revetment just downstream. Bank instability at this location was potentially caused by removal of the trees for use in log revetment construction, or from natural channel adjustments following construction. The dominant vegetation along the bank includes reed canary grass and smooth brome. The bank retreated approximately 1 to 2 feet between 2013 and 2014, but does not appear to have retreated further in the past year. Erosion severity along this bank is considered low to moderate.

At eroding bank EBR1, several trees have fallen into the channel due to undercutting directly across the channel from EBL4. Trees have also fallen away from the channel, providing evidence of undercutting and block failure, or blow down. Photo evidence does not indicate further erosion beneath the fallen trees, and it does not appear this bank has laterally migrated in the past year. The vegetation community along this bank consists of cottonwood, speckled alder, smooth brome, and bog birch. Bank erosion severity along this 58-foot segment is considered low.

Erosion at EBR2 was noted along 65 feet of the channel across from the head of the deactivated stream channel. Erosion at this location is due to channel adjustments and scour along the outside of a meander. No additional erosion was noted over the past year at this bank. The vegetation community is dominated by reed canary grass with a speckled alder and bog birch overstory. These factors contribute to an overall low erosion severity rating. Of note, the adjustment in channel alignment due to erosion at EBL1-2 may eventually result in additional erosion at eroding bank EBR2 due to high flows directed toward eroding bank EBR2.

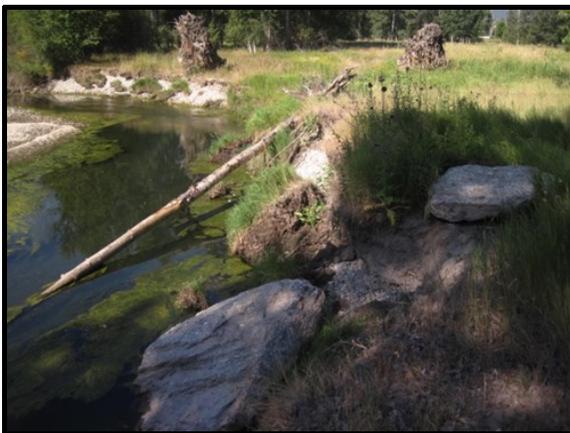
**Photo Point 4.4—2013**  
**Description:** View of boulders, logs, and root wads placed on bank. **Compass:** 248 (West-Southwest)

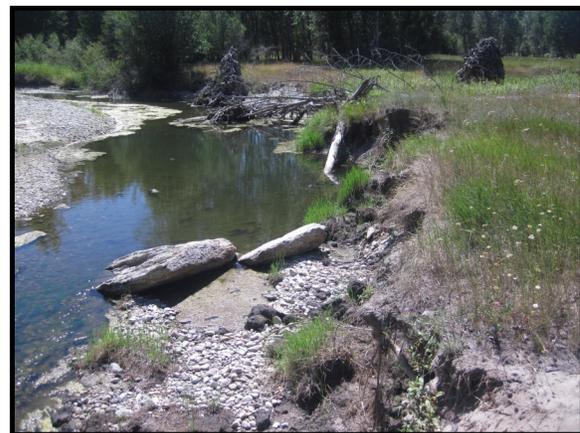
**Photo Point 4.3—2015**  
**Description:** View of boulders, logs, and root wads placed on bank. **Compass:** 248 (West-Southwest)

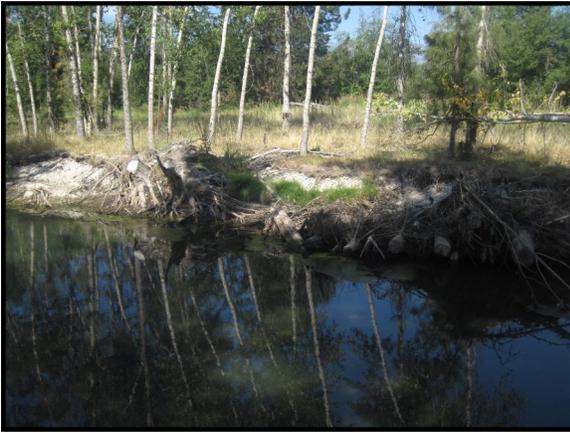
**Additional Photo 5**  
**Description:** Eroding streambank EBL4 in 2013.

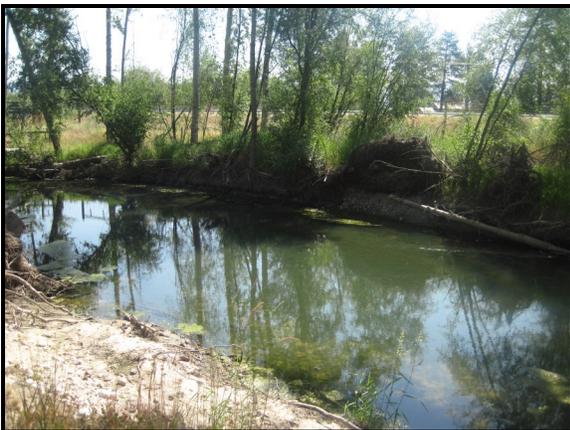
**Additional Photo 6**  
**Description:** Eroding streambank EBR1 in 2013.

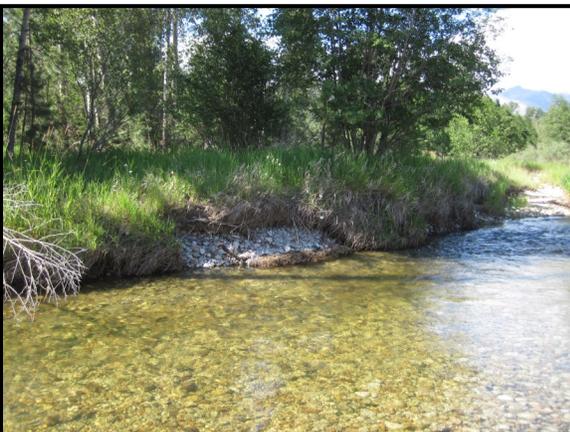
**Additional Photo 7**  
**Description:** Eroding streambank EBR2 in 2014.

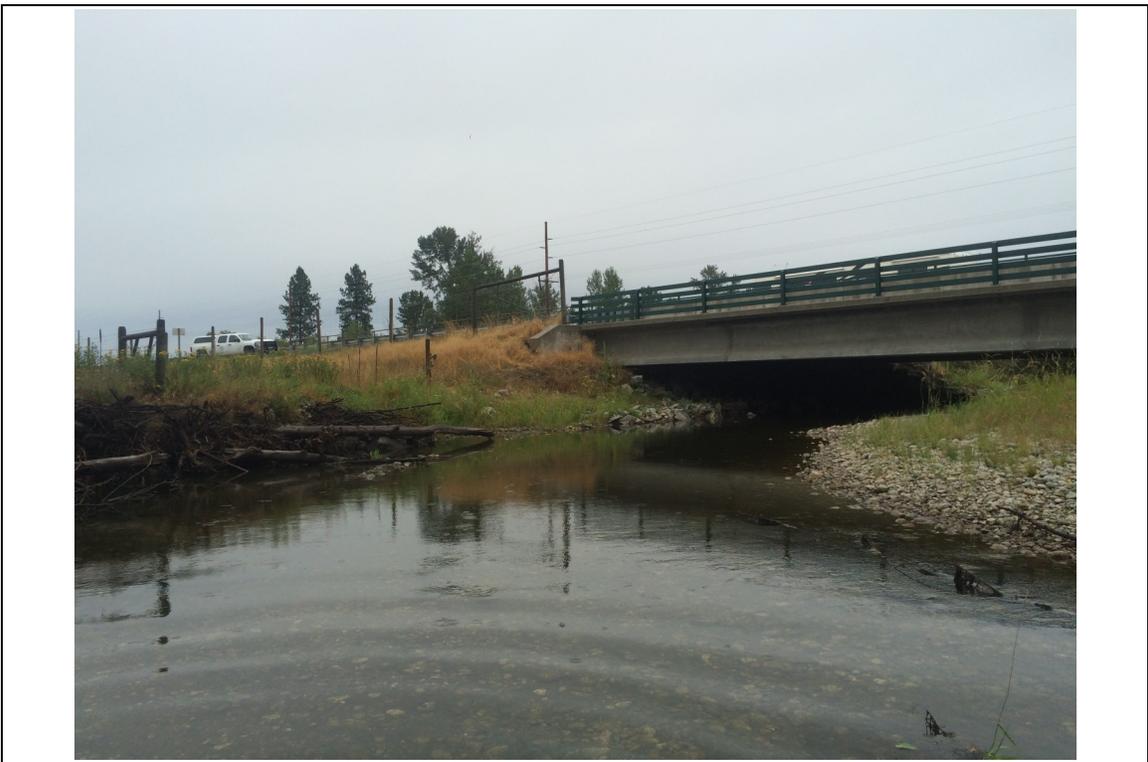
T4 LOOKING EAST DOWNSTREAM FROM MIDDLE CREEK

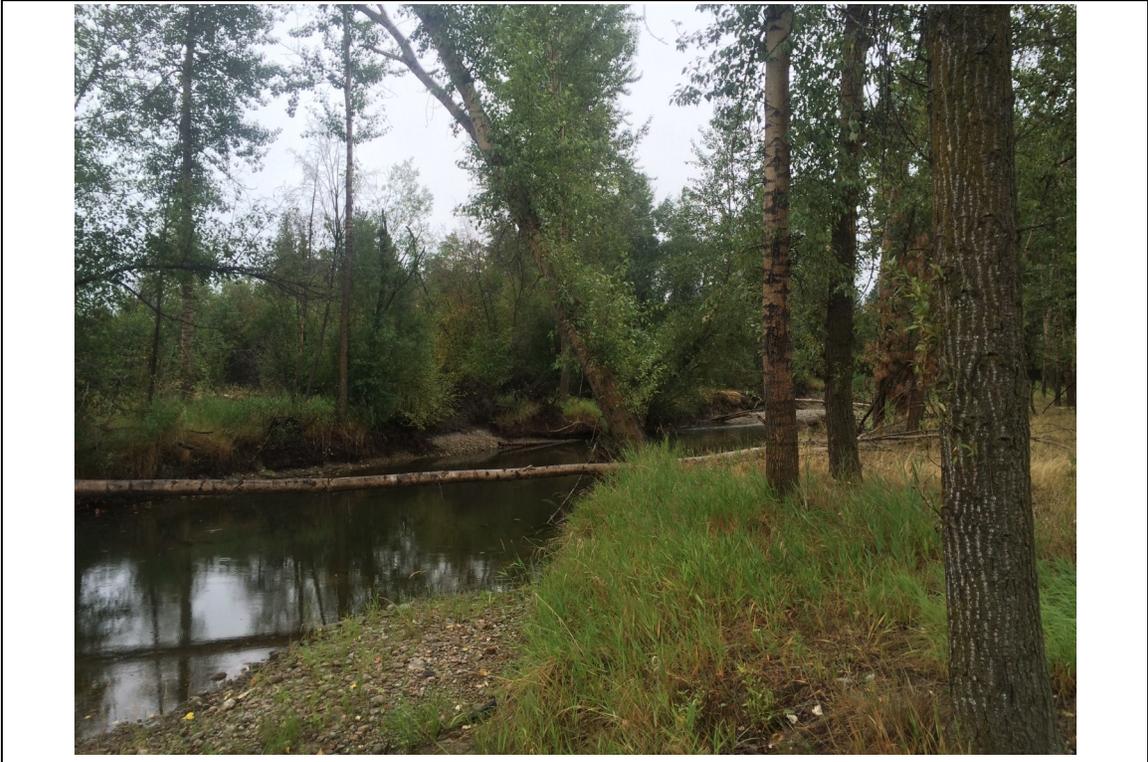
T4 LOOKING WEST UPSTREAM FROM NORTH BANK

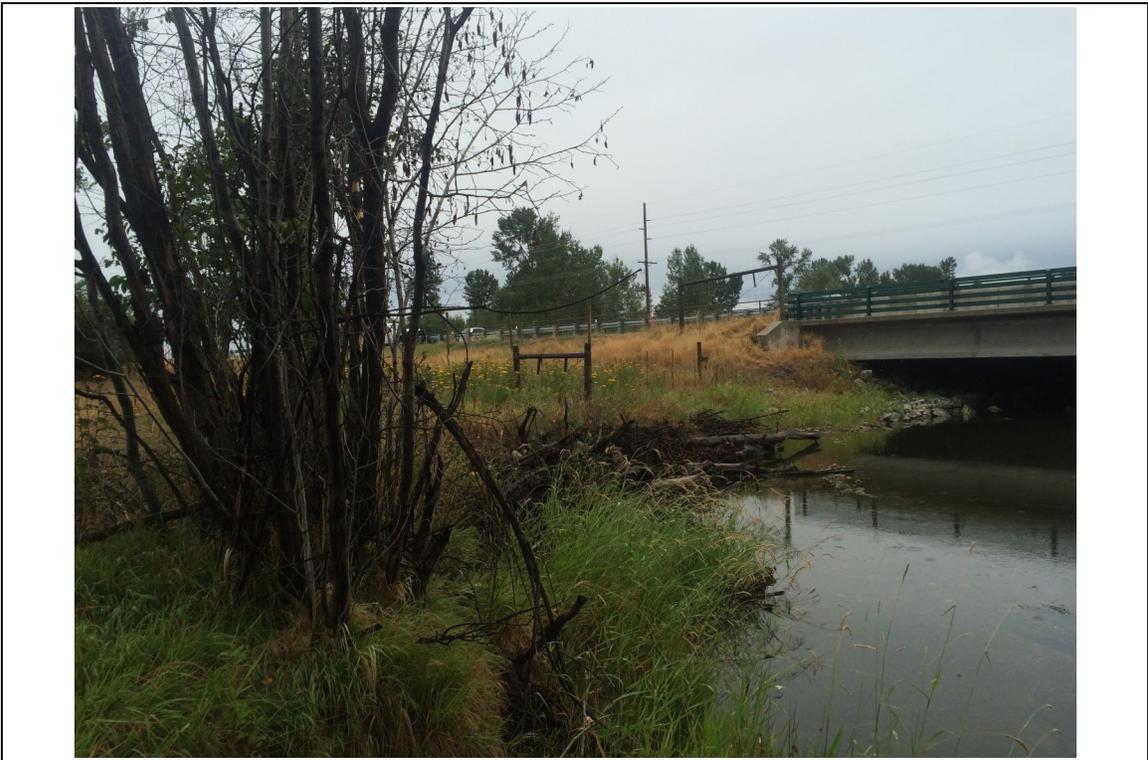
T4 LOOKING EAST DOWNSTREAM FROM NORTH BANK
